Ocean Way – extract of Stability Booklet

Report on aspects of the flooding that led to the loss of *Ocean Way*

***Report on aspects of the flooding
which led to loss of FV 'Ocean Way'
Marine Accident Investigation Branch***

April 2017

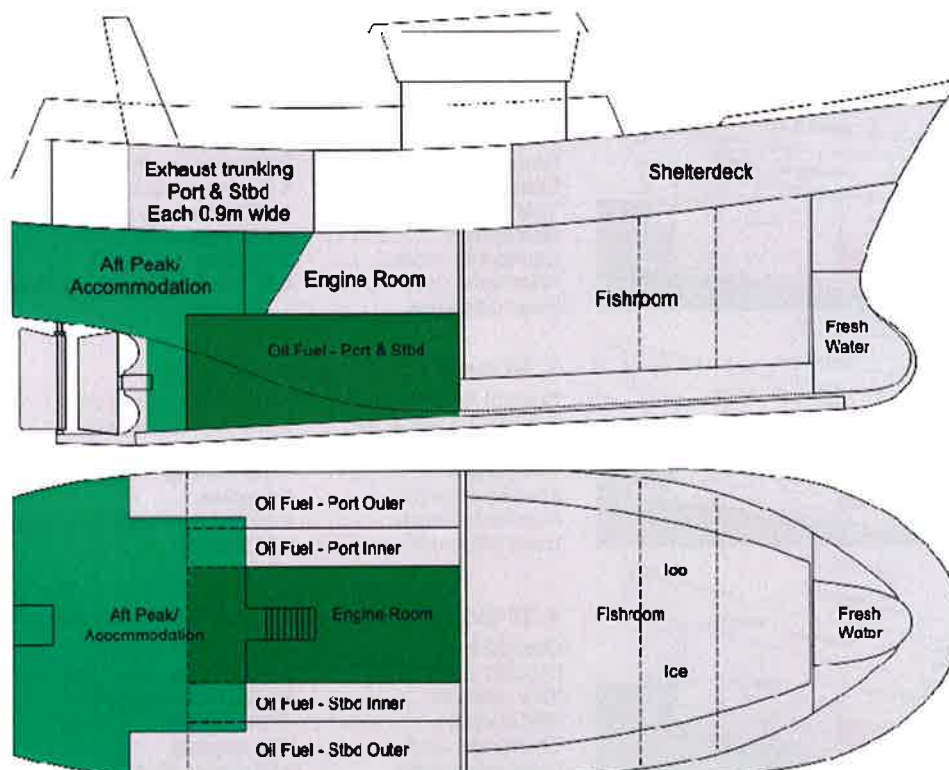
Diagram 4 – Configuration of volumes considered to flood

For the purposes of this report, it has been considered that loss became inevitable once the seawater level had reached the door sill above the aft peak escape hatch on the centreline (see diagram 2). After this event, flooding into the aft peak increased dramatically and the rapidly increasing angle of equilibrium (see data for snapshot No. 8 in Section 4) that resulted would inevitably immerse other apertures into compartments further forward.

The area coloured light green in the diagram below show the contours of the aft peak/ accommodation used in the damaged state calculations, the results of which comprise Section 4. The dark green area shows the extent of the engine room bilge which is also assumed to have partially flooded for the analysis in Section 8. All other volumes were considered to remain intact until loss became inevitable.

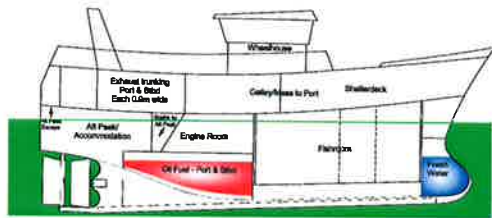
1. Condition prior to accident

Draught forward: 4.364 metres about keel line
 Draught t AP: 5.138 metres about keel line
 Trim over LBP: 0.276 metres by bow
 GMf upright: 0.599 metres
 Equilibrium angle: 0 degrees
 Floodwater depth: 0 metres

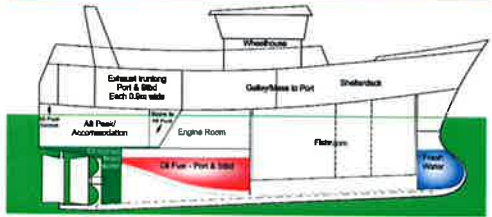
2. 10 tonnes floodwater in aft peak

Draught forward: 4.251 metres about Base Line
 Draught 1m fwd of AP ..: 4.231 metres about Base Line
 Trim over LBP: 0.021 metres by bow
 GMf upright: 0.524 metres
 Equilibrium angle: 0 degrees
 Floodwater depth: 3.48 metres (flooding via breach only)
 Head difference: 1.71 metres

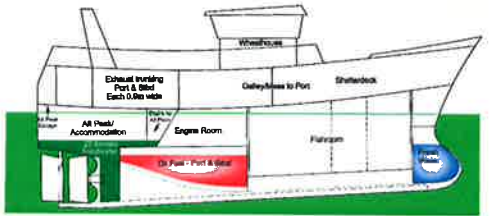
3. 20 tonnes floodwater in aft peak

Draught forward: 4.156 metres about Base Line
 Draught 1m fwd of AP ..: 4.399 metres about Base Line
 Trim over LBP: 0.254 metres by stern
 GMf upright: 0.483 metres
 Equilibrium angle: 0 degrees
 Floodwater depth: 3.75 metres (flooding via breach only)
 Head difference: 1.50 metres

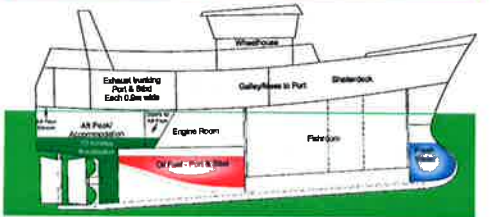
4. 30 tonnes floodwater in aft peak

Draught forward: 4.048 metres about Base Line
 Draught 1m fwd of AP ..: 4.578 metres about Base Line
 Trim over LBP: 0.556 metres by stern
 GMf upright: 0.381 metres
 Equilibrium angle: 0 degrees
 Floodwater depth: 4.01 metres (flooding via breach only)
 Head difference: 1.42 metres

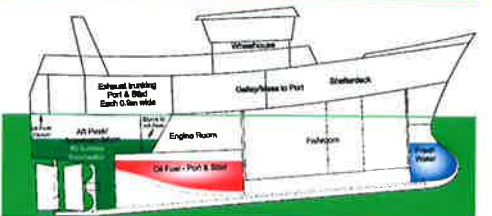
5. 40 tonnes floodwater in aft peak

Draught forward: 3.913 metres about Base Line
 Draught 1m fwd of AP ..: 4.768 metres about Base Line
 Trim over LBP: 0.897 metres by stern
 GMf upright: 0.291 metres
 Equilibrium angle: 0 degrees
 Floodwater depth: 4.26 metres (flooding via breach only)
 Head difference: 1.35 metres

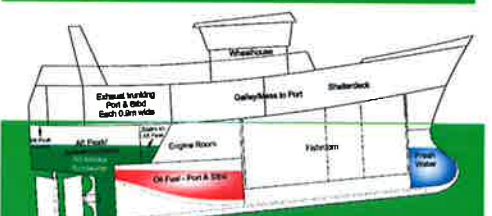
6. 50 tonnes floodwater in aft peak

Draught forward: 3.765 metres about Base Line
 Draught 1m fwd of AP ..: 5.010 metres about Base Line
 Trim over LBP: 1.306 metres by stern
 GMf upright: 0.170 metres
 Equilibrium angle: 0 degrees
 Floodwater depth: 4.51 metres (flooding via breach only)
 Head difference: 1.30 metres

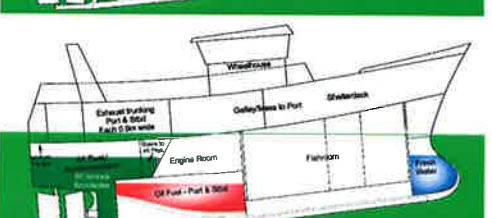
7. 60 tonnes floodwater in aft peak

Draught forward: 3.582 metres about Base Line
 Draught 1m fwd of AP ..: 5.339 metres about Base Line
 Trim over LBP: 1.848 metres by stern
 GMf upright: 0.015 metres
 Equilibrium angle: 0 degrees
 Floodwater depth: 4.74 metres (flooding via breach only)
 Head difference: 1.31 metres

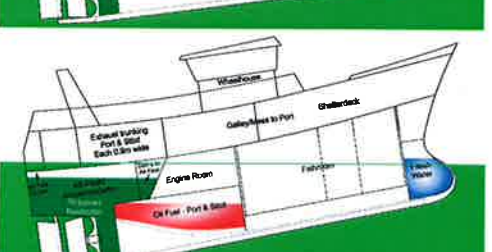
8. 70 tonnes floodwater in aft peak (open escape hatch immersed)

Draught forward: 2.100 metres about Base Line
 Draught 1m fwd of AP ..: 5.642 metres about Base Line
 Trim over LBP: 3.178 metres by stern
 GMf upright: -0.241 metres
 Equilibrium angle: 50.4 degrees
 Floodwater depth: 4.98 metres (flooding via breach and escape hatch)
 Head difference: 0.81 metres

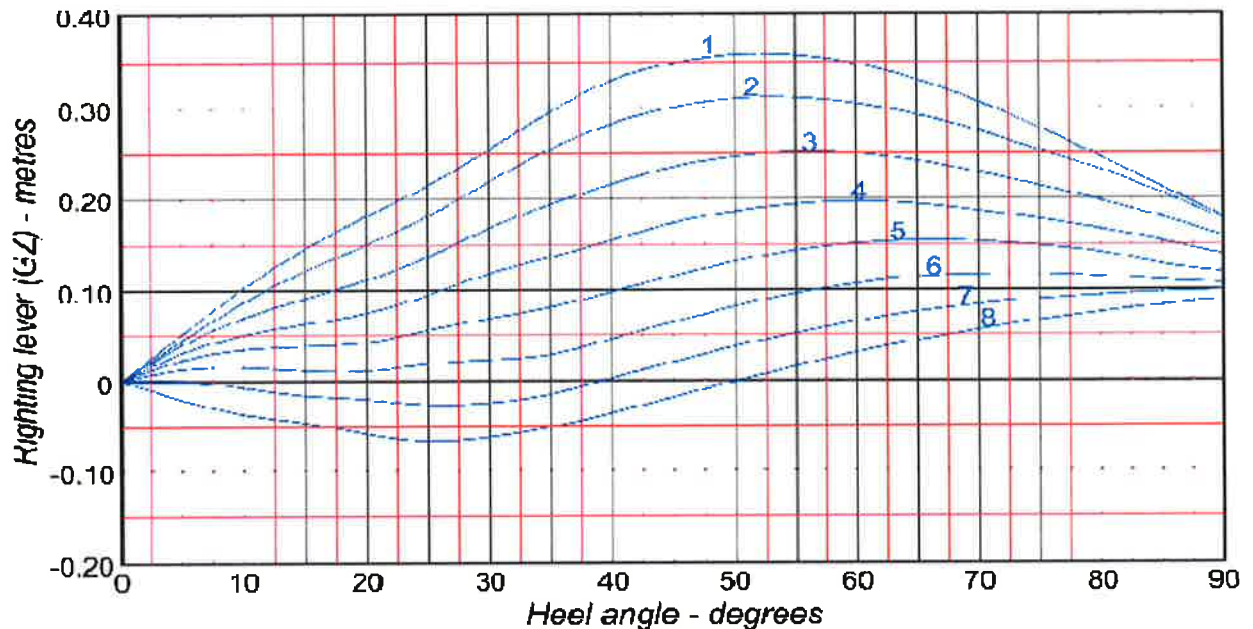
Diagram 6 – Righting lever curves at 10 tonne floodwater increments

It should be noted that the accuracy of these curves is reliant in large part on the precision of the lightship figures (displacement weight and centre of gravity location) recorded at the 2002 inclining trial and on the assumptions that flooding was symmetrical and that the transverse centre of gravity was on the centreline. It should be noted in this context that if the centre of gravity had been, for example, 25mm off the centreline, the vessel would not have been upright with 50 tonnes of floodwater aboard (see data for snapshot 6 on the previous page) but would have had an angle of heel at equilibrium of over 24 degrees.

These considerations may have had an influence on the rate of flooding into the aft peak. If the vessel was heeling before the accident a breach in the hull would have moved significantly further below the water surface (thereby increasing the rate of flooding) as the vessel heeled in response to a negative GM (upright) than otherwise.

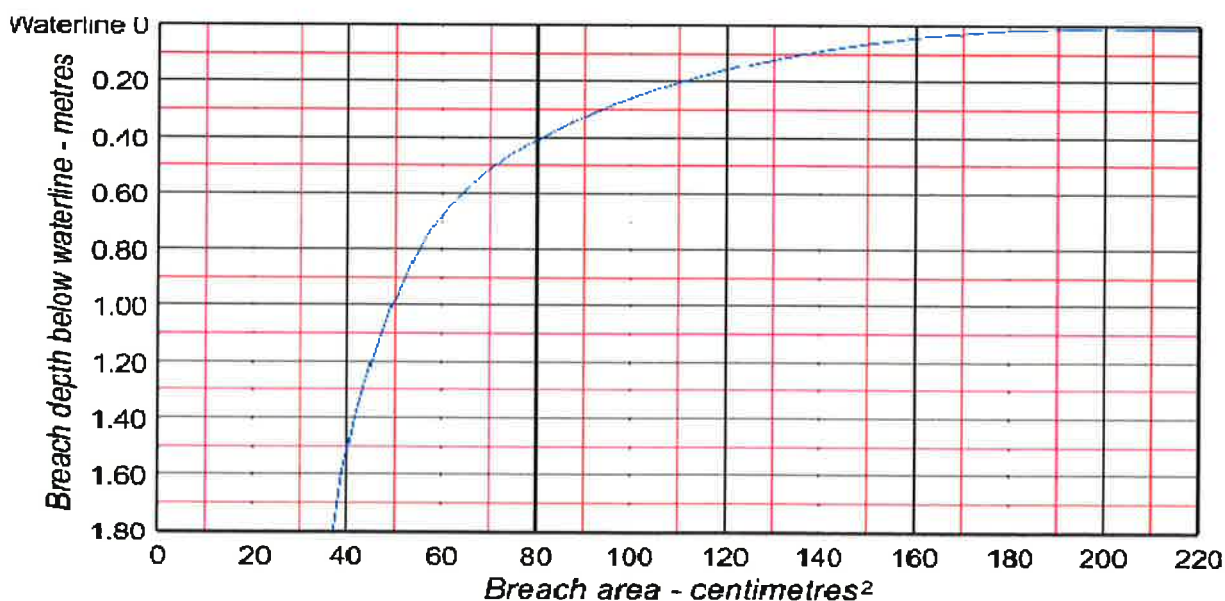
Diagram 7 – Plot of breach depth against area

If the damage occurred at the proposed maximum 1.8 metres below the waterline and the flow rate was 790 litres per minute, the breach area was approximately 37cm² in area. Assuming the damage was at half that depth (i.e. 0.9 metres) with the same flow rate, the breach area would increase to about 52cm². Had the damage been sustained just below the waterline, for example 0.2 metres below, the area would increase to about 111cm². The diagram below plots breach area against depth below waterline at 790 litres/minute flow rate:
