**INCIDENT**

<b>Aircraft Type and Registration:</b>	Jetstream 4100, G-MAJI	
<b>No &amp; Type of Engines:</b>	2 Garrett Airesearch TPE 331-14HR-804H turboprop engines	
<b>Year of Manufacture:</b>	1993	
<b>Date &amp; Time (UTC):</b>	1 May 1998 at 1550 hrs	
<b>Location:</b>	Southampton Airport	
<b>Type of Flight:</b>	Public Transport	
<b>Persons on Board:</b>	Crew - 3	Passengers - 24
<b>Injuries:</b>	Crew - None	Passengers - None
<b>Nature of Damage:</b>	Damage to the right-hand starter/generator electrical terminal block and electrical supply cables. A small fire in lower engine cowling	
<b>Commander's Licence:</b>	Airline Transport Pilot's Licence	
<b>Commander's Age:</b>	37 years	
<b>Commander's Flying Experience:</b>	2,769 hours (of which approximately 750 were on type) Last 90 days - approximately 160 hours Last 28 days - 75 hours	
<b>Information Source:</b>	AAIB Field Investigation

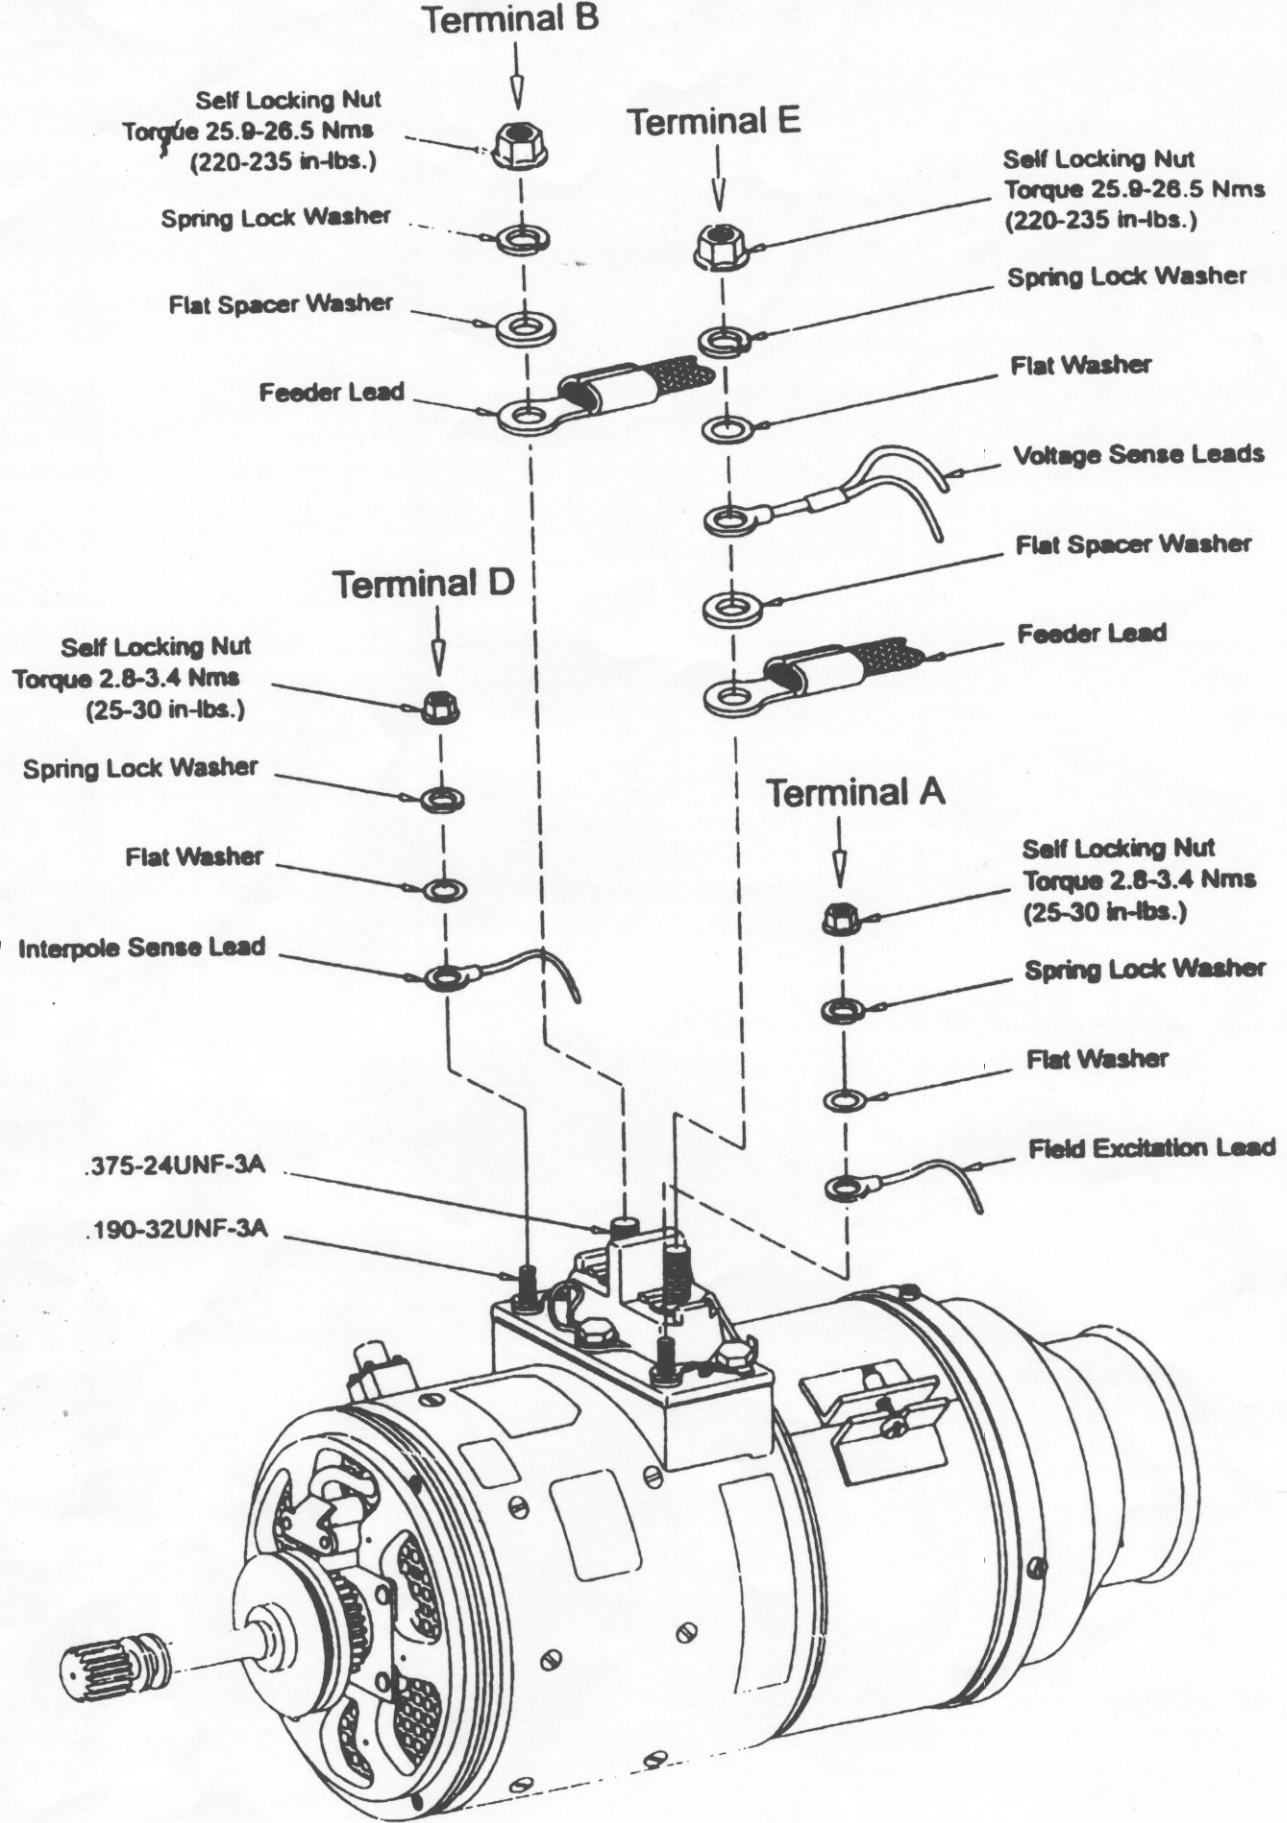
**Figure 1** Correct starter/generator terminal build-up

Subsequent inspection of the right engine found that the starter/generator's main electrical terminal block had suffered severe heat damage and that the positive electrical supply cable was no longer connected to the 'B' terminal (see diagram at Figure 1), although the self-locking terminal nut was still

located on the terminal threads. The 'eye' end of the positive supply cable tag had been partially burnt away to the extent that only half of the circumference of the eye end of the tag remained attached to the cable. The smoke had been caused by a rag, which had been inadvertently left in the lower engine cowling, that had been ignited by pieces of molten metal which had fallen from the terminal block.

The starter/generator unit was removed from the aircraft and taken to a manufacturer's approved overhaul organisation for detailed examination. This examination revealed that the B (positive) terminal of the starter generator had been incorrectly assembled (Figure 1) in that the large spacer washer had been fitted between the stator lug and the supply cable eye end. This incorrect assembly had resulted in the spacer washer being part of the electrical current path between the supply cable eye end and the stator lug, a purpose for which it was not designed; the spacer washer was manufactured from mild steel and effectively reduced the contact area between the supply cable eye end and the stator lug. Overheating, arcing and melting had consequently occurred due to the resultant high resistance at this supply connection. There was also no evidence of the lock washer which should have been fitted below the lock nut. In addition, it was noted during this examination that both the positive ('B') and negative ('E') terminals were identical, with no identifying marks.

Re-issued SIL 24-005 with two diagrams for the terminal build-up configurations.

Revised the AMM to improve the clarity of the starter/generator terminal build-up description.

Revised the IPC to correct the error in the terminal build-up illustration.

Introduced labels on starter/generator units to show the terminal build-up and to state the torque value for the studs.
