Operational incident following signal passed at danger, Bethnal Green, 8 April 2018

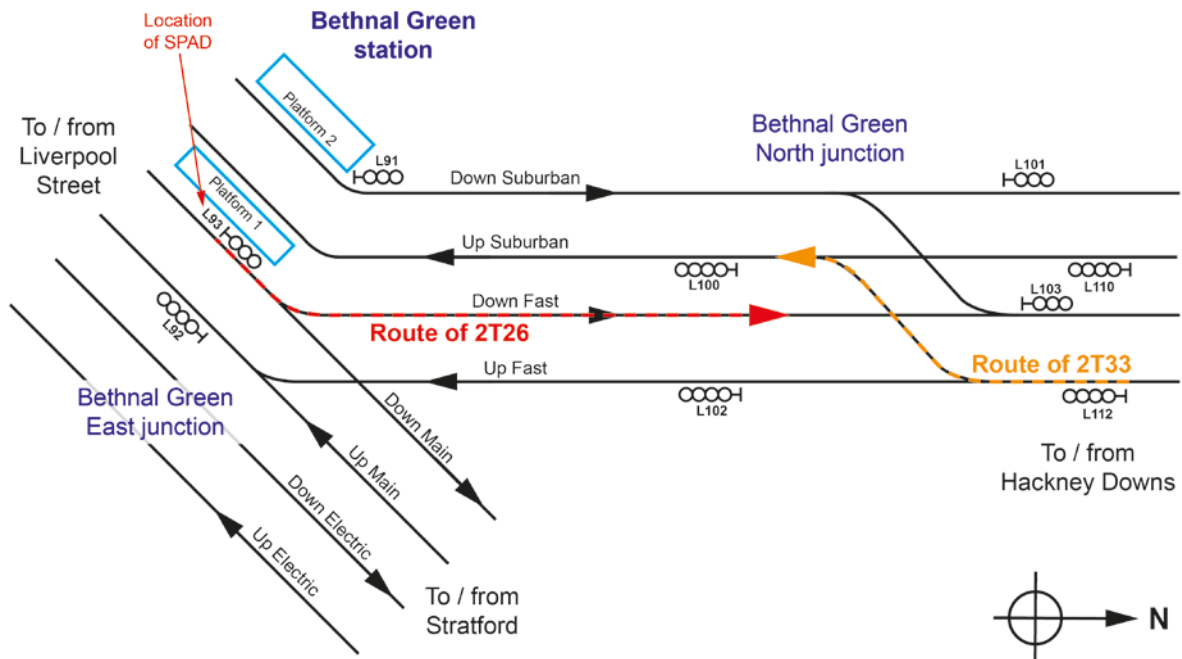
Simplified schematic layout of Bethnal Green East and North junctions

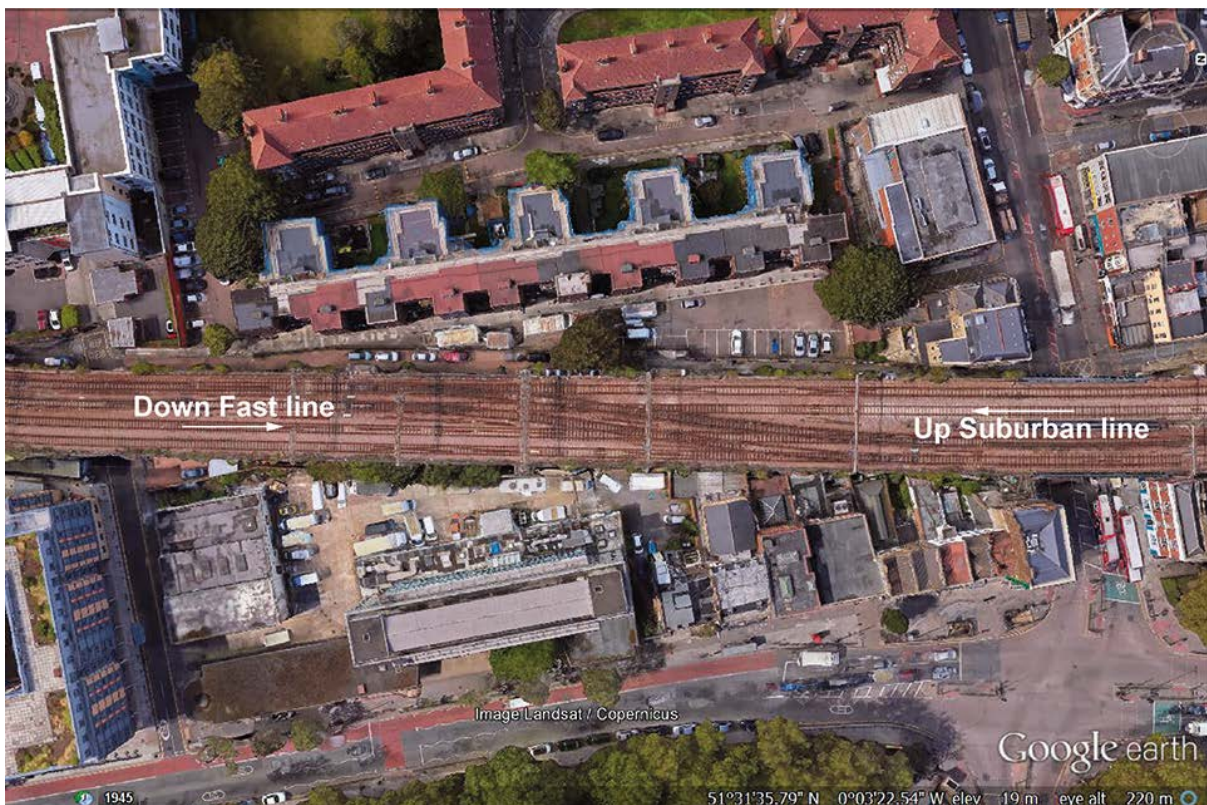
Aerial view of Bethnal Green North junction
