ACCIDENT

Aircraft Type and Registration:	1) North American P-51D, Mustang, G-SHWN 2) North American P-51D-20 (Modified), Mustang, G-BIXL
No & Type of Engines:	1) 1 Rolls-Royce V-1650-7 piston engine 2) 1 Packard Motor Car Co Merlin V-1650-7 piston engine
Year of Manufacture:	1) 1944 (Serial no: 122-40417) 2) 1944 (Serial no: 38675)
Date & Time (UTC):	23 September 2017 at 1530 hrs
Location:	Near Duxford Airfield, Cambridgeshire
Type of Flight:	1) Private 2) Private
Persons on Board:	1) Crew - 1 Passengers - None 2) Crew - 1 Passengers - None
Injuries:	1) Crew - None Passengers - N/A 2) Crew - None Passengers - N/A
Nature of Damage:	1) Propeller 2) Horizontal stabiliser
Commander's Licence:	1) Airline Transport Pilot Licence 2) Airline Transport Pilot Licence
Commander's Age:	1) 52 years 2) 53 years
Commander's Flying Experience:	1) 18,000 hours (of which 600 were on type) Last 90 days - 9 hours Last 28 days - 5 hours 2) 19,000 hours (of which 87 were on type) Last 90 days - 119 hours Last 28 days - 37 hours

Information Source:	AAIB Field Investigation

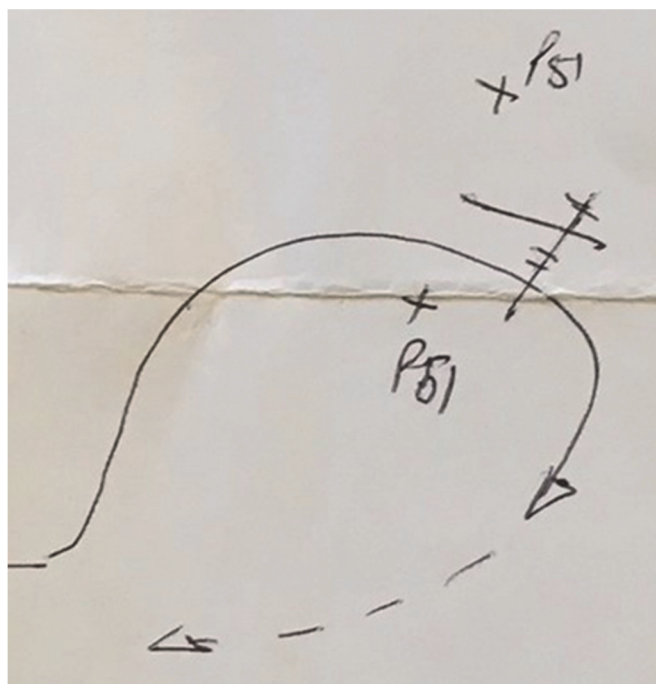
Figure 1

G-BIXL's pilot stated that when he draws a diagram of a formation display he usually annotates an aircraft symbol with 'ME' to indicate which aircraft is his in the formation. On this occasion he annotated 'P51' against both symbols representing the P-51s (Figure 1). He is "fairly sure" that had he differentiated between the two symbols, he would not have joined the B-17 on the right. He stated that he would ensure that he always does so in future.

Part of G-BIXL's pilot's annotated diagram

At the briefing, the pilots of the DC-3, C-47, B-17 and P-51s were given a written description of the flypast by the leader. During the briefing, G-BIXL's pilot drew a diagram of the flypast with aircraft symbols. While he would normally annotate such a diagram with 'ME' against the symbol depicting his aircraft, in this case he annotated 'P51' for both the symbols that represented the P51s. Having done this, he was not subsequently able to identify from the sketch which side he was briefed to join the B-17. However, he added that had he been in any doubt, he would have sought clarity over the radio.

He stated that in future he would keep the lead aircraft visual until it is established in formation with the flypast's lead aircraft before moving to his briefed side. Had he believed G-SHWN was on the incorrect side he would have sought clarity over the radio.

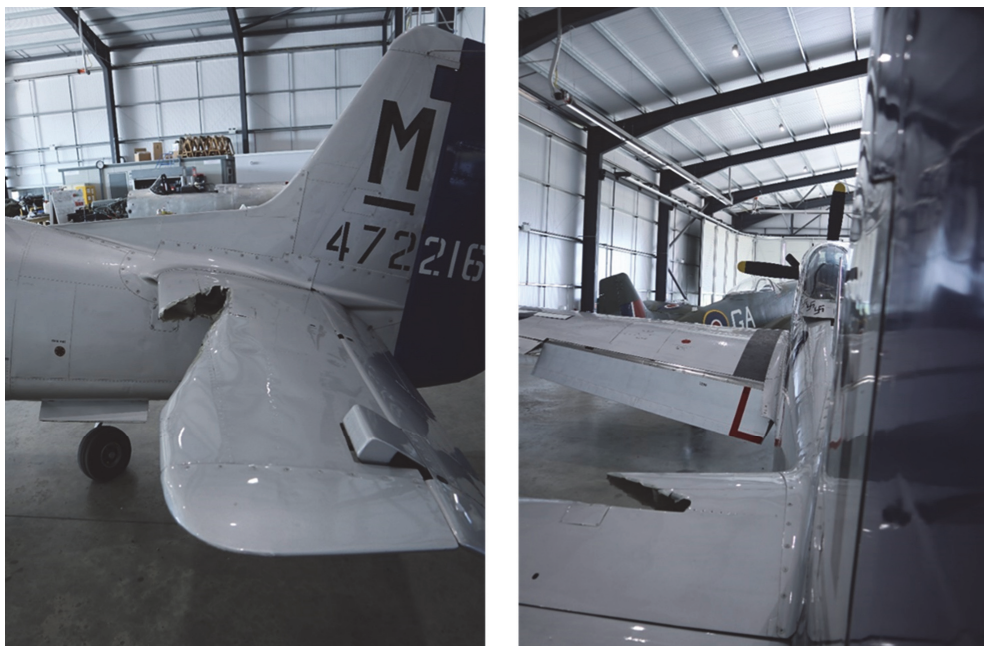
Figure 3

Damage was present on both aircraft from contact between the propeller blades of G-SHWN with the left horizontal stabiliser of G-BIXL (Figures 3 and 4). The blade strike on the horizontal stabiliser was within a few centimetres of the control cables for the elevator trim system, but resulted in structural damage only. The propeller blades all exhibited scuffing to the paint, but no visible structural damage.

Damage to horizontal stabiliser of G-BIXL

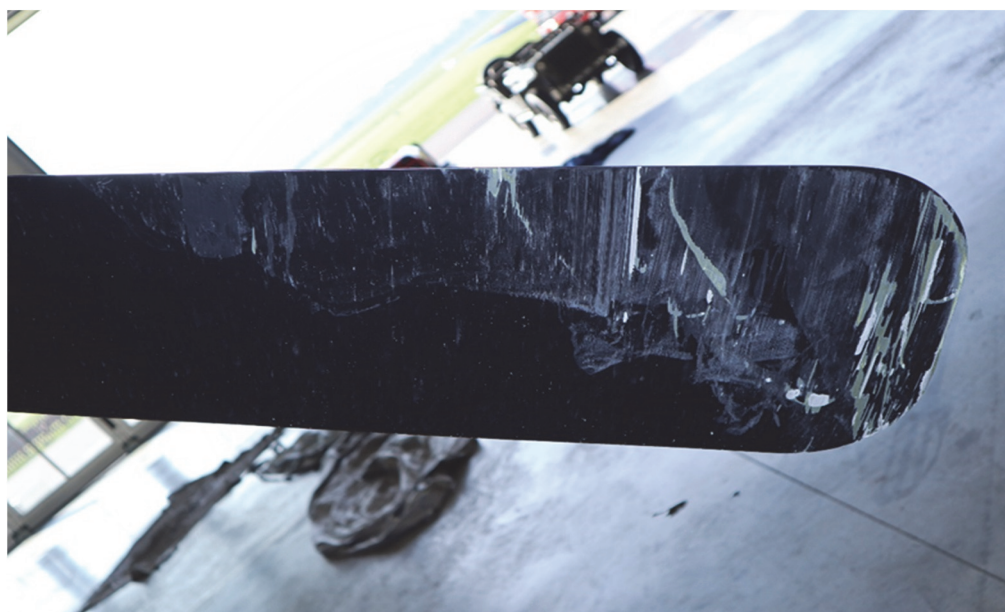
Figure 4

Damage to rear face of G-SHWN propeller blade

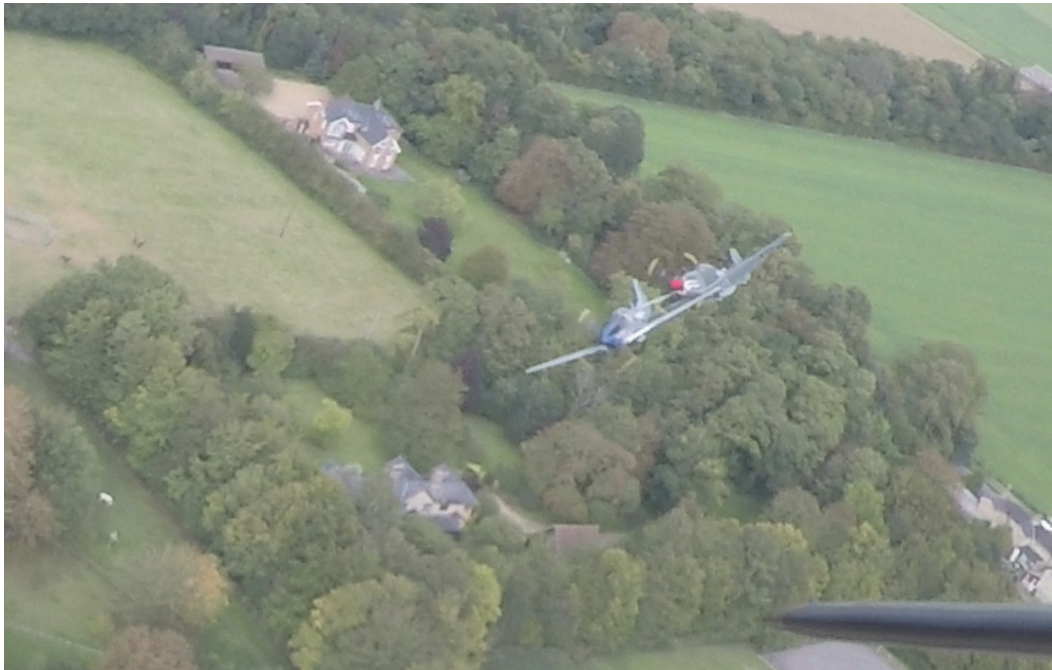
Figure 5

Video still showing the collision
