ACCIDENT

Aircraft Type and Registration:	Europa XS, G-JAGY
No & Type of Engines:	1 Rotax 914-UL piston engine
Year of Manufacture:	2000 (Serial no: A094)
Date & Time (UTC):	4 February 2018 at 1429 hrs
Location:	Compton Verney, Wellesbourne, Warwickshire
Type of Flight:	Private
Persons on Board:	Crew - 1 Passengers - None
Injuries:	Crew - 1 (Minor) Passengers - N/A
Nature of Damage:	Aircraft extensively damaged
Commander's Licence:	Private Pilot's Licence
Commander's Age:	61 years
Commander's Flying Experience:	263 hours (of which 7 were on type) Last 90 days - 9 hours Last 28 days - 0 hours
Information Source:	Aircraft Accident Report Form submitted by the pilot

Synopsis

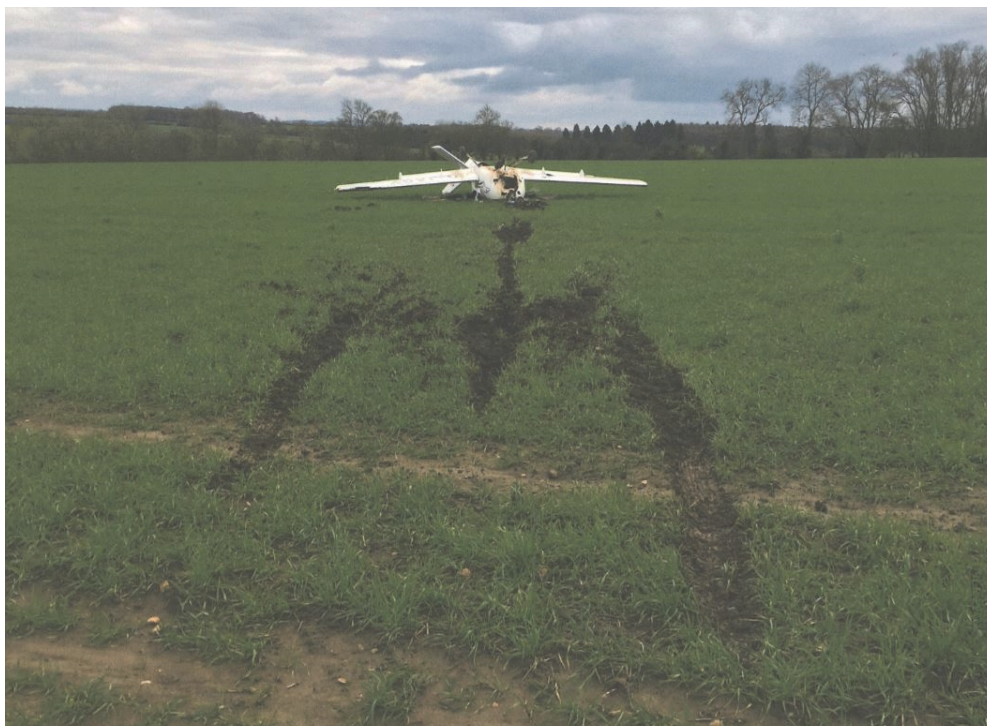
Figure 1

The pilot selected a large field to land in that was downwind, with slight downslope in the selected landing area. The aircraft touched down in the field on the main landing gear, before the nose landing gear leg dug in, causing the aircraft to nose-over and come to rest inverted (Figure 1). The pilot reported that the field was soft due to recent wet weather.

Accident site

The aircraft's engine abruptly stopped during a local flight and with the aircraft in a position with insufficient height to glide back to Wellesbourne Mountford airfield. During the resulting forced landing in a field the aircraft nosed-over, coming to rest inverted, and the pilot received minor injuries. The cause of the engine failure was not established.

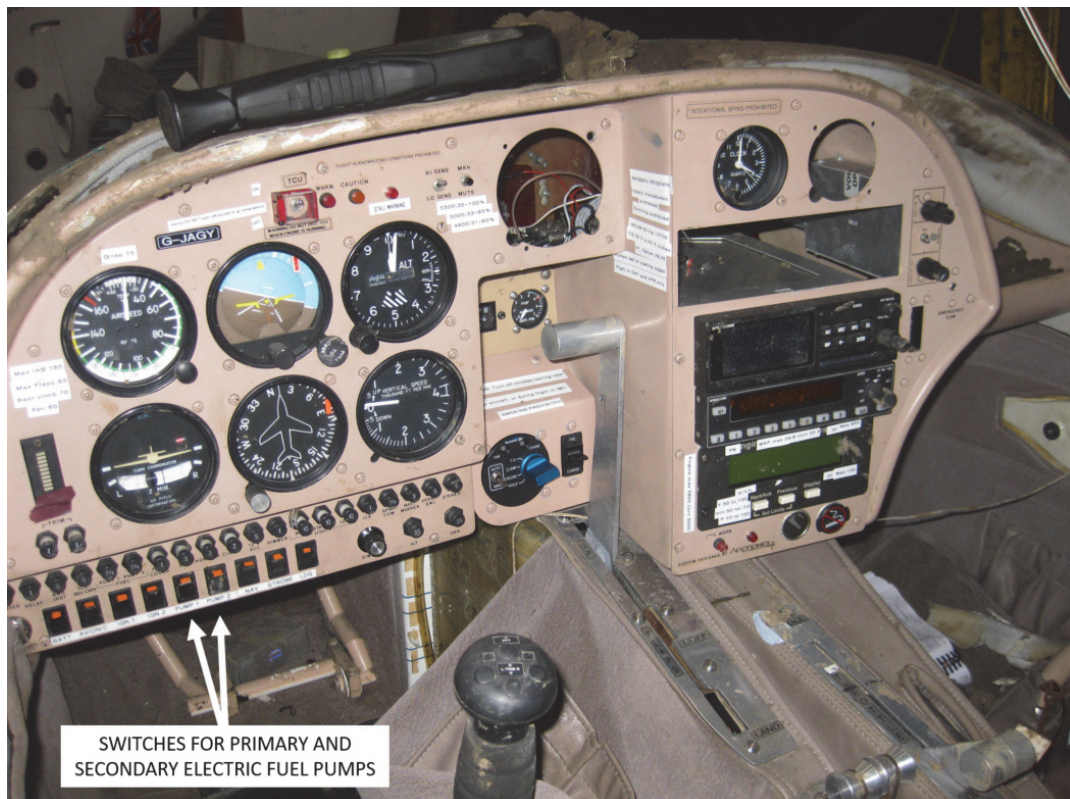
The LAA aircraft examination identified that the aircraft's instrument panel featured switches to control electrical power to each of the aircraft's electric fuel pumps (Figure 2).

Figure 2
Fuel pump switches

This arrangement is contrary to the Europa XS build manual, which requires that the primary electric fuel pump is powered directly from the engine's alternator with overload protection provided by a 5 amp circuit breaker. This design ensures that the primary fuel pump is powered whenever the engine is running.

The initial LAA Permit to Fly inspection following the aircraft's importation from the USA did not detect the non-standard fuel pump switching arrangement in G-JAGY. The LAA publishes guidance on the inspection of imported homebuilt aircraft in Technical Leaflet TL 1.06², which includes the need to check that the imported aircraft complies with the LAA-approved design standard. Despite this variation in the aircraft's fuel system configuration, there was no evidence to show that it had been the cause of the engine failure and the pilot recalled hearing at least one of the aircraft's fuel pumps running following the accident.
