## ACCIDENT

<b>Aircraft Type and Registration:</b>	Tecnam P2008-JC, G-HRLE	
<b>No &amp; Type of Engines:</b>	1 Rotax 912-S2 piston engine	
<b>Year of Manufacture:</b>	2015 (Serial no: 1052)	
<b>Date &amp; Time (UTC):</b>	19 April 2018 at 1010 hrs	
<b>Location:</b>	Fishburn Airfield, Durham	
<b>Type of Flight:</b>	Private	
<b>Persons on Board:</b>	Crew - 1	Passengers - None
<b>Injuries:</b>	Crew - None	Passengers - N/A
<b>Nature of Damage:</b>	Damaged beyond economic repair	
<b>Commander's Licence:</b>	Light Aircraft Pilot's Licence	
<b>Commander's Age:</b>	63 years	
<b>Commander's Flying Experience:</b>	196 hours (of which 41 were on type) Last 90 days - 6 hours Last 28 days - 2 hours	
<b>Information Source:</b>	Aircraft Accident Report Form submitted by the pilot

## Synopsis

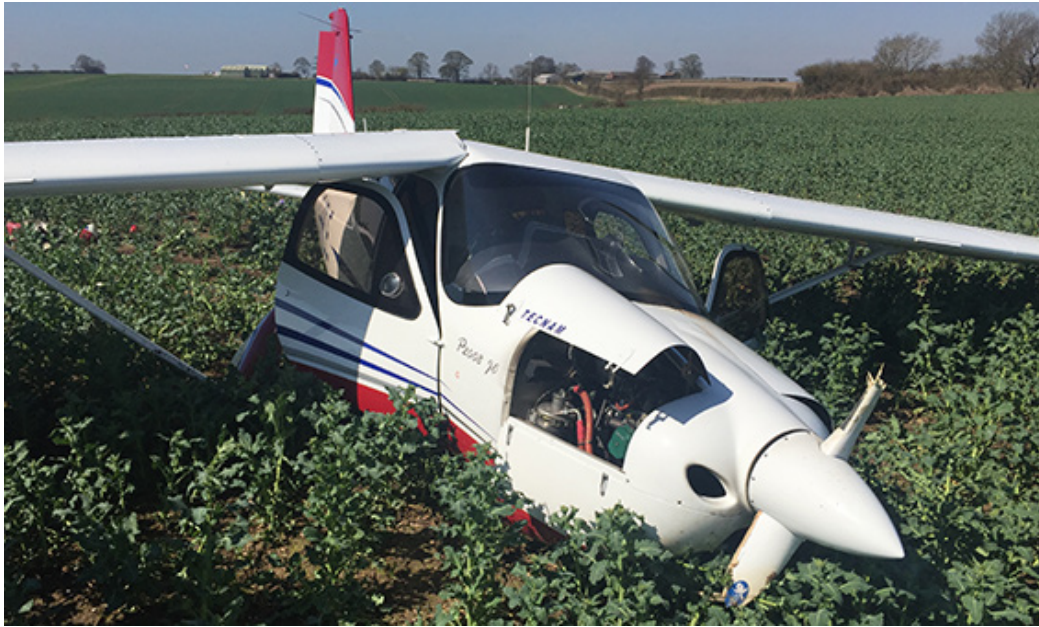
**Figure 1**

The grass Runway 08 was used for takeoff and all was normal until approximately 150 ft agl, when the engine "spluttered" and lost power, forcing the pilot to land ahead in an adjacent field of rapeseed. The aircraft touched down heavily, causing the landing gear to collapse and damaging the wings, but it came to rest upright and the pilot was able to turn off the electrics and vacate out his door.

G-HRLE after the accident, with the airfield background left
