**ACCIDENT**

<b>Aircraft Type and Registration:</b>	Zenair Ch 601ULA Zodiac, G-CIWS
<b>No &amp; Type of Engines:</b>	1 Rotax 912ULS piston engine
<b>Year of Manufacture:</b>	1995 (Serial no: 6-8027)
<b>Date &amp; Time (UTC):</b>	13 May 2018 at 1245 hrs
<b>Location:</b>	North Moor Airfield, near Scunthorpe, Lincolnshire
<b>Type of Flight:</b>	Private
<b>Persons on Board:</b>	Crew - 1                      Passengers - None
<b>Injuries:</b>	Crew - None                      Passengers - N/A
<b>Nature of Damage:</b>	Damaged beyond economic repair
<b>Commander's Licence:</b>	Private Pilot's Licence
<b>Commander's Age:</b>	73 years
<b>Commander's Flying Experience:</b>	1,417 hours (of which 26 were on type) Last 90 days - 27 hours Last 28 days - 20 hours
<b>Information Source:</b>	Aircraft Accident Report Form submitted by the pilot

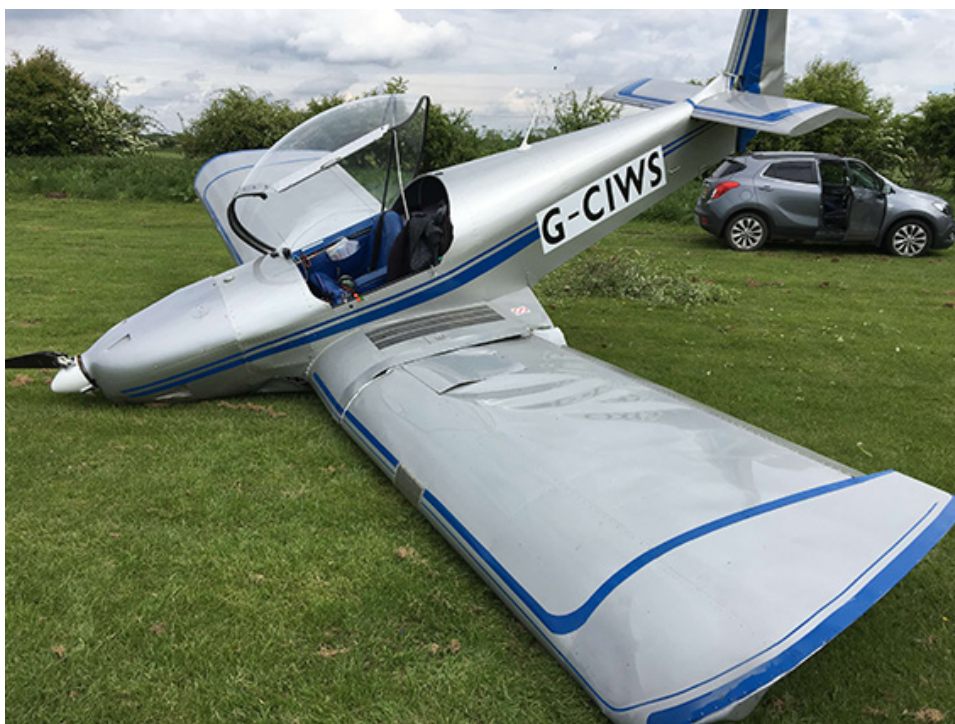
**Figure 1**

The pilot was returning to North Moor, his home airfield and, because it was a warm day and the atmosphere was thermally active, he expected turbulence near the airfield. He positioned the aircraft on final approach for the grass Runway 27 and estimated the wind was from 300° at a maximum of 9 kt. Because there are power lines approximately 225 m from the airfield boundary, the pilot flew above them, before steepening his approach and aiming to land near the runway threshold. However, the aircraft sank unexpectedly and, despite adding power, the pilot could not prevent it colliding with a hedge at the eastern airfield boundary. After penetrating the hedge, the aircraft passed close to a parked vehicle and the nose landing gear collapsed before it came to rest near the runway threshold (Figure 1). The pilot opened the canopy and evacuated without injury.

There are hangars and other buildings to the north of the runway threshold and the pilot thinks that the north-westerly wind may have curled over these buildings, creating a strong downdraught which he encountered. In hindsight, and considering the wind direction, he believes he might have avoided the worst of the downdraught had he stayed a little higher on final approach and landed slightly further down the runway than normal.

G-CIWS near the vehicle that it missed and with the hedge visible behind
