ACCIDENT

| Aircraft Type and Registration: | Ikarus C42 FB80, G-CICG | |
| Location: | Popham Airfield, Hampshire | |

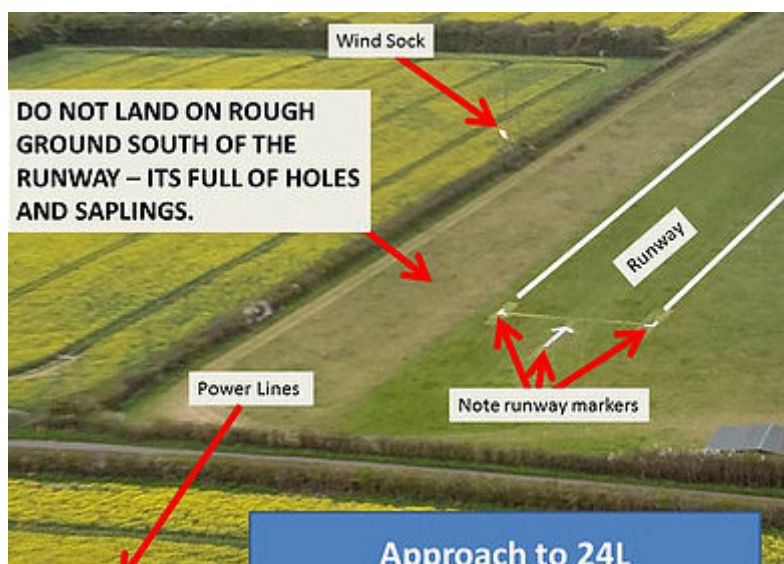
Figure 1

Following subsequent enquiries, the pilot discovered that the aircraft had hit and destroyed one of several traffic cones, placed to deter pilots from using a strip of rough ground to the left of Runway 24 at Chilbolton. The pilot regarded himself as familiar with Chilbolton, although he had not landed there for eight months, and he knew there was likely to be a contrast in colour between the runway and the rough ground to the side. Unfortunately, due to the ambient conditions, he was distracted, and he did not see the white markings by the runway threshold and misidentified the darker coloured strip of rough ground to be the runway.

Chilbolton is an unlicensed airfield but the operator tries to alert pilots to the presence of the adjacent rough ground in flight guides and on its website. The pilot was aware of the website but had not referred to it prior to this flight and he had not seen a photograph, recently added and labelled, to show pilots what to look for when landing on Runway 24² (Figure 1).

Illustration from the on-line brief for Chilbolton Airfield, highlighting the rough ground beside the runway. The illustrated white parallel lines do not represent ground markings

² The airfield's operator referred to Runway 24 as '24L', indicating that a left-hand circuit was required, to avoid noise sensitive areas. The operator has stated an intention to review its guidance material, having learnt that this designation infers there are parallel runways such as Runway 24 Left and Runway 24 Right.
