**ACCIDENT**

<b>Aircraft Type and Registration:</b>	Cessna 208B Grand Caravan, G-BZAH
<b>No &amp; Type of Engines:</b>	1 Pratt & Whitney Canada PT6A-114A turboprop engine
<b>Year of Manufacture:</b>	2000 (Serial no: 208B0811)
<b>Date &amp; Time (UTC):</b>	21 February 2018 at 1630 hrs
<b>Location:</b>	Netheravon Airfield, Wiltshire
<b>Type of Flight:</b>	Private
<b>Persons on Board:</b>	Crew - 1                      Passengers - None
<b>Injuries:</b>	Crew - None                      Passengers - N/A
<b>Nature of Damage:</b>	Nose gear drag link spring failure
<b>Commander's Licence:</b>	Commercial Pilots Licence
<b>Commander's Age:</b>	36 years
<b>Commander's Flying Experience:</b>	3,000 hours (of which 2,100 were on type) Last 90 days - 150 hours Last 28 days - 40 hours
<b>Information Source:</b>	Aircraft Accident Report Form submitted by the pilot and further work commissioned by the operator

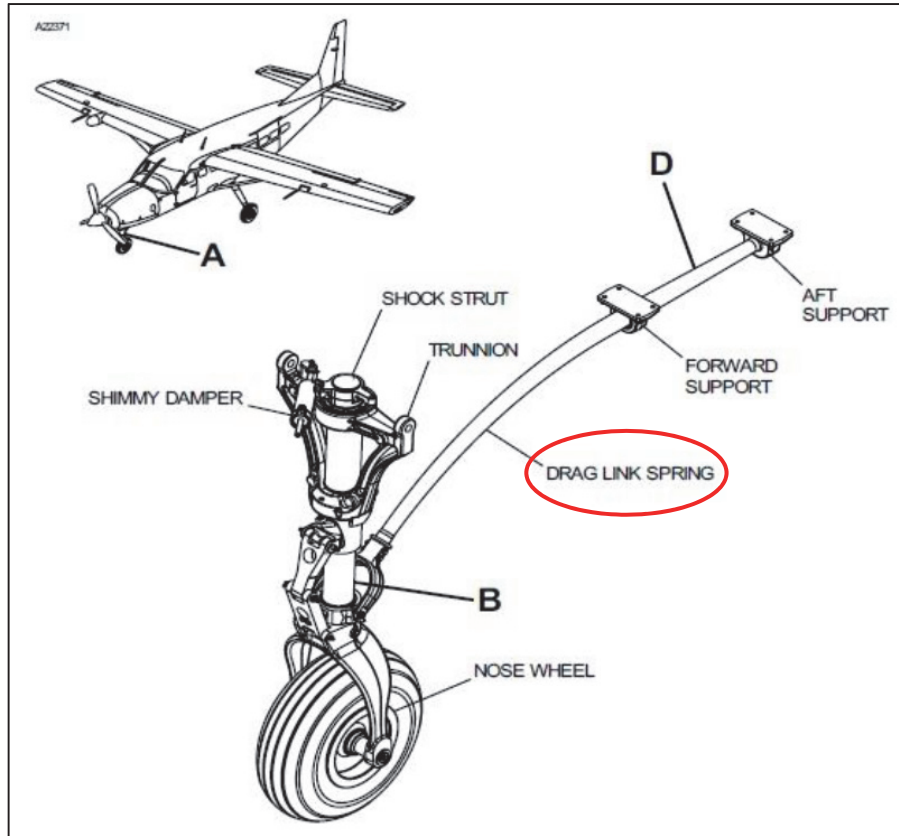
**Figure 1**  
General arrangement of nose landing gear

The pilot reported that during the landing roll, following a normal landing, he heard a loud bang, after which the aircraft nose appeared to be lower than normal. He stopped the aircraft and shut it down to carry out an inspection. This identified that the nose landing gear drag link spring had failed (Figure 1).

A detailed analysis of the failed part, carried out on behalf of the operator, indicated that the failure was most likely due to damage to the protective coating which had allowed the high-strength steel material to be exposed to moisture. A corrosion fatigue mechanism then led to the crack which resulted in the failure.

The failure is being dealt with through normal continued airworthiness processes.
