ACCIDENT

Aircraft Type and Registration:	Jetstream 4100, G-MAJC	
No & Type of Engines:	2 Garrett Airesearch TPE331-14GR-807H turboprop engines	
Year of Manufacture:	1992 (Serial no: 41005)	
Date & Time (UTC):	16 October 2017 at 0835 hrs	
Location:	Hawarden Airport, Chester	
Type of Flight:	Commercial Air Transport (Passenger)	
Persons on Board:	Crew - 3	Passengers - 9
Injuries:	Crew - None	Passengers - 1 (Minor)
Nature of Damage:	Damage to right propeller and right overwing emergency escape hatch	
Commander's Licence:	Airline Transport Pilot's Licence	
Commander's Age:	42 years	
Commander's Flying Experience:	5,000 hours (of which 450 were on type) Last 90 days - 150 hours Last 28 days - 52 hours	
Information Source:	Aircraft Accident Report Form submitted by the pilot and additional enquiries by the AAIB

Synopsis

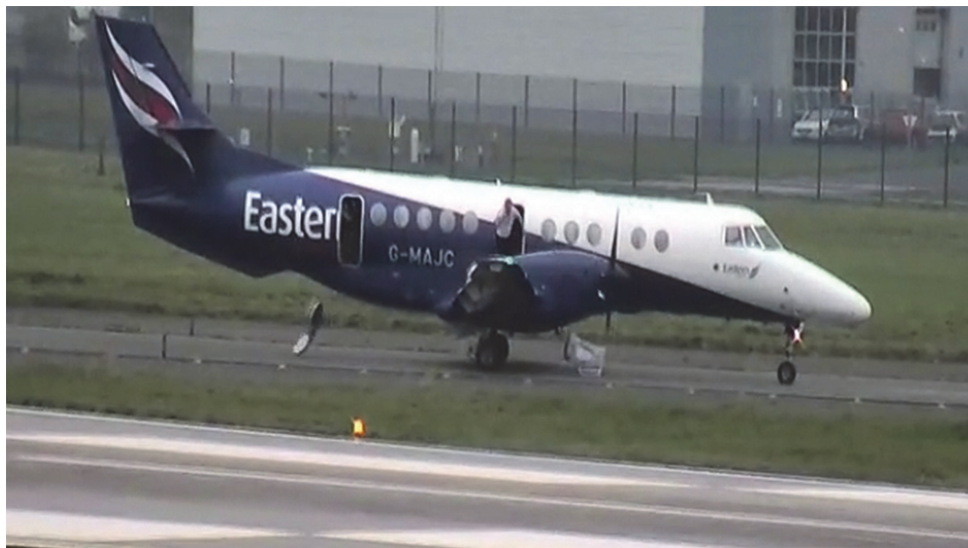
Figure 1
Aircraft evacuation

After the commander made the evacuation announcement to the cabin, the engines continued to operate at idle power for 8 seconds before they started to run down; the propellers continued turning for a further 40 seconds. The forward cabin door and the two mid-cabin over wing emergency exits were opened by the passengers. The right over wing exit door was dropped

to the ground behind the wing and blown forwards by the wind into the still rotating right propeller. The aft cabin exit door was opened by the cabin crew member; it fell to the ground and was blown rearwards by the propeller wash from the right engine (Figure 1).

The aircraft was inspected at the Operator's maintenance facility and damage was found to three separate areas. The right-hand overwing emergency exit door had been struck by the right-hand propeller, causing damage to both. The right hand rear emergency exit door was damaged by contact with the taxiway surface.

Three of the four emergency exits are behind the wing and thus the possibility of walking into a propeller is reduced. However, the forward exit presents a high risk to personnel, especially when there is no crew member in attendance. The operator recognises this by requiring the engines to be shut down and the propellers confirmed to have stopped

rotation before an evacuation is initiated. The combined rundown time for the engine and the propellers, as demonstrated in this case, may be in excess of 40 seconds.

- Review and amend the passenger emergency briefing to include a warning about the danger of rotating propellers.

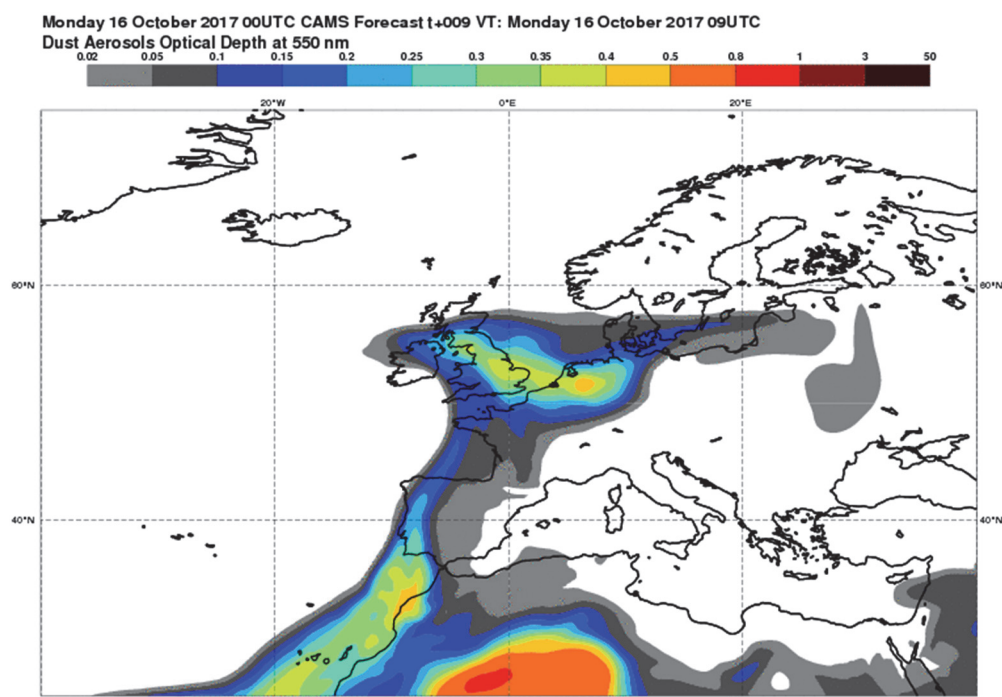
Figure 3a

On 13 October 2017 the UK Met Office Environment Monitoring and Response Centre (EMARC) noted on satellite imagery a quantity of dust which had lifted from the Sahara Desert and was tracking towards the UK, carried by strong southerly winds on the eastern side of ex-hurricane Ophelia. This air also picked up and carried quantities of smoke from a series of forest fires on the Iberian Peninsula. By 16 October this air reached the UK and was concentrated into a denser layer by the cold front associated with Ophelia. The Met Office forecasts for 0900 hrs 16 October 2017, separately for dust and biomass burning, are reproduced at Figures 3a and 3b.

16 October 2017 forecast Dust Aerosols for 0900 hrs

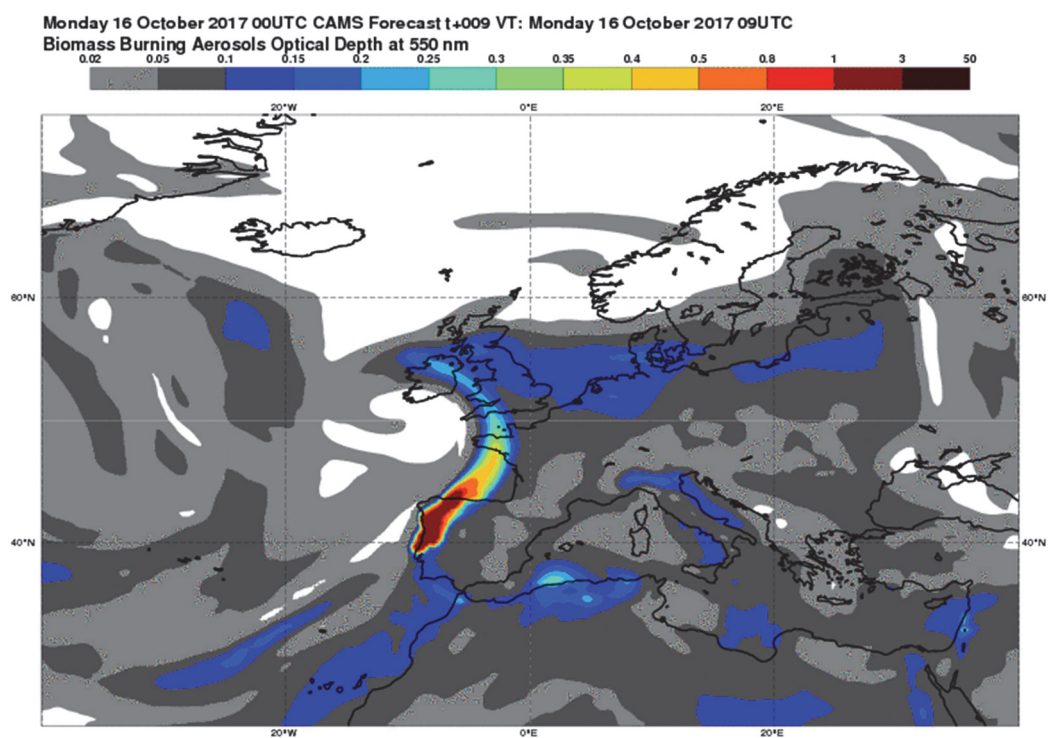
Figure 3b

16 October 2017 forecast Biomass Burning Aerosols for 0900 hrs
