ACCIDENT

Aircraft Type and Registration:	Cessna 152, G-BOLW
No & Type of Engines:	1 Lycoming O-235-L2C piston engine
Year of Manufacture:	1977 (Serial no: 152-80589)
Date & Time (UTC):	29 March 2018 at 1100 hrs
Location:	Beccles Airfield, Suffolk
Type of Flight:	Private
Persons on Board:	Crew - 1 Passengers - None
Injuries:	Crew - None Passengers - N/A
Nature of Damage:	Damage to nose landing gear and propeller; possible shock-loading of engine
Commander's Licence:	Private Pilot's Licence
Commander's Age:	71 years
Commander's Flying Experience:	350 hours (of which 257 were on type) Last 90 days - 3 hours Last 28 days - 2 hours
Information Source:	Aircraft Accident Report Form submitted by the pilot

Synopsis

While landing, the aircraft bounced and then contacted the ground in a nose-down attitude, causing damage to the nose landing gear and propeller.

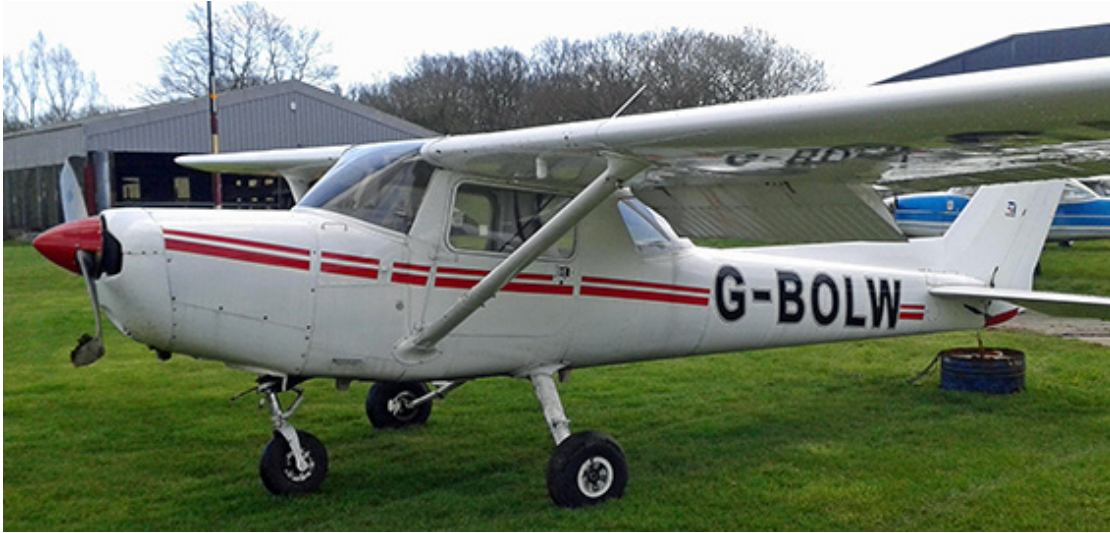
Figure 1

It is probable the aircraft's rate of descent then increased, because it landed heavily and bounced, before contacting the runway a second time, in a nose-down attitude. This caused the nose landing gear to partially collapse while both propeller blades struck the surface (Figure 1), before the aircraft came to rest in soft ground to the right of the runway. After turning the fuel and electrics off, the pilot opened the passenger door and vacated.

G-BOLW with the nose landing gear angled rearwards and the propeller tips bent
