ACCIDENT

Aircraft Type and Registration:	Diamond DA 42 M Twin Star, G-DOSB	
No & Type of Engines:	2 Thielert TAE 125-02-99 piston engines	
Year of Manufacture:	2008 (Serial no: 42.328)	
Date & Time (UTC):	6 April 2018 at 0743 hrs	
Location:	Bournemouth Airport, Dorset	
Type of Flight:	Training	
Persons on Board:	Crew - 2	Passengers - None
Injuries:	Crew - None	Passengers - N/A
Nature of Damage:	Damage to propellers, engine gearboxes, lower engine cowlings and various underside panels	
Commander's Licence:	Commercial Pilot's Licence	
Commander's Age:	63 years	
Commander's Flying Experience:	9,000 hours (of which 4,000 were on type) Last 90 days - 100 hours Last 28 days - 27 hours	
Information Source:	Aircraft Accident Report Form submitted by the pilot and enquiries made by the AAIB

Synopsis

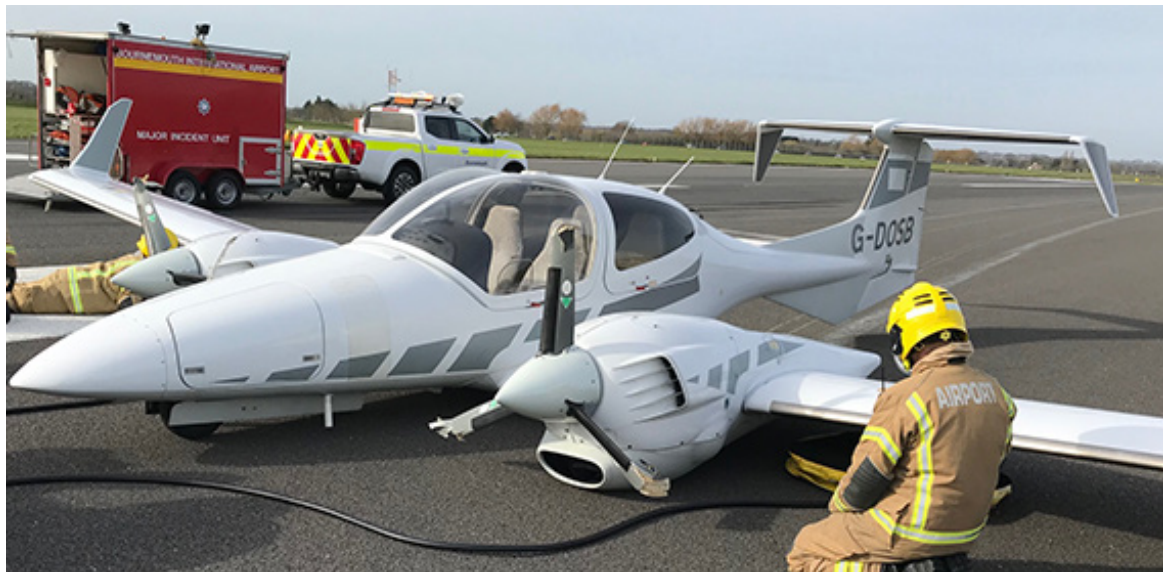
Figure 1

As they passed over the runway threshold, the student gradually reduced power and the aircraft made a gentle touchdown on the asphalt runway, without any initial indication of abnormality. However, unusual noises were then heard and it became apparent that the landing gear was UP and that the propellers were striking the surface as the aircraft slid to a halt, with the underside of the engine cowlings and the fuselage in contact with the runway. The instructor then shut the aircraft systems down, before he and the student opened the canopy and vacated. They observed that the landing gear lever was in the UP position but noticed that the gear doors appeared to have opened and that the tyres had become partially visible (Figure 1).

G-DOSB prior to an attempt to raise it using airbags.
The nose landing gear doors are open and the nosewheel appears to rest on the runway
