**Grounding of the general cargo vessel
Ruyter
Rathlin Island, UK
10 October 2017**

SUMMARY

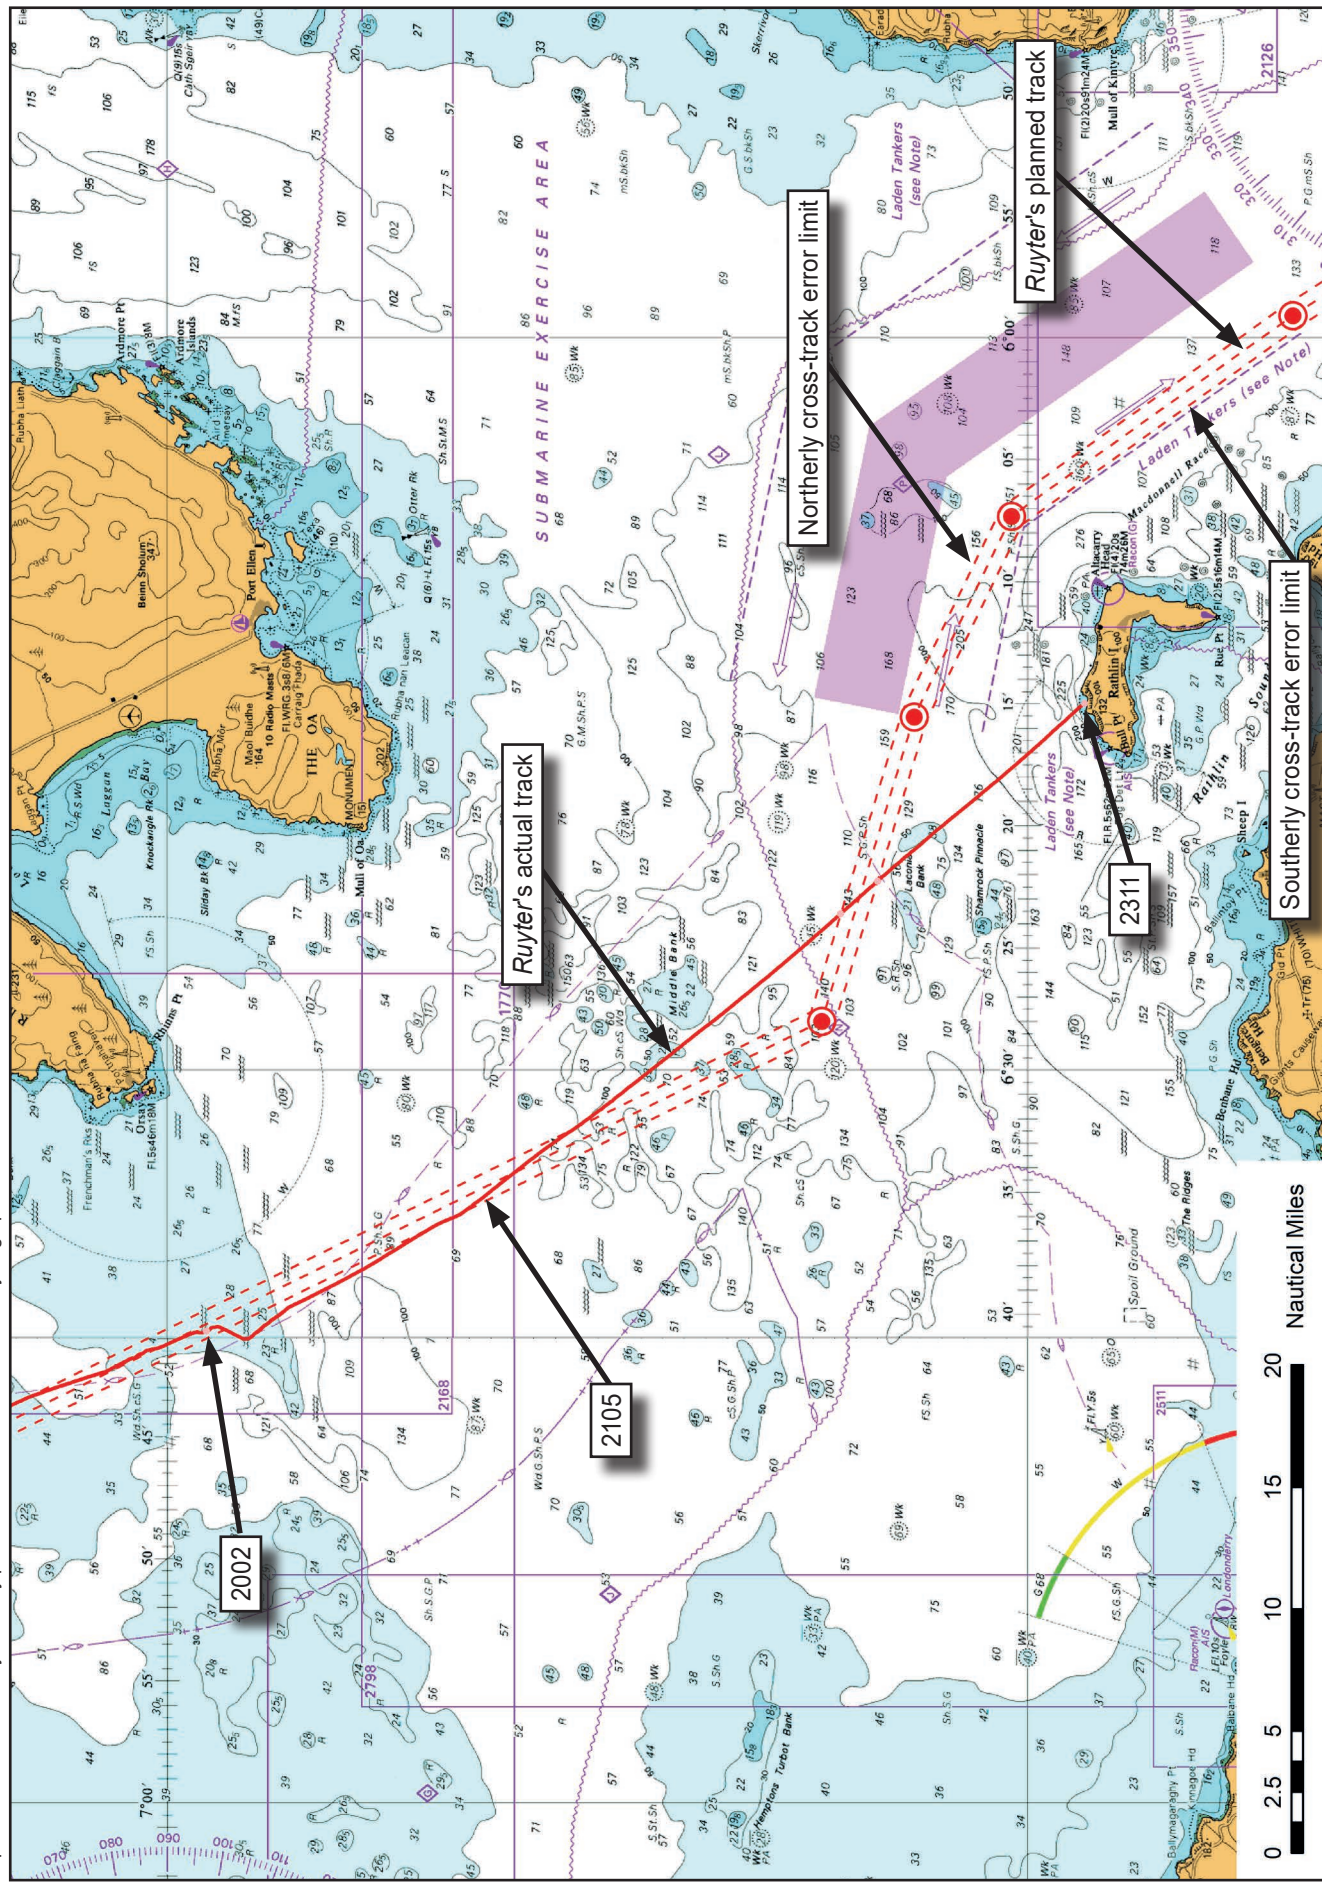
Figure 1: Ruyter's planned and actual tracks

Shortly before 2000, *Ruyter* was 5.5nm to the west of Orsay, Isle of Islay, and making a course over the ground (COG) of 162° at a SOG of 4.9 knots (**Figure 1**). The master returned to the bridge for his designated 2000 to 2400 watch. Again, the chief officer smelled alcohol on the master's breath but remained satisfied that the master was fit for watchkeeping duties. After briefing the master on the local traffic situation and handing over the watch to him, the chief officer went below, leaving the master alone on the bridge.

At 2105, *Ruyter*'s master set the autopilot to steer 145°. The ship then maintained this heading until about 2311, when it ran aground on the north shore of Rathlin Island.

After the master had left the bridge, *Ruyter* ran aground because:

- The bridge was unattended and there was no-one in a position to hear and act on the navigational alarms.
- The BNWAS was switched off, so the chief officer was not alerted that the bridge was unmanned.
