Report on the investigation of the  
grounding and loss  
of the UK registered yacht  
**CV24**  
at Cape Peninsula, South Africa,  
on 31 October 2017

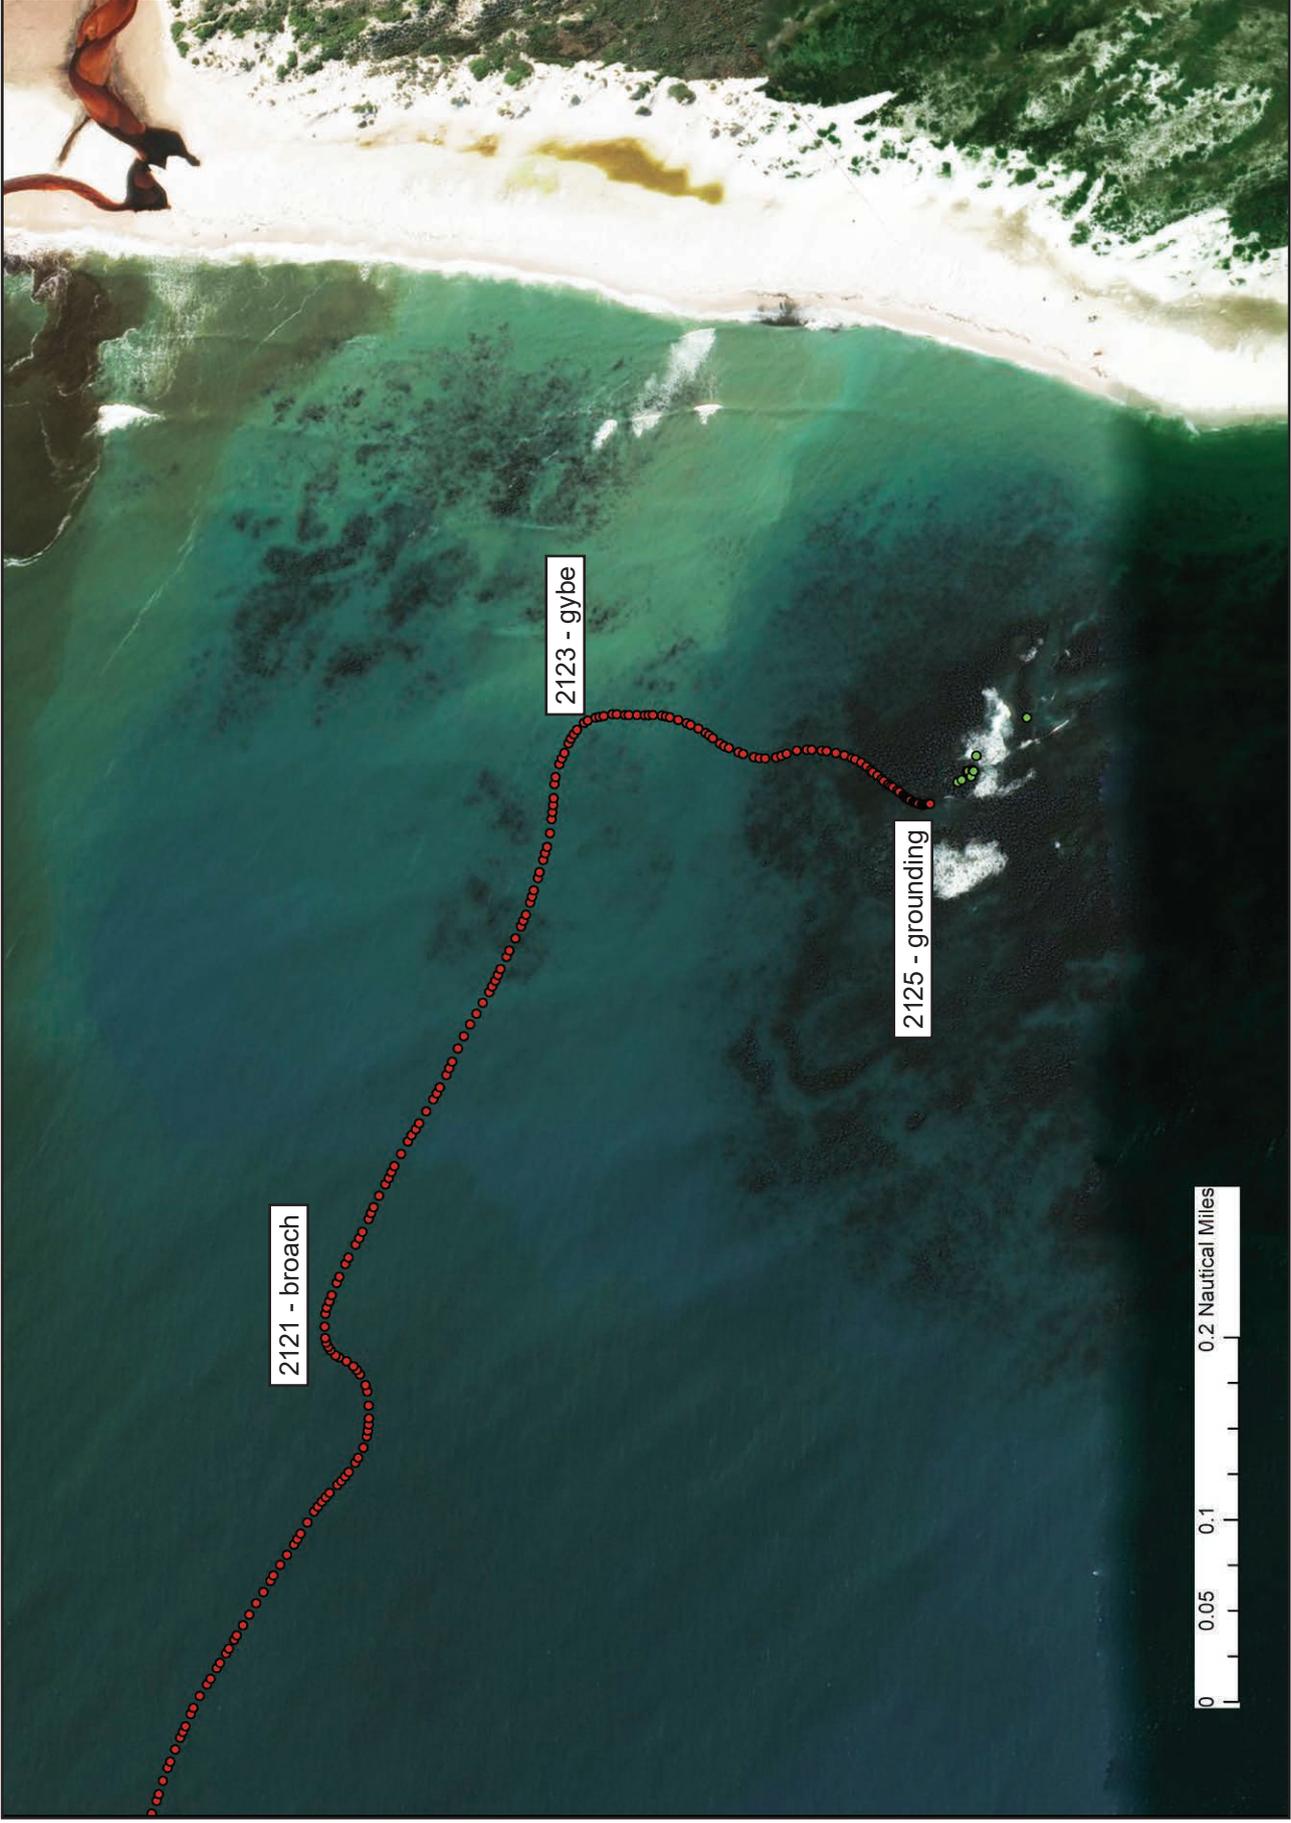
At 2121, CV24 was hit by a gust of wind that caused it to broach, heeling heavily to starboard and veering off course to port (**Figure 3**). After about a minute, the crew had CV24 back under control on a course of about 120°; the skipper was in the cockpit taking firm charge of the crew on deck to expedite the gybe.

Figure 3: CV24's Timezero track data superimposed on earth satellite imagery

At 2125, CV24 grounded softly, the speed reduced, then it came to a very abrupt stop when evidently striking solid ground (**Figure 3**). Just after grounding, the crew member who had filled in the log came back on deck but realised that it was too late to pass on the observation made a few moments earlier at the nav station.

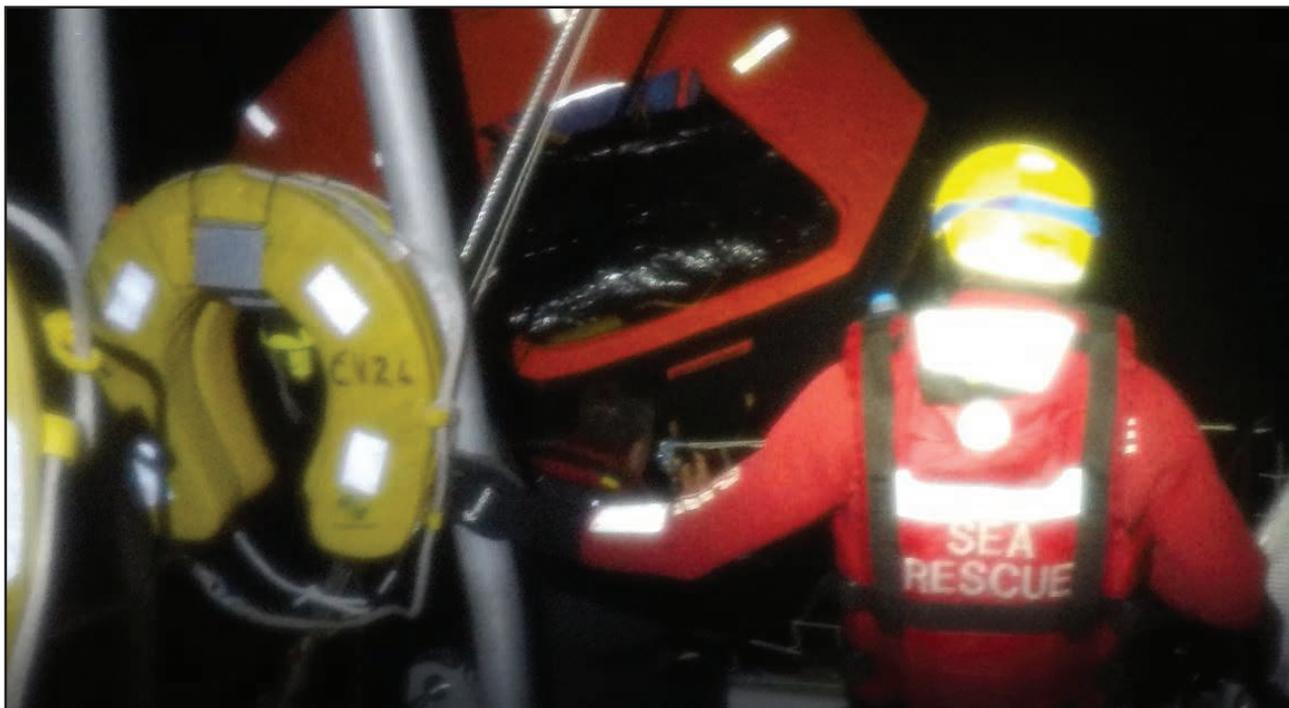
**Figure 4:** NSRI rescue swimmer on board CV24 with an inflated liferaft tethered astern

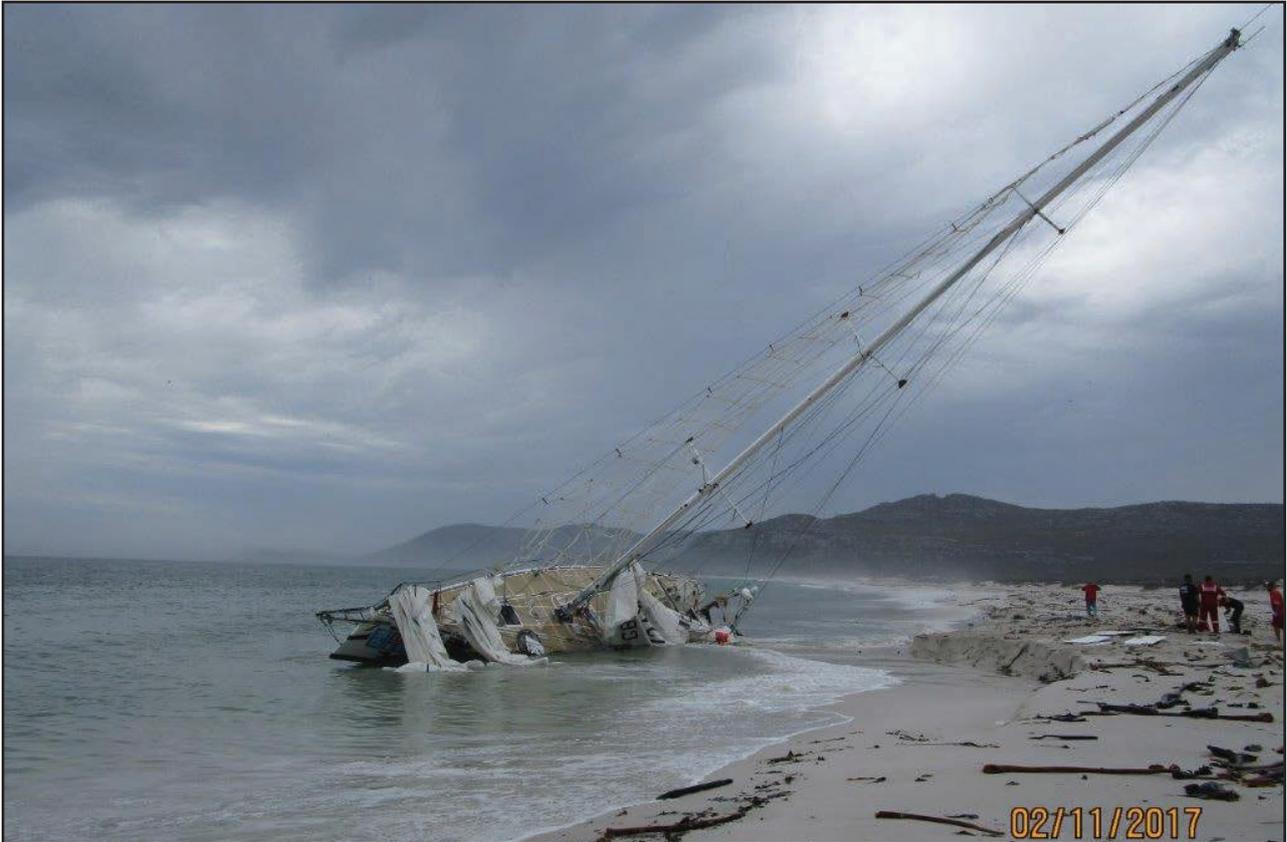
On 1 November 2017, Clipper Ventures' staff gained access to CV24 by a small boat to retrieve the hard drive from the Timezero navigation computer and assess the possibility of recovering the yacht. It was apparent that CV24's port side was badly damaged, with uncontrolled water ingress through widespread hull damage.

**Figure 5:** CV24 washed up on the beach 2 days after the accident

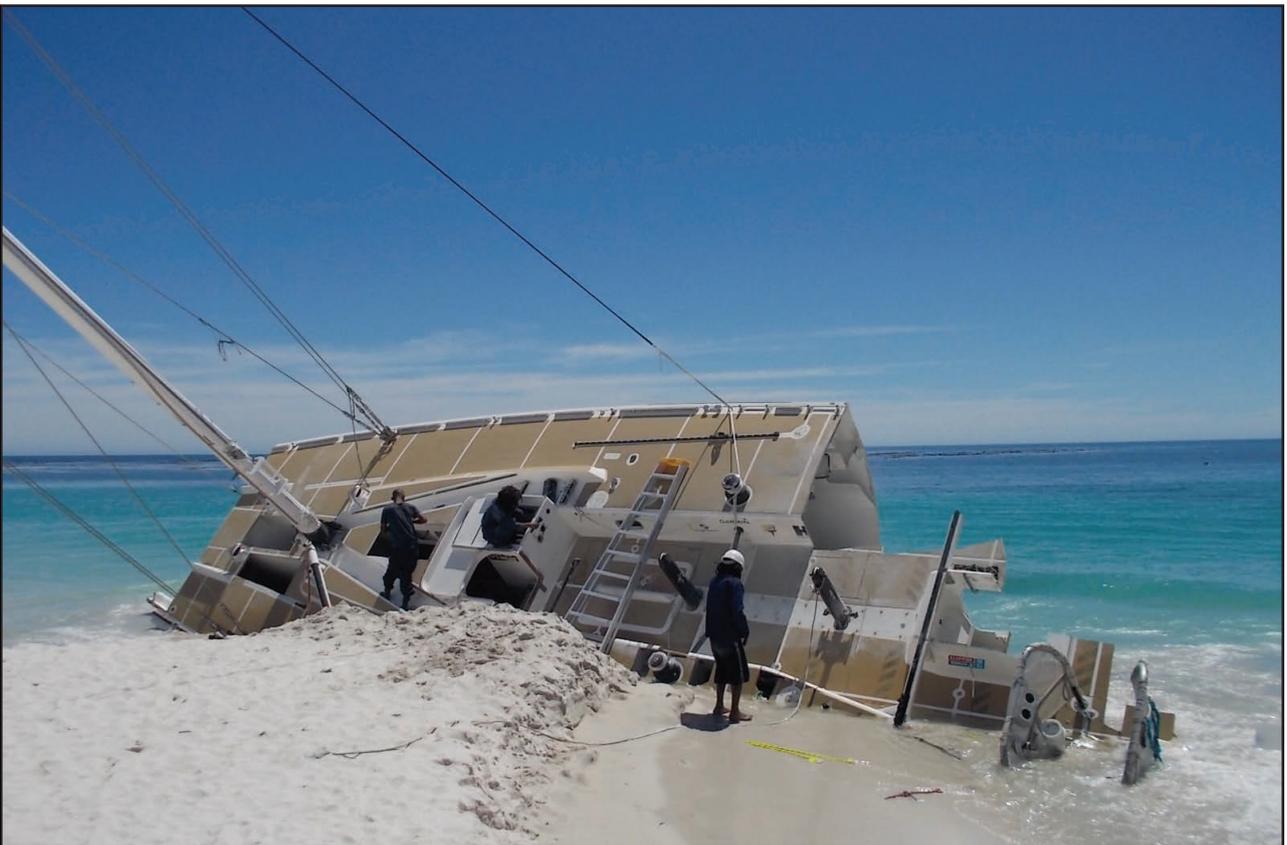
**Figure 6:** Disposal of CV24 by cutting into sections and removal from the beach

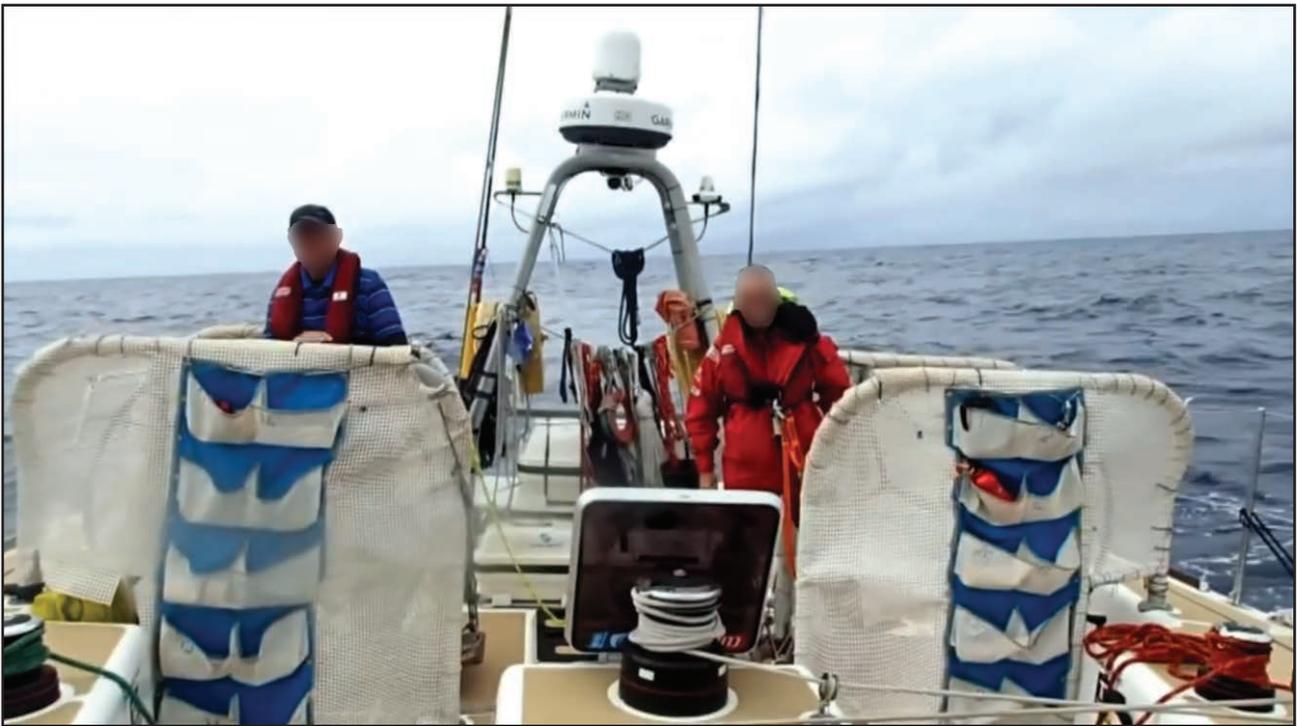
When describing the design of the Clipper 70 yacht, the Race Crew Manual<sup>11</sup> (**Annex E**) stated that *the navigation station is placed towards the stern, providing a closer link between the navigator and the helmsman*. Between the port and starboard helm positions, there was a hatch that led directly to the nav station (**Figure 11**). Prior to the 2017 - 2018 race, crews of Clipper 70s would sometimes open this hatch when at sea to permit direct dialogue between crew at the helm and nav stations (**Figure 12**). As a result of incidents of water ingress through this hatch when open, for the 2017 - 2018 race the yachts' crews were permitted to open it only for an actual emergency. Clipper Ventures had also fitted the nav station hatches with an anti-tamper device that would show the company's staff if it had been opened.

**Figure 12:** Clipper 70 - nav station hatch open at sea during the previous round the world race

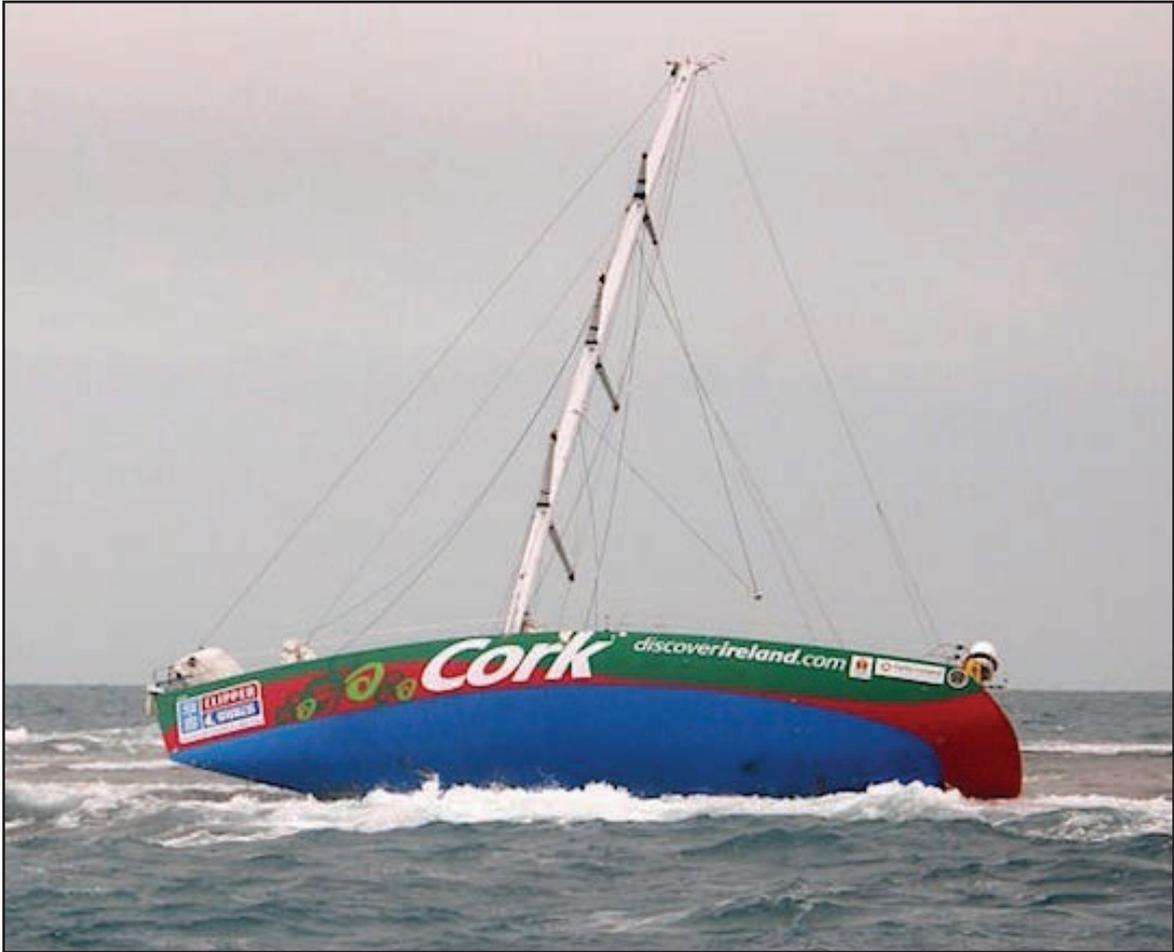
At about 0400 local time on 14 January 2010, the Clipper 68 yacht CV4 ran aground on the Gosong Mampango reef in the Java Sea, Indonesia. The reef was a waypoint for the race and the crew approached it in dark, windy and rough conditions. Despite the crew's efforts to free the yacht, it could not be moved. Later that day and in daylight, the crew abandoned the yacht (**Figure 16**) and were rescued by another Clipper Ventures' yacht; some of the crew suffered minor injuries.

**Figure 16:** CV4 aground on the Gosong Mampango reef in 2010

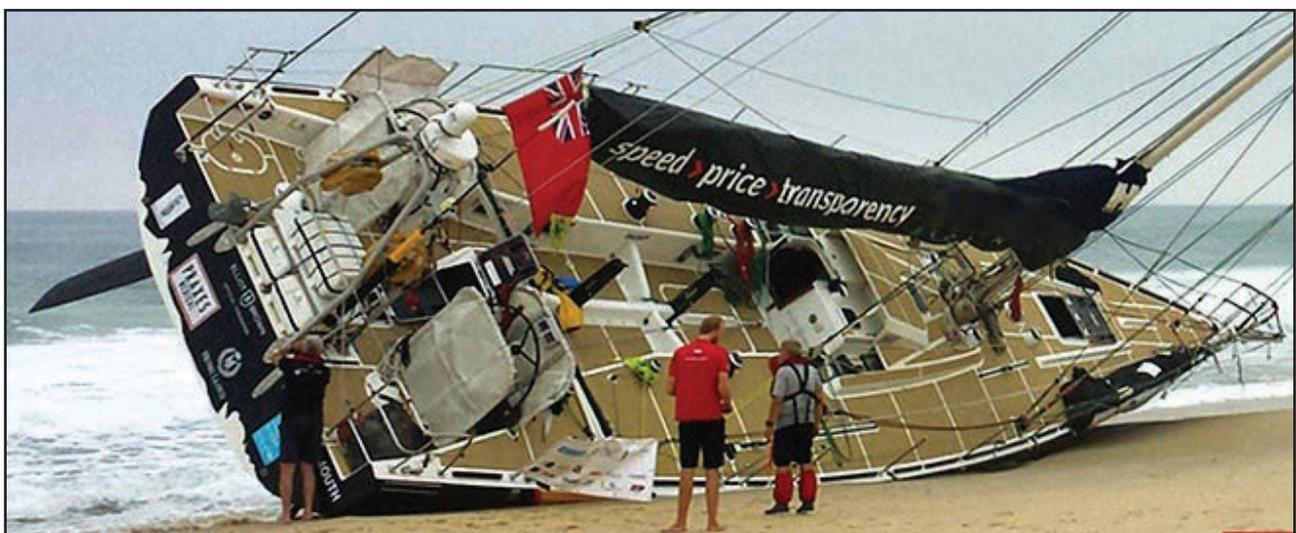
- CV24 and CV28. At 0012 local time on 30 September 2015, CV24 ran aground when motoring on an inshore night passage between Rio de Janeiro and Angra dos Reis, Brazil (**Figure 17**). CV24 was being moved in preparation for some work to be undertaken the following day; visibility was good, sea state slight and light winds. There was a reduced crew of four on board and the helmsman, who was alone on deck, became disorientated, resulting in the grounding. There was no water ingress or injuries, but the yacht's starboard rudder was broken off. Clipper Ventures' report to the MAIB of the grounding stated that all crew had been re-briefed on the importance of following a navigation plan. At about 1815 local time on 2 October 2015, CV28 ran aground when motoring to assist the grounded CV24. CV28 caught a line around its propeller and, soon after losing propulsion, drifted ashore; there were no injuries but CV28's port rudder was broken. CV24 and CV28 were both towed off the beach and lifted out of the water for inspection and repairs.

**Figure 17:** CV24 aground in Brazil in 2015

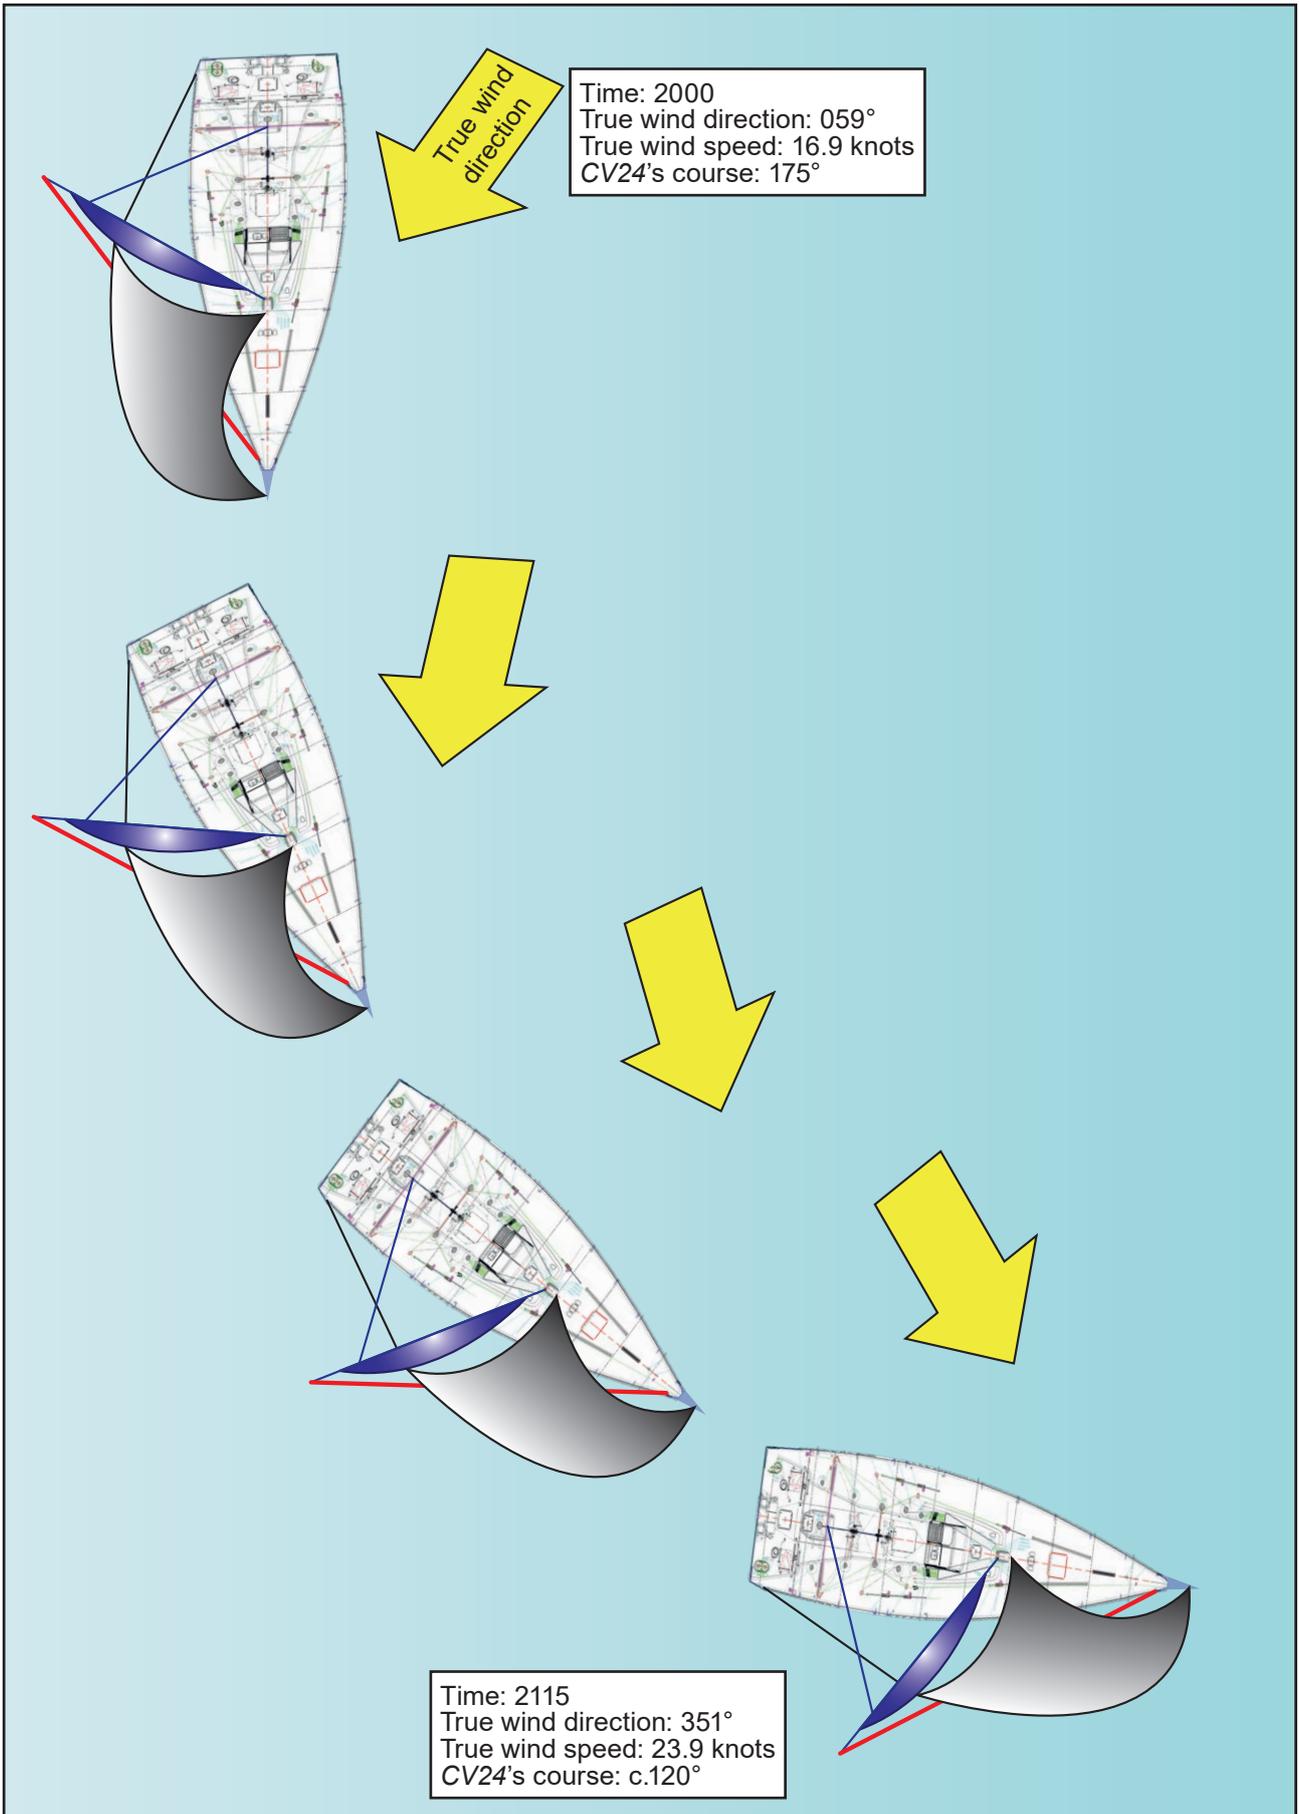
**Figure 19:** Diagram illustrating CV24's turn to port as the wind backed

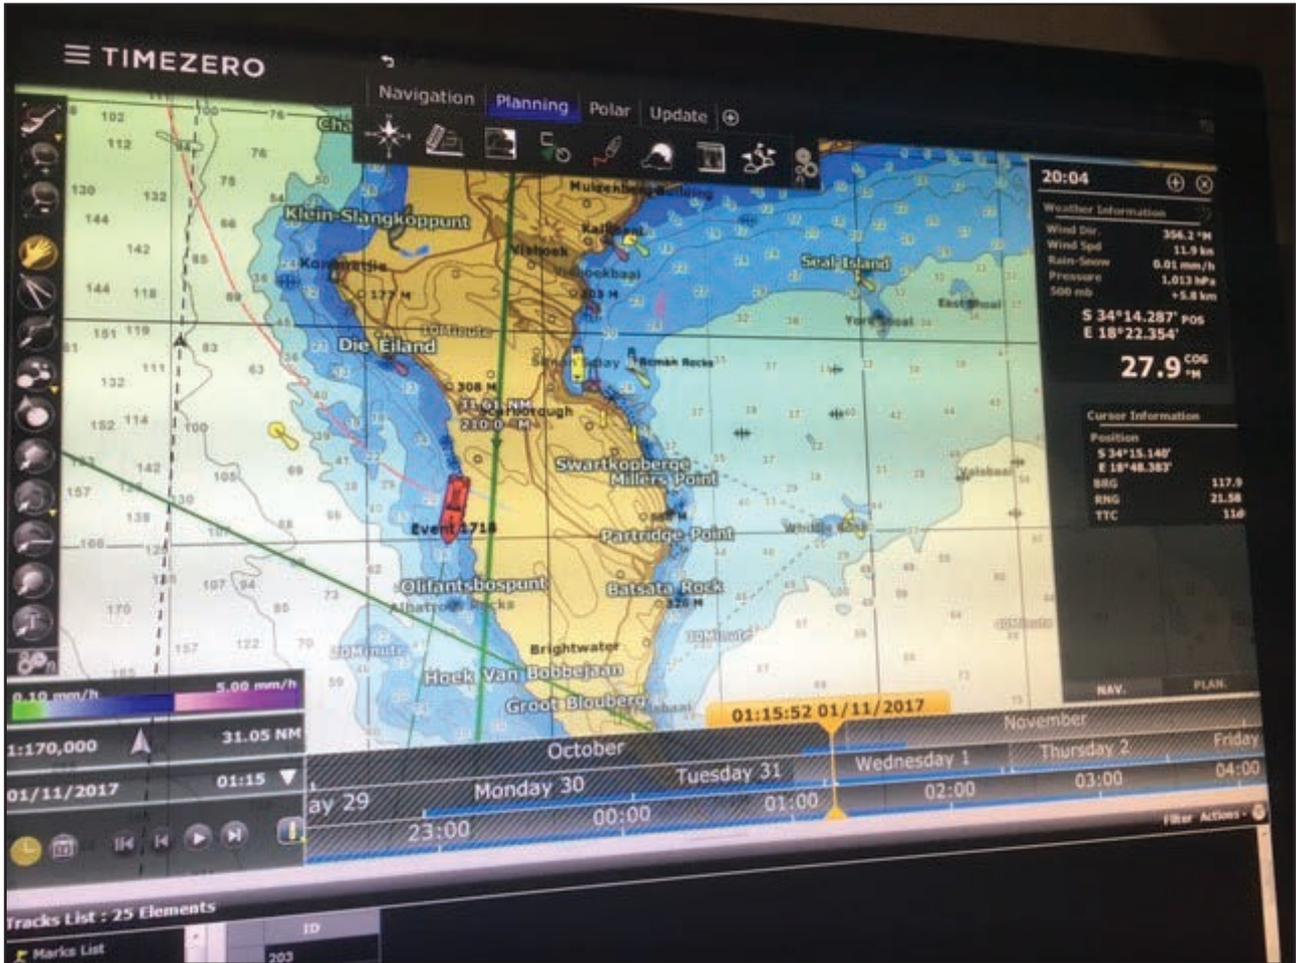
Although the South African coastline had been identified as a hazard in the written plan, there was no information detailing how CV24 was to be kept safe. While this written passage plan fulfilled the company's obligation for skippers to complete a plan, it fell short of the level of detail necessary, particularly for the coastal passage stage of the voyage. The skipper's electronic planning on Timezero was focused on the ocean passage and did not highlight hazards for the coastal passage. The safety features available in Timezero had not been utilised and no electronic track with cross track distances had been plotted, no dangers had been highlighted and no safety depths or parameters for a look ahead zone had been calculated. **Figure 21** is a photograph of CV24's Timezero display taken when aground, illustrating the absence of any electronic safety information for the coastal passage. **Figure 7** also illustrates that none of the yachts adhered to the company's planning guidance, that navigational hazards should, where possible, be avoided by 10nm at night.

Figure 21: Image of CV24's Timezero plotter when aground illustrating the absence of a passage plan or safety areas
