Fatal man overboard from fishing vessel *Varuna* west of Camusterrach on the north-west coast of Scotland 20 November 2017

SUMMARY

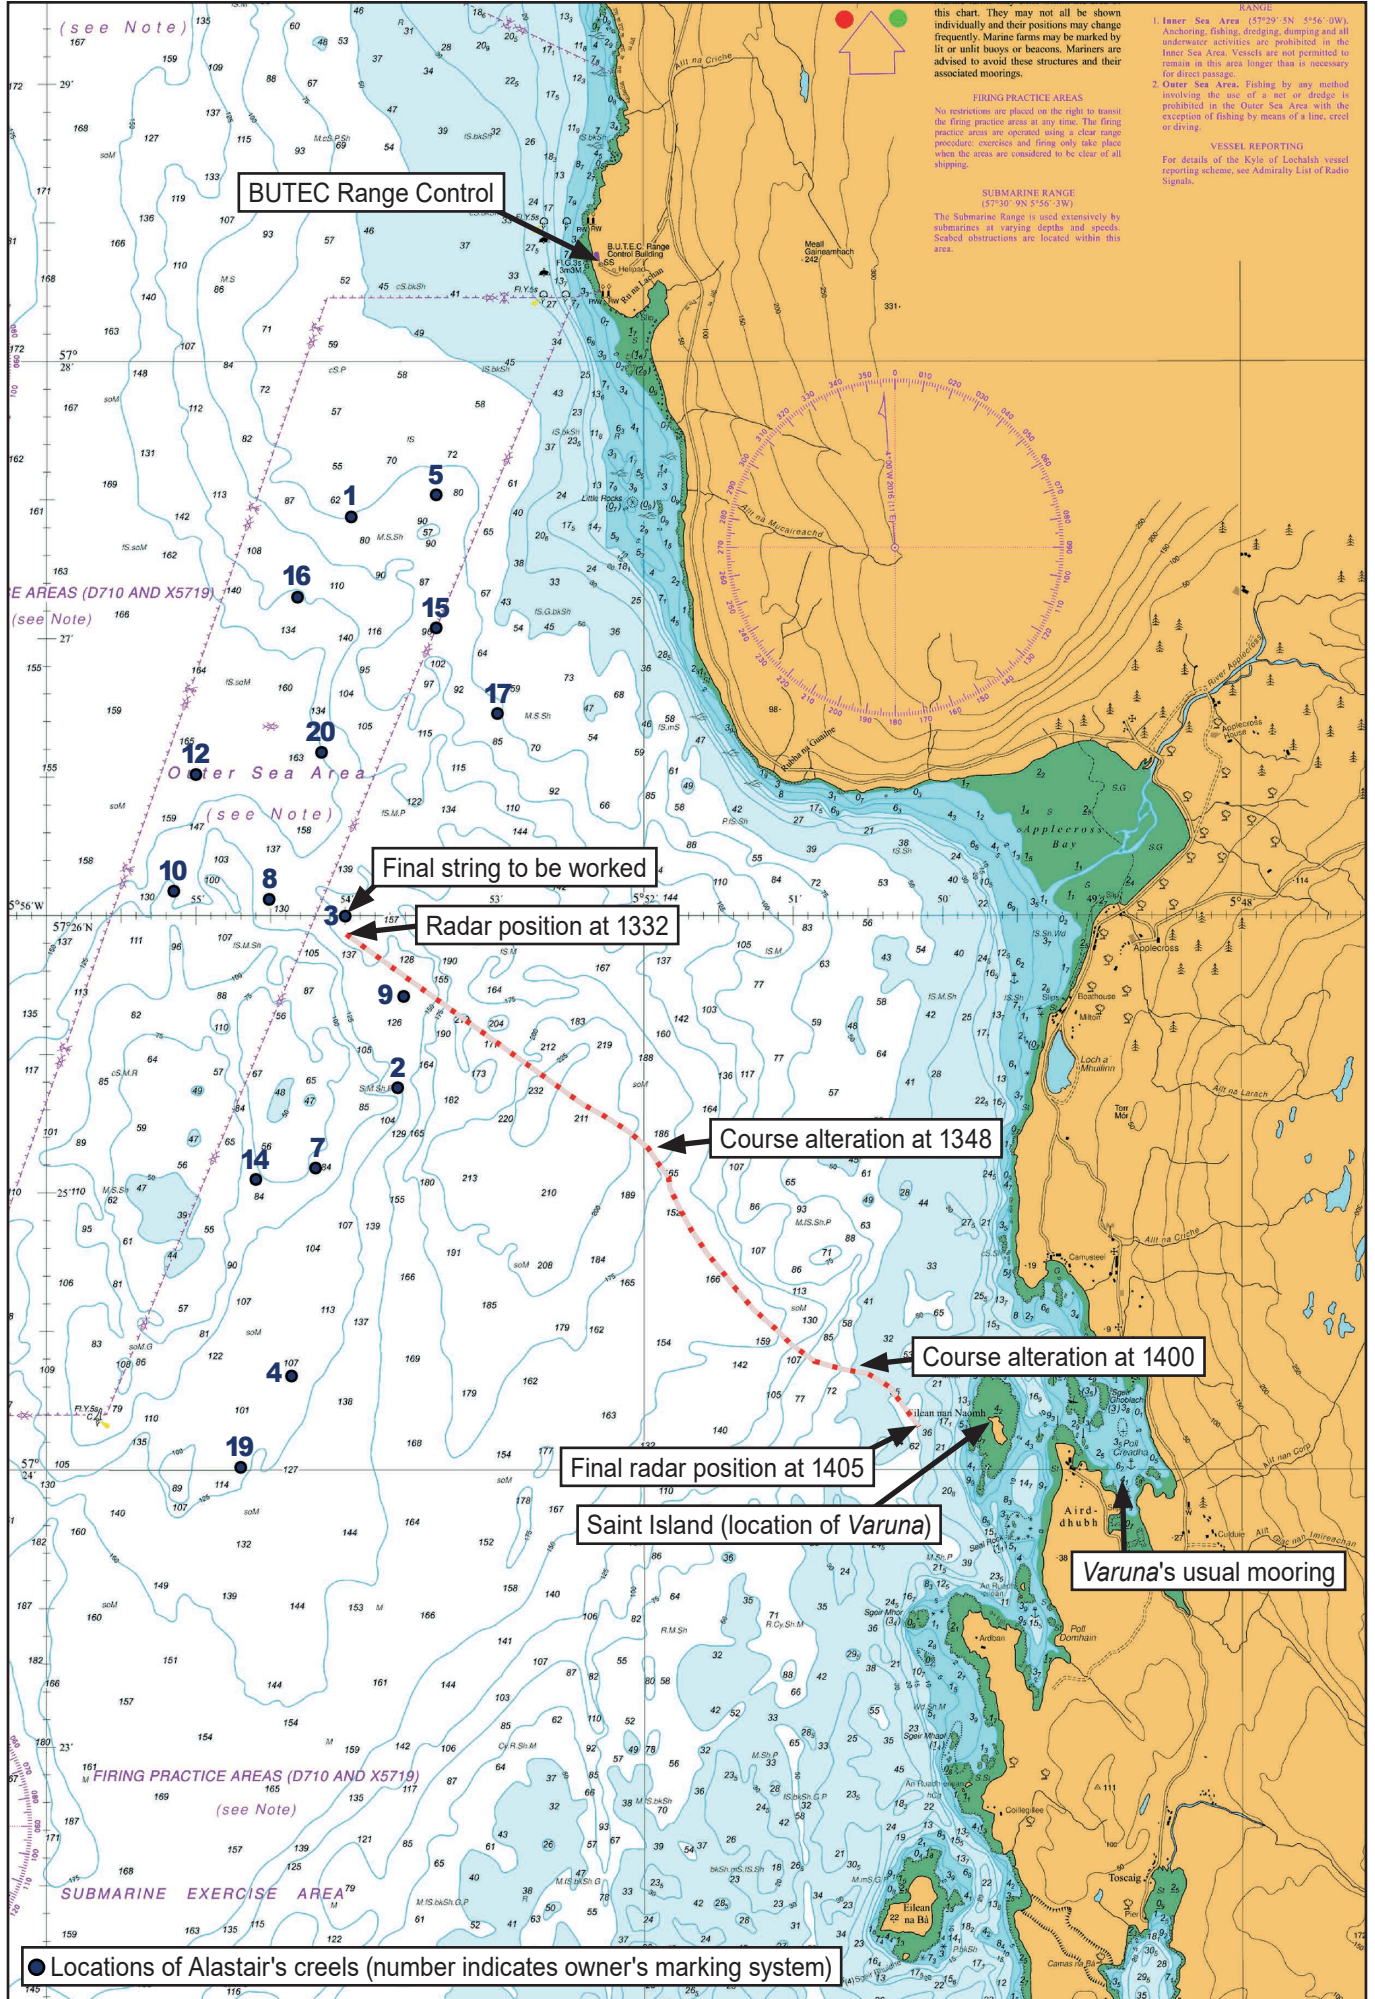
Figure 2: Chart showing Varuna's track and creel locations

At 1332, *Varuna*'s radar echo again appeared on the BUTEC Range Control radar, which had been reactivated following the earlier maintenance (**Figure 2**). The radar echo tracked in a south-easterly direction until 1348, when it altered about 20° to the south before gradually returning to approximately its original track direction. At approximately 1400 the boat's track again altered about 20° to the south. Radar contact was lost at 1405, when *Varuna*'s final radar echo return indicated that the boat was very close to Eilean nan Naomh (Saint Island).

Varuna's track obtained from the BUTEC Range Control radar indicates that Alasdair had completed his fishing and was returning *Varuna* to its mooring. This is supported by the engine throttle position when found after the accident, which was commensurate with the boat's usual passage speed of 4 to 5 knots. The track direction change at 1348 suggests that Alasdair was on board *Varuna* at this point and manually altered course. However, his reason for doing so is unknown.

Following the alteration, the boat resumed its original track towards Saint Island, probably under the control of the autopilot, before again altering course at about 1400.

The BUTEC radar contact of *Varuna* was lost at 1405 so the boat's track after this time is unknown until it was observed aground at 1415. However, given the alterations to *Varuna's* course it is probable that Alasdair fell overboard shortly before the boat ran aground.

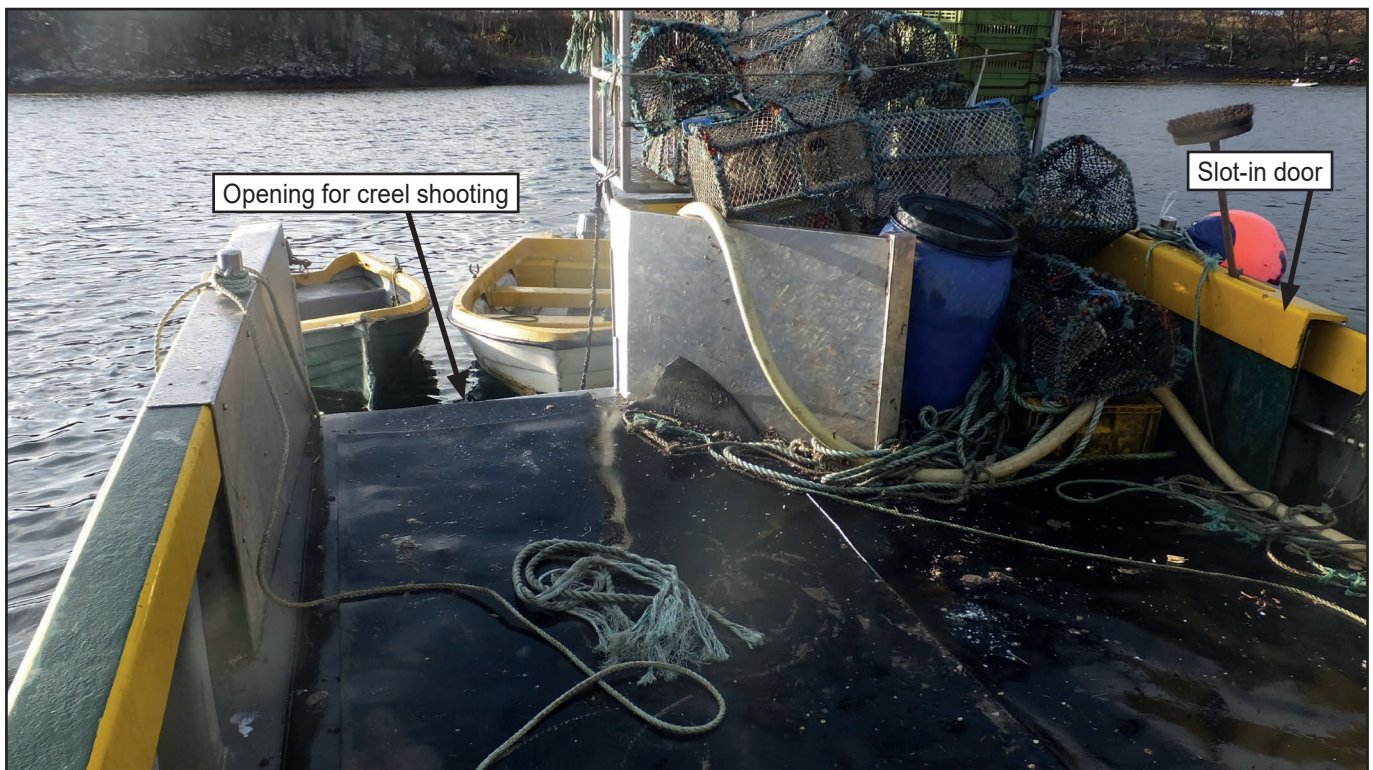
Figure 3: *Varuna*'s shooting gate

Varuna was configured to operate as a single-handed creel boat with a hydraulic hauler and remote engine and steering controls. It had a cut-out 'shooting gate' in the transom to facilitate shooting the creels (**Figure 3**). There was a slot-in door secured to the port bulwark, which could be fitted in way of the shooting gate on completion of shooting. The door was found secured to the port bulwark following the accident and there was no evidence to indicate that it had ever been used.

As *Varuna* appears to have been returning to its mooring, it is likely that Alasdair had been preparing the catch and washing down the working deck in accordance with his normal practice. As *Varuna* was on passage the open shooting gate in the transom presented an unnecessary hazard. The slot-in door had not been fitted following shooting and, with no means of fall prevention in use, there was an increased risk of Alasdair falling overboard through the shooting gate, and it is possible that he did so.

- Had Alasdair been required to produce a written risk assessment, identifying the need to close the shooting gate when not in use and to wear a PFD while working on deck, this might have provided a stimulus for him to have adopted safer working practices. It is therefore hoped that the ratification of ILO 188 provides an opportunity to extend the requirement to document a risk assessment to all commercial fishing vessels.

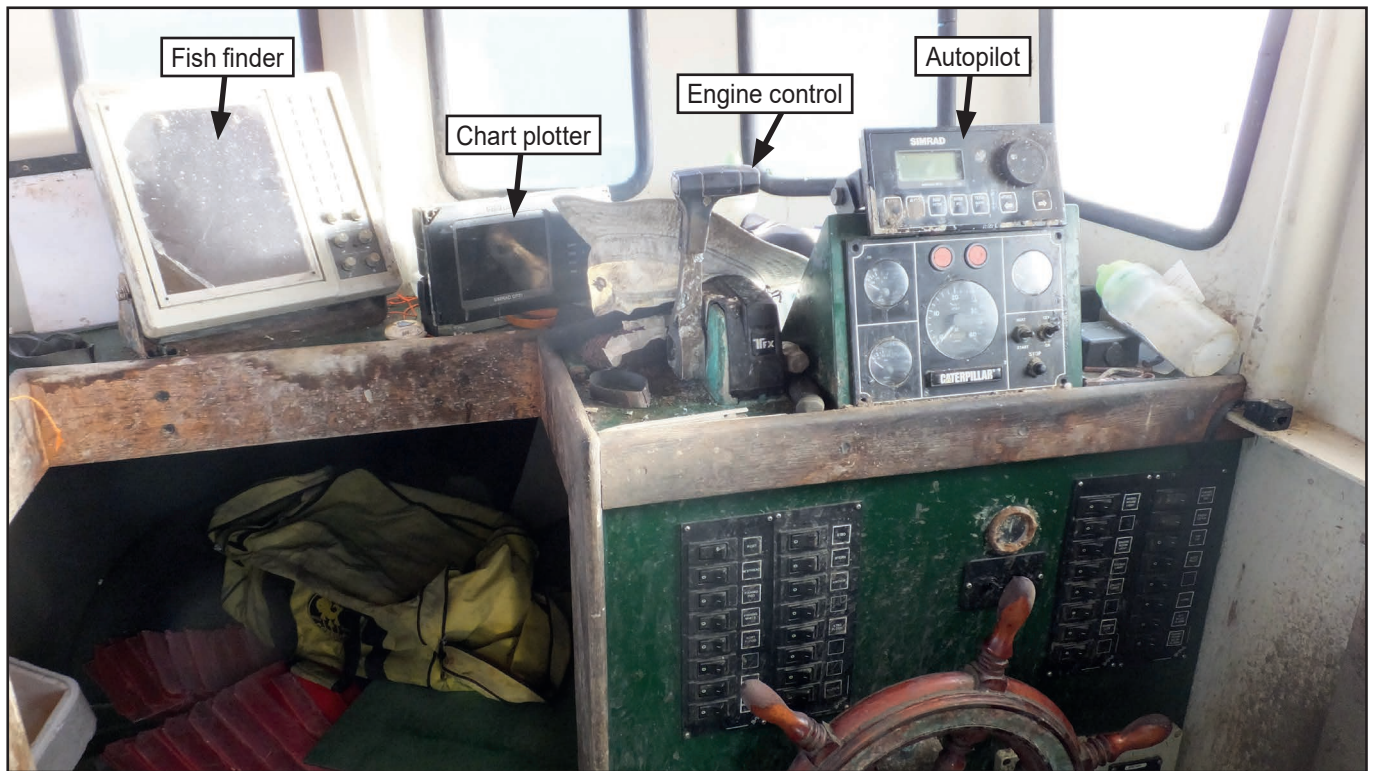
Figure 4: *Varuna's* wheelhouse

Varuna's navigational aids included a Simrad CP31 chart plotter, a Simrad AP35 autopilot and a Suzuki color [sic] sounder ES-2035 fish finder (**Figure 4**). The boat was also fitted with a Vespermareine XB8000 AIS⁶ transponder which, although switched on, was not functioning during the period leading up to and following the accident.

The throttle control was found to have been set at about two-thirds ahead, which would have resulted in a boat speed of 4 to 5 knots through the water. There were no creels on board. However, there was one box containing recently caught prawns, a bucket of tailed squat lobsters and some unused bait. The plotter did not contain any information relating to Alasdair's fishing pattern, but a handwritten notebook found in the wheelhouse had been used to record the positions of his strings of creels.
