ENVIRONMENTAL ALERT

ALERT NUMBER: 01/2015

ISSUE DATE: 3 March 2015

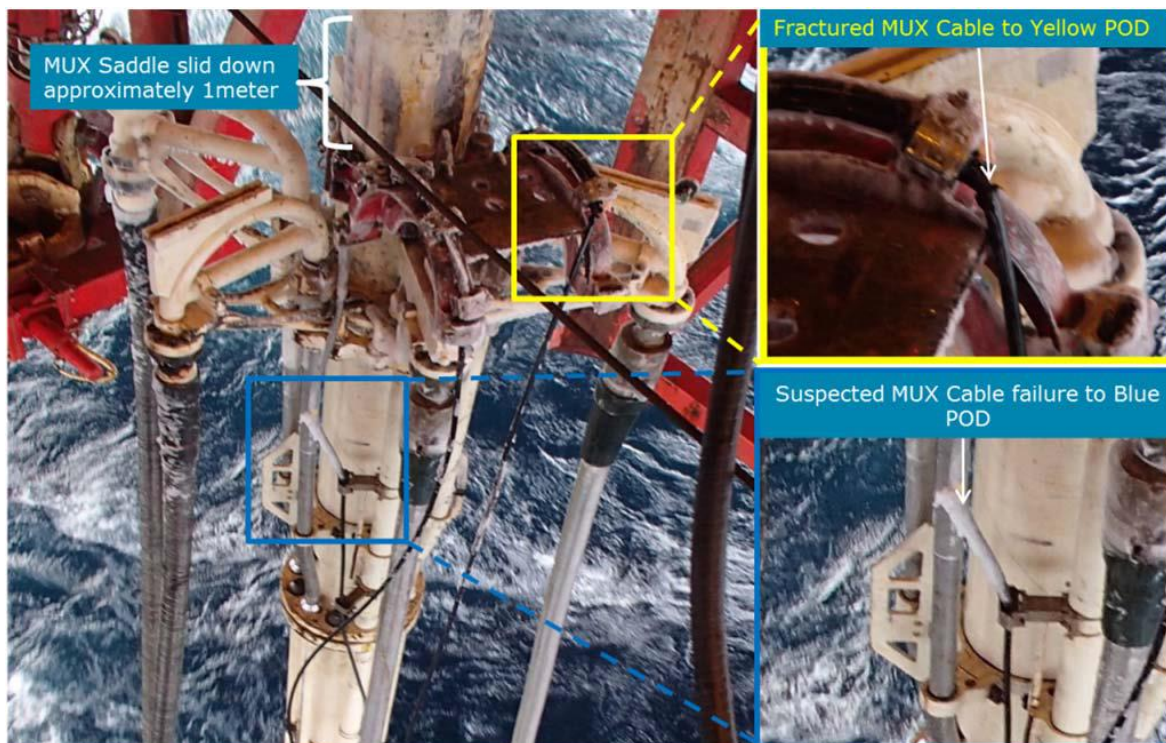
An inspection of the lines revealed the saddle arrangement for attaching the MUX lines to the lower (fixed) portion of the slip joint slipped downwards approximately one metre. It was also observed that the yellow line had come off of the gooseneck arrangement and had been severely damaged. Lesser damage was observed to the blue line but was still sufficient to cause partial loss of signal.

Operators /Drilling Contractors are reminded of the requirement to critically review the configuration of the assembly used to attach the BOP MUX cables to the slip joint and to otherwise ensure that the arrangement of these lines in the moon-pool area is sufficiently robust to prevent damage even during severe weather conditions.

- The arrangement for securing the MUX saddle assembly to the slip joint including the need to ensure proper torque is applied to bolts as well as the need for a back-up mechanical stop to preclude movement of the assembly.
- The possible need to utilise bend restrictors, spiral wrap; and sufficient clamps to ensure the robustness of the arrangement.
- A requirement to exercise close management oversight while rigging the lines.
- Ensure detailed procedures for installing the lines are available to crews. Close attention to ensure proper payout of the lines to ensure an optimal storm loop under full slip joint stroke is also important.
- Periodic inspection and monitoring of the arrangement in the moon-pool area to assure its ongoing integrity and reliability, particularly following storms. Give consideration to visual markings to aid crews in detecting any movement of the assembly.
