Serious Incident

Aircraft Type and Registration:	Boeing 787-9 Dreamliner, G-ZBKF	
No & Type of Engines:	2 Rolls-Royce Trent 1000-J2 turbofan engines	
Year of Manufacture:	2016 (Serial no: 38622)	
Date & Time (UTC):	29 April 2017 at 1040 hrs	
Location:	En route from London Heathrow to New Delhi airport	
Type of Flight:	Commercial Air Transport (Passenger)	
Persons on Board:	Crew - 13	Passengers - 124
Injuries:	Crew - None	Passengers - None
Nature of Damage:	None	
Commander's Licence:	Airline Transport Pilot's Licence	
Commander's Age:	50 years	
Commander's Flying Experience:	14,200 hours (of which 1,238 were on type) Last 90 days - 175 hours Last 28 days – 48 hours	
Information Source:	AAIB Field Investigation

Synopsis

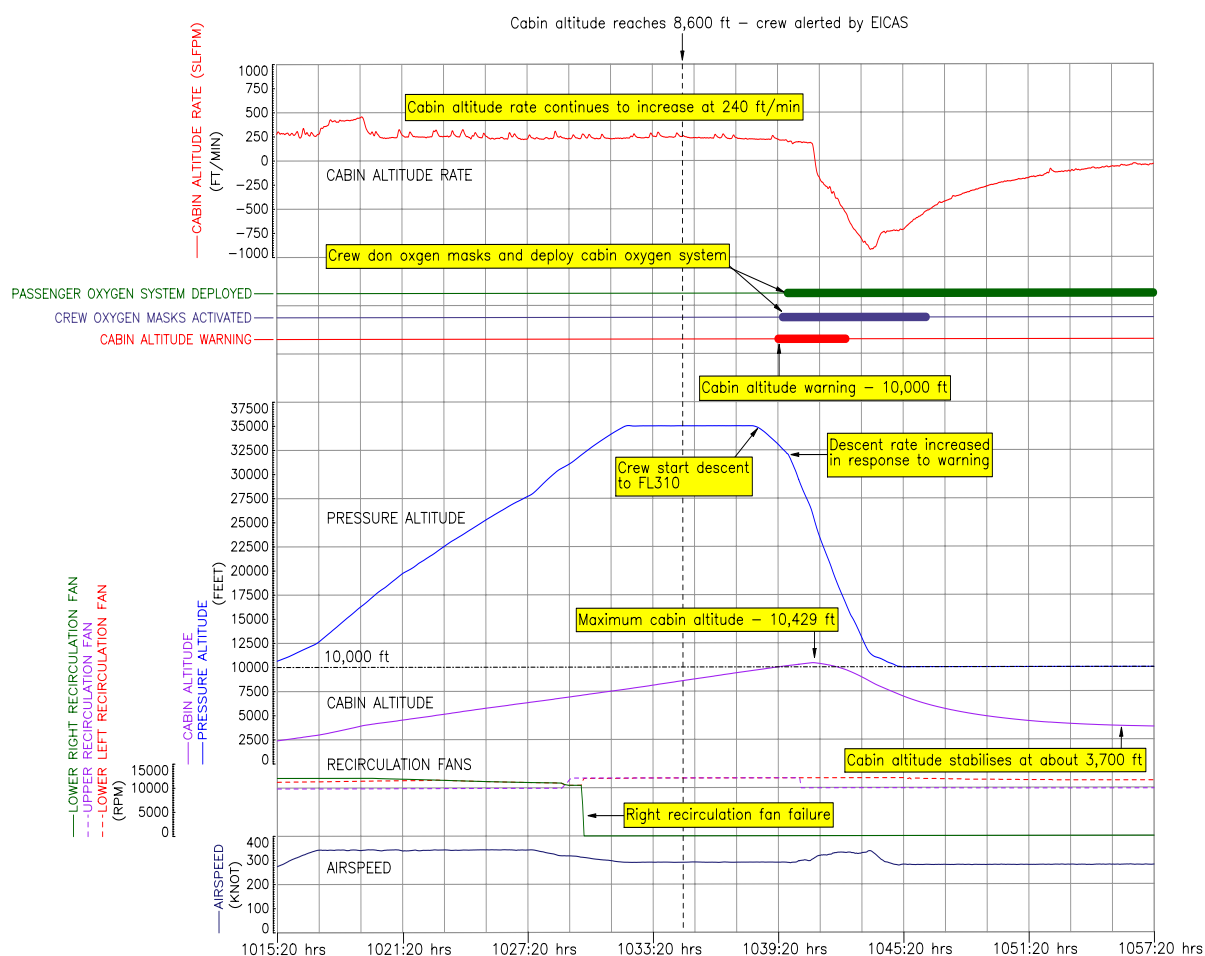
Figure 2

At 1029:54 hrs, as the aircraft was climbing through FL320, the air conditioning lower right recirculation fan stopped. The cabin altitude was 7,000 ft at this time and at 1033 hrs system status message 'RECIRC FAN LWR R' was triggered by the CMCF. This message was subsequently referred to by the crew about a minute later, after they had been alerted to the abnormal cabin pressure on EICAS.

Descent from FL350 following cabin altitude warning

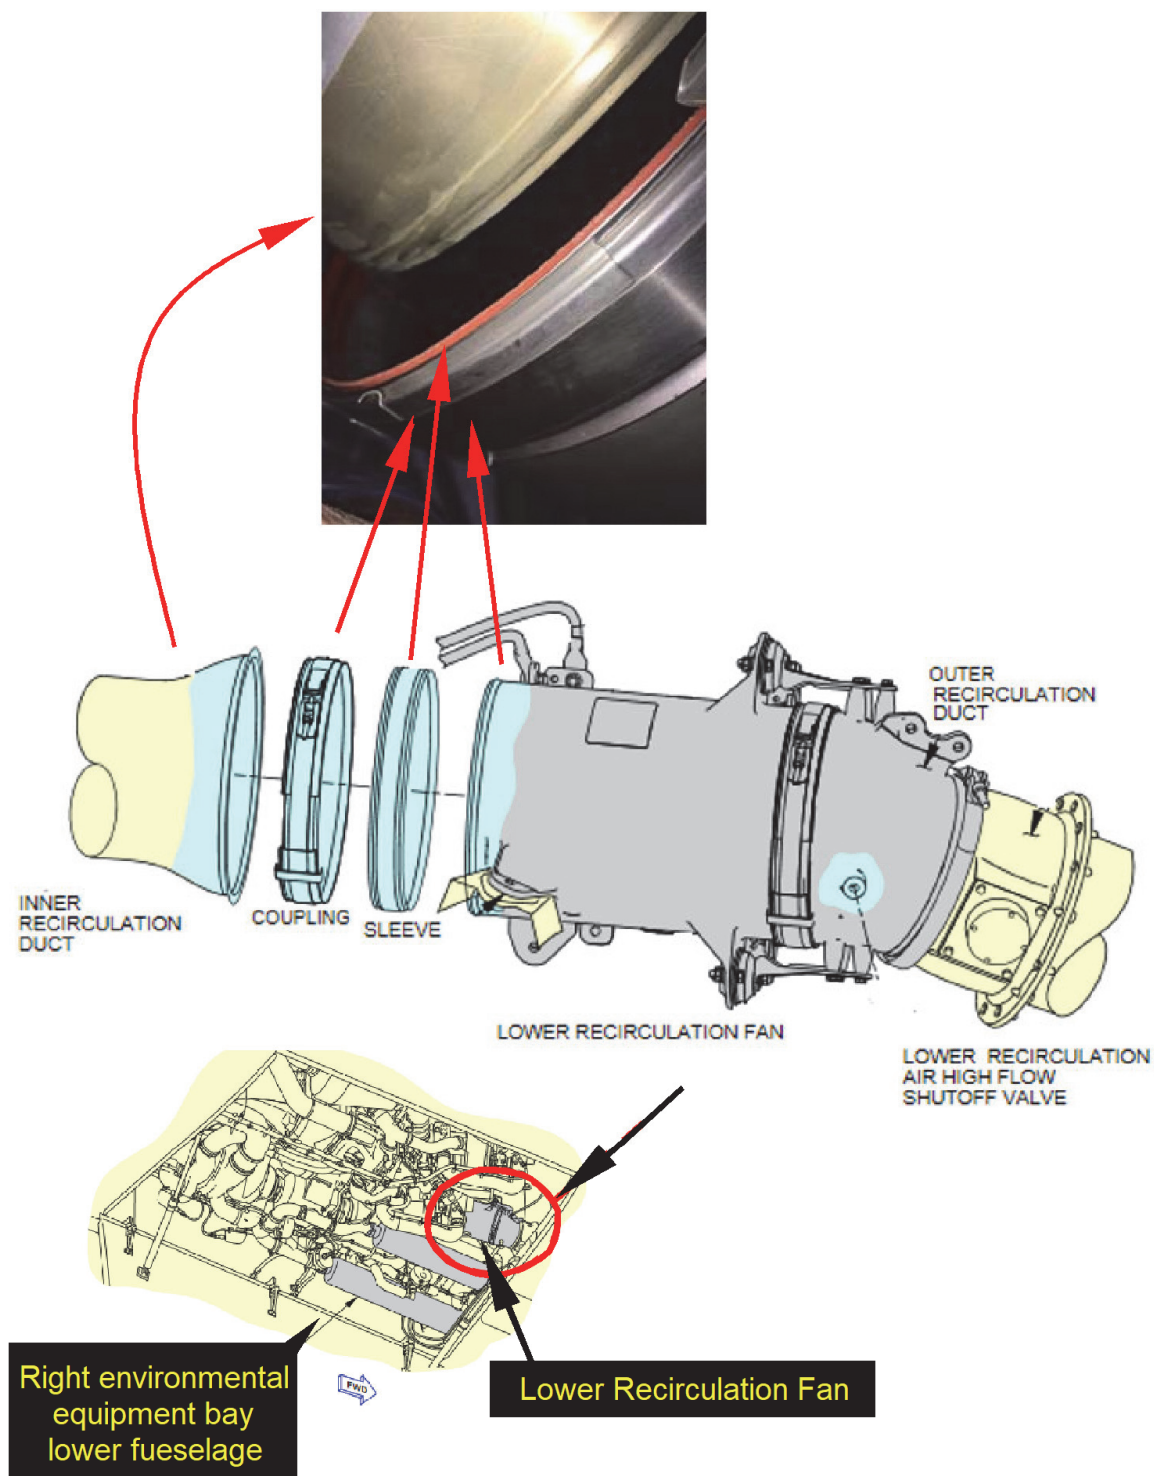
Following the return of the aircraft to Heathrow after the incident, an examination took place monitored by the AAIB. It was found that the right-hand inner recirculation duct was disconnected from the lower right-hand recirculation fan (Figure 3). Once the duct and fan unit were removed, there was evidence that the coupling and seal joining the two had been incorrectly aligned when last assembled. The V-band clamp joining the other end of the duct to the heat exchanger was correctly fitted.

Examination of the coupling system used to connect the recirculation fan to the inner duct showed that if the coupling were not installed correctly, there was less visible evidence and a reduced tactile feel compared to that of the V-band clamp used at the opposite end of the duct. The connection of the right-hand recirculation fan is located in a position that requires reaching through an extensive system of ducting and components to install it. Viewing of the connection between the duct and fan is also restricted. Figure 3 shows the relative position of the recirculation fan and the disconnected duct.

Position of Right Lower Recirculation Fan and photograph of disconnected duct

1. The incorrect fitment of the sleeve and coupling joining the replaced lower recirculation fan to the inner recirculation duct in the right air conditioning (AC) system allowing a leak of cabin air.
2. The maintenance organisation did not identify that the continuing air leakage, which persisted as a consequence of this incorrect fitment of the sleeve on the right AC system, would affect the pressurisation system performance if the aircraft were flown with the left AC unit disabled.
3. Fracture of a component (tie-rod) within the L2 CAC of the left air conditioning system, resulting from a manufacturing quality control shortfall.
4. Damage to the L1 CAC of the left AC system as a result of ingestion of a liberated part of the failed L2 CAC tie-rod and its nut, leading to the disabling of the left AC system before flight.

The incorrect fitment of the coupling and sleeve was partly a consequence of the inaccessibility of those components in the right AC unit and the lack of tactile feel enabling an incorrectly assembled coupling to be easily identified. The resulting leakage from the recently assembled coupling was identified by the AHM Customised Alert and analysed by the operator's Technical Support department. It was decided that, as the aircraft was

The inability of the aircraft to maintain normal cabin pressure was found to have been caused by the right lower recirculation fan becoming detached from the inner duct, which allowed air from the AC unit to leak to atmosphere rather than provide the required cabin pressure on a sector where the left air conditioning system had been disabled before flight.

When the aircraft was operated during the incident flight with only the right air conditioning system available, the system did not have sufficient capacity to overcome the effect of the leak. It was concluded that the lower right recirculation fan had not been correctly attached to the inner duct when the fan had been installed on 18 April 2017.

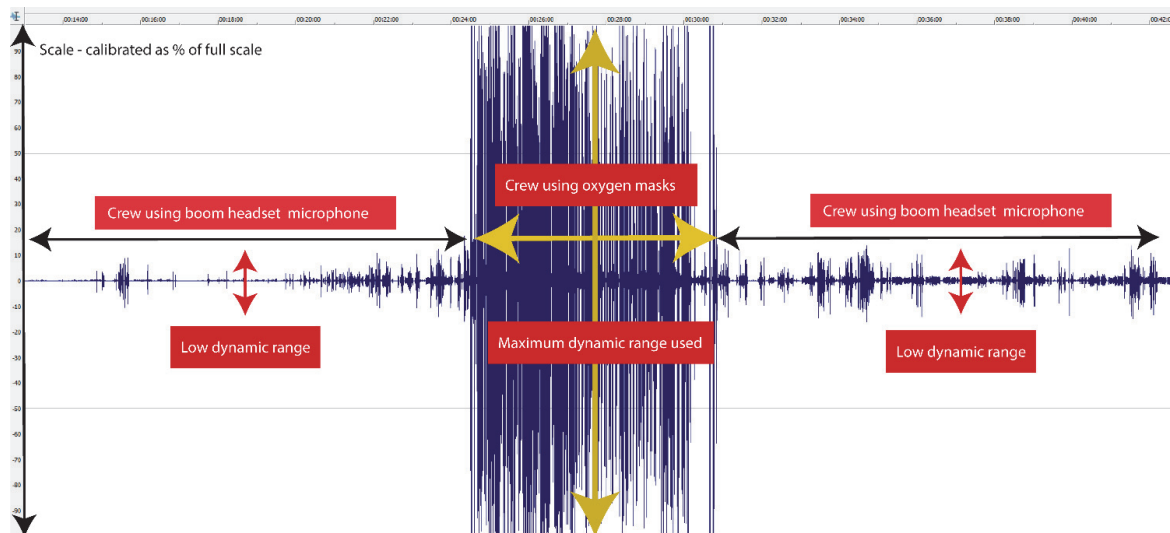
Further to the previous findings of the NTSB, the AAIB also identified that when the flight crew of G-ZBKF had used their oxygen masks, the full dynamic recording range of the crew CVR channels was used, with occasional clipping of the signal. Figure 4 reflects the difference in dynamic recording range when the flight crew used the headset and oxygen mask microphones.

G-ZBKF – CVR waveform of crew channel showing difference in use of available dynamic recording range between headset and oxygen mask microphone signals

crew are using the oxygen masks, due to the disparity in the recorded dynamic range of the sidetone and oxygen mask signals. A Safety Recommendation has been made to address this.

It is recommended that the Federal Aviation Administration require Boeing to modify the audio system fitted to the Boeing 787, so that sidetone signals recorded on the cockpit voice recorder crew channels are not masked when flight crew oxygen mask microphones are in use.

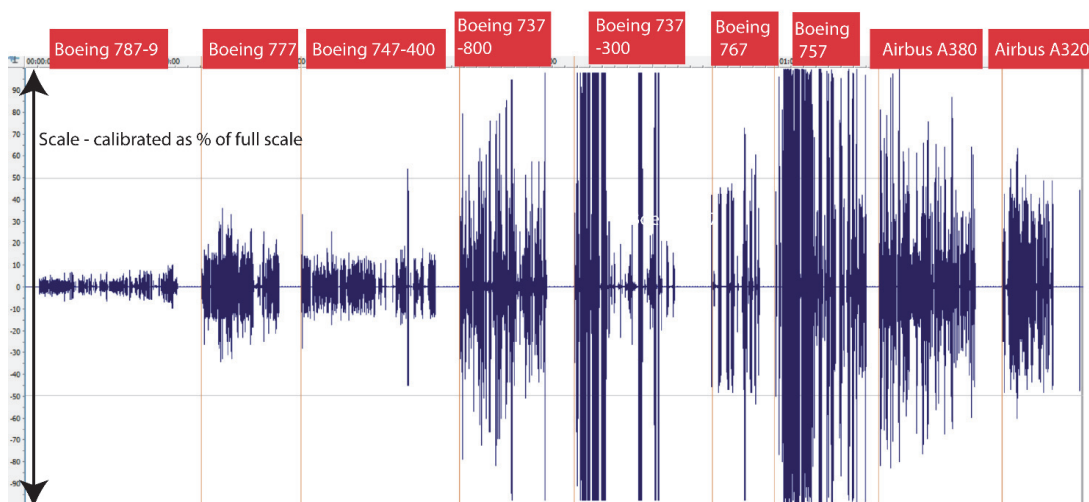
Figure 5

Boeing 787 and Airbus A380 had the highest levels of background ambient noise which, depending on the phase¹⁶ of flight, could mask crew conversation. The Airbus A320 CVR system provided a reasonable balance of the use of the dynamic recording ranges and level of ambient noise on the CAM channel that meant that the majority of sounds and communications could be readily transcribed.

Nine aircraft types - differences in dynamic range used for recording of crew channels

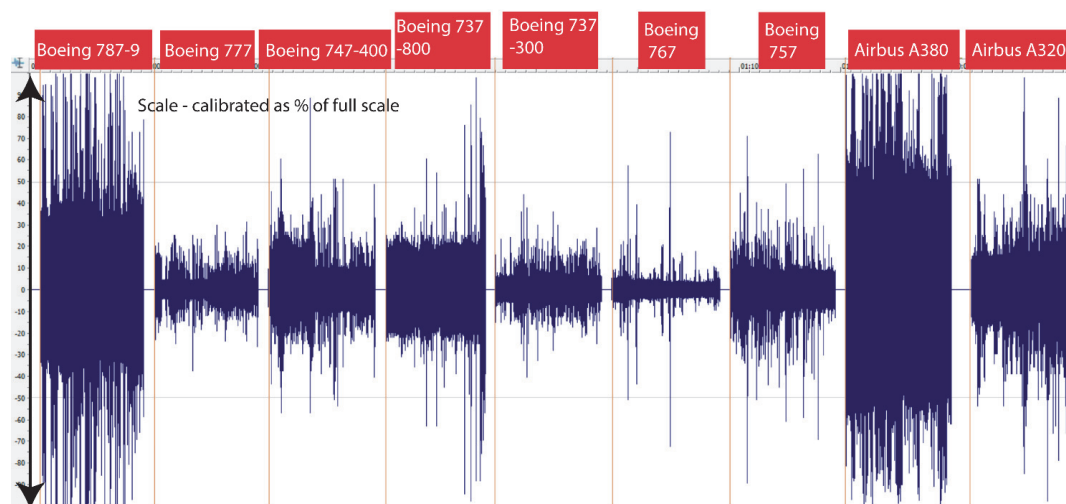
Figure 6

Nine aircraft types - differences in dynamic range used for recording of CAM channel
