Catastrophic engine failure, resulting in a fire and serious injuries to the engineer on board *Wight Sky*, off Yarmouth 12 September 2017

SUMMARY

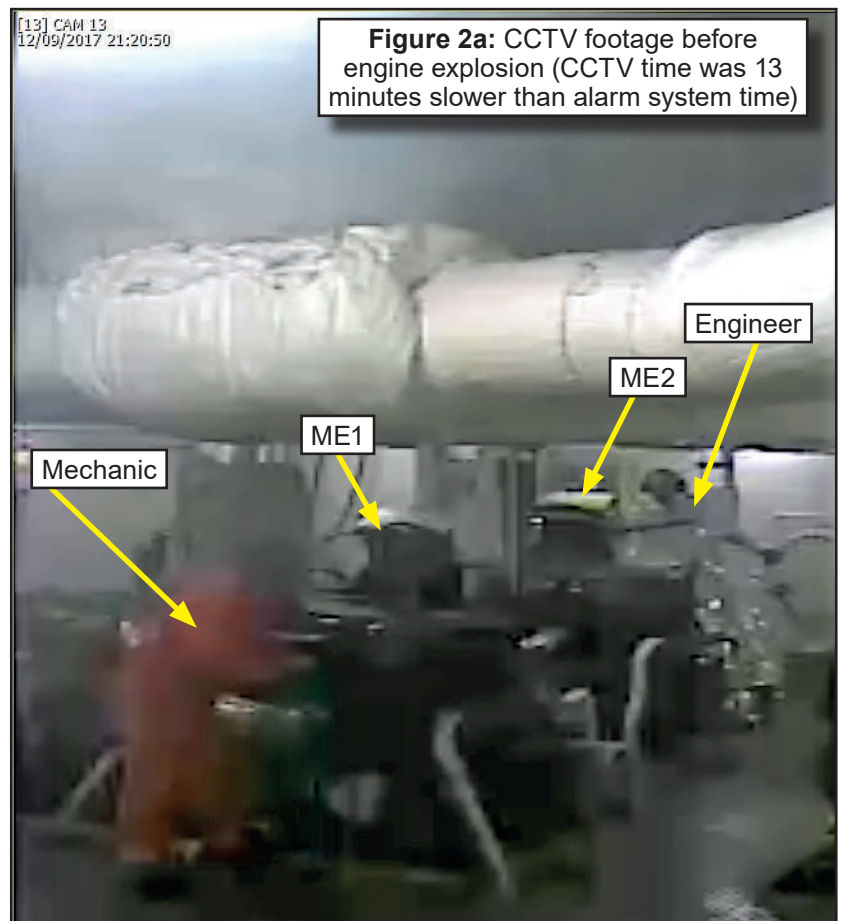
At around 2130, the engineer went down to the forward engine room from the machinery monitoring room (MMR), located on the main vehicle deck immediately above, to note the machinery running parameters for the logbook. He saw that the high temperature cooling water header tank for ME2 required topping up and, while he was filling the tank with coolant, he heard an unusually loud sound from the engine. The mechanic was attending to main propulsion engine 1 (ME1) located in the same space (**Figure 2a**). At 2133:51, as the engineer rushed towards ME2’s emergency shutdown button, there was a loud explosion from its crankcase (**Figure 2b**).

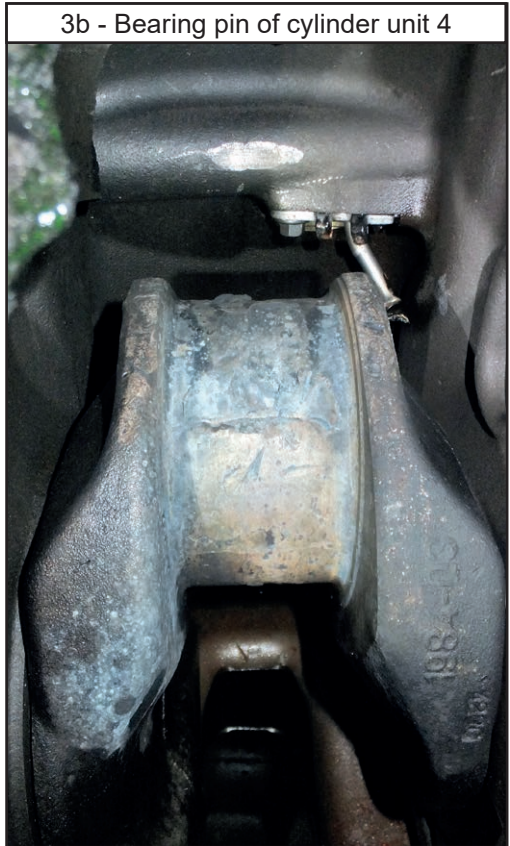
3b - Bearing pin of cylinder unit 4

Most of the visible damage was observed in and around cylinder unit 4 of ME2. The big end bearing was distorted radially (**Figure 3a**), white metal had melted onto the bearing pin on the crankshaft (**Figure 3b**) and two of the four big end bearing bolts had sheared at the joining face between the top and bottom halves of the bearing keep. The outboard side of the crankcase was punctured (**Figure 3c**), creating a large opening through which several components, including the gudgeon pin, connecting rod and fragments of the piston and cylinder liner had been ejected. There was fire damage on and around the engine (**Figure 3d**).

Volvo Penta's finding, that debris in the oil channels was the likely cause of the bearing shells turning, was not supported by direct evidence, such as embedded debris in the shells. However, debris of significant hardness and size, if lodged between the main bearing and crankshaft journal, has the potential to disrupt the hydrodynamic lubrication, resulting in metal to metal contact. This would be rapidly followed by the bearing shells turning, blocking the oil supply to the big end bearing, which then resulted in its failure.

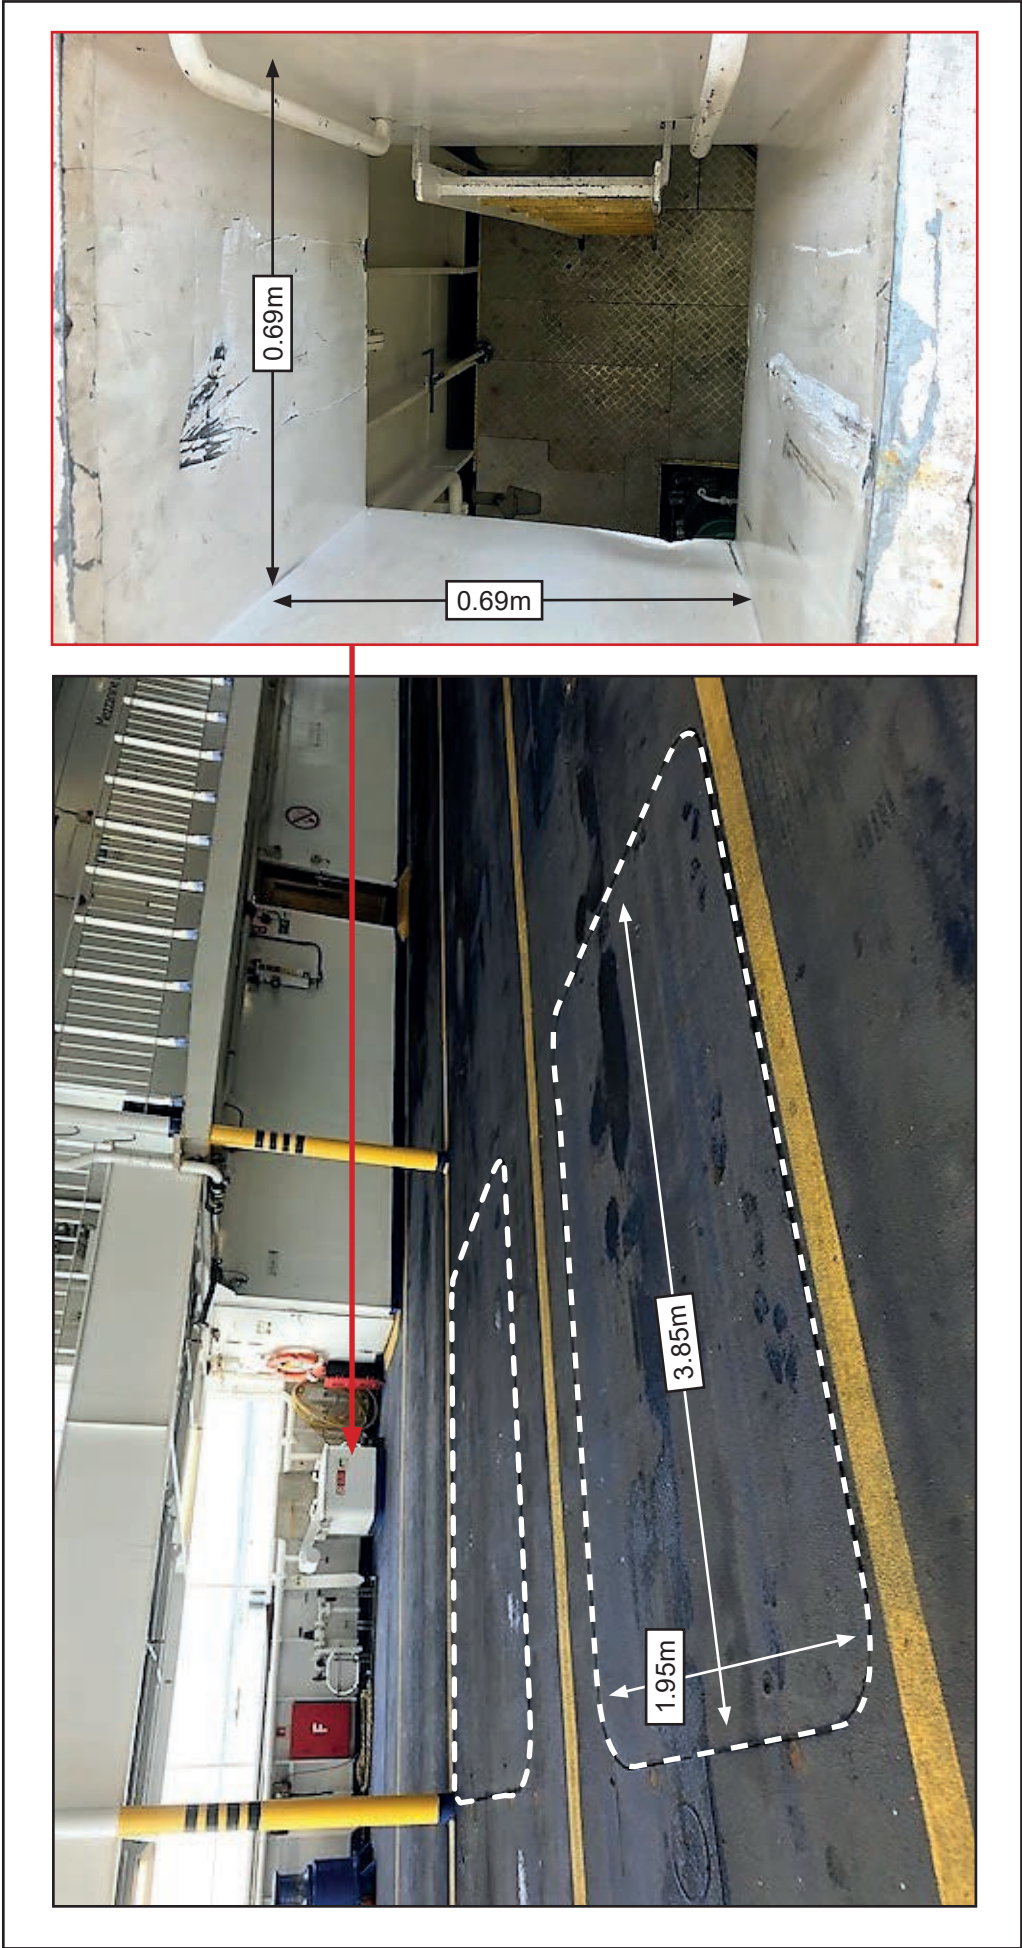
Figure 5: Soft patch and escape hatch

All of *Wight Sky*'s four main propulsion engines had a 'soft patch' in the deckhead directly above them that could be removed to permit the removal and replacement of complete engines (**Figure 5**). Each opening was 3.85m by 1.95m and was closed with a steel plate bolted down and sealed flush with the vehicle deck. At the deckhead level in the engine room, the soft patch was insulated and covered over with cladding plates held in place by pop rivets. Opening the soft patch involved the removal of several items associated with the engine, including a large section of exhaust pipe, crankcase breather, engine lifting beam and several brackets supporting the pipes.

The soft patches were not used to move the engines in or out of the engine rooms due to the disruption their removal would cause. Therefore, RKM planned its work around the use of the emergency hatch. This required the engines to be partially disassembled and rebuilt in the engine room, transporting the majority of the components in the short block.

The source of any debris that might have entered the oil channels cannot be known for certain. However, ME2's short block had been exposed to the elements for 3 days with only a loose plastic sheet for protection, and debris could have entered the oil channels during this time.

Rebuilding the entire engine under a clean and controlled environment and transferring it directly into the engine room through the soft patch would have significantly reduced the likelihood of debris ingress during transit and while awaiting fitting.

- Agreed with RKM that all engines will be fully assembled and load-tested prior to delivery on board.
- Put in place signage to ensure that the circuit breakers for the essential services switchboard are correctly set at all times.

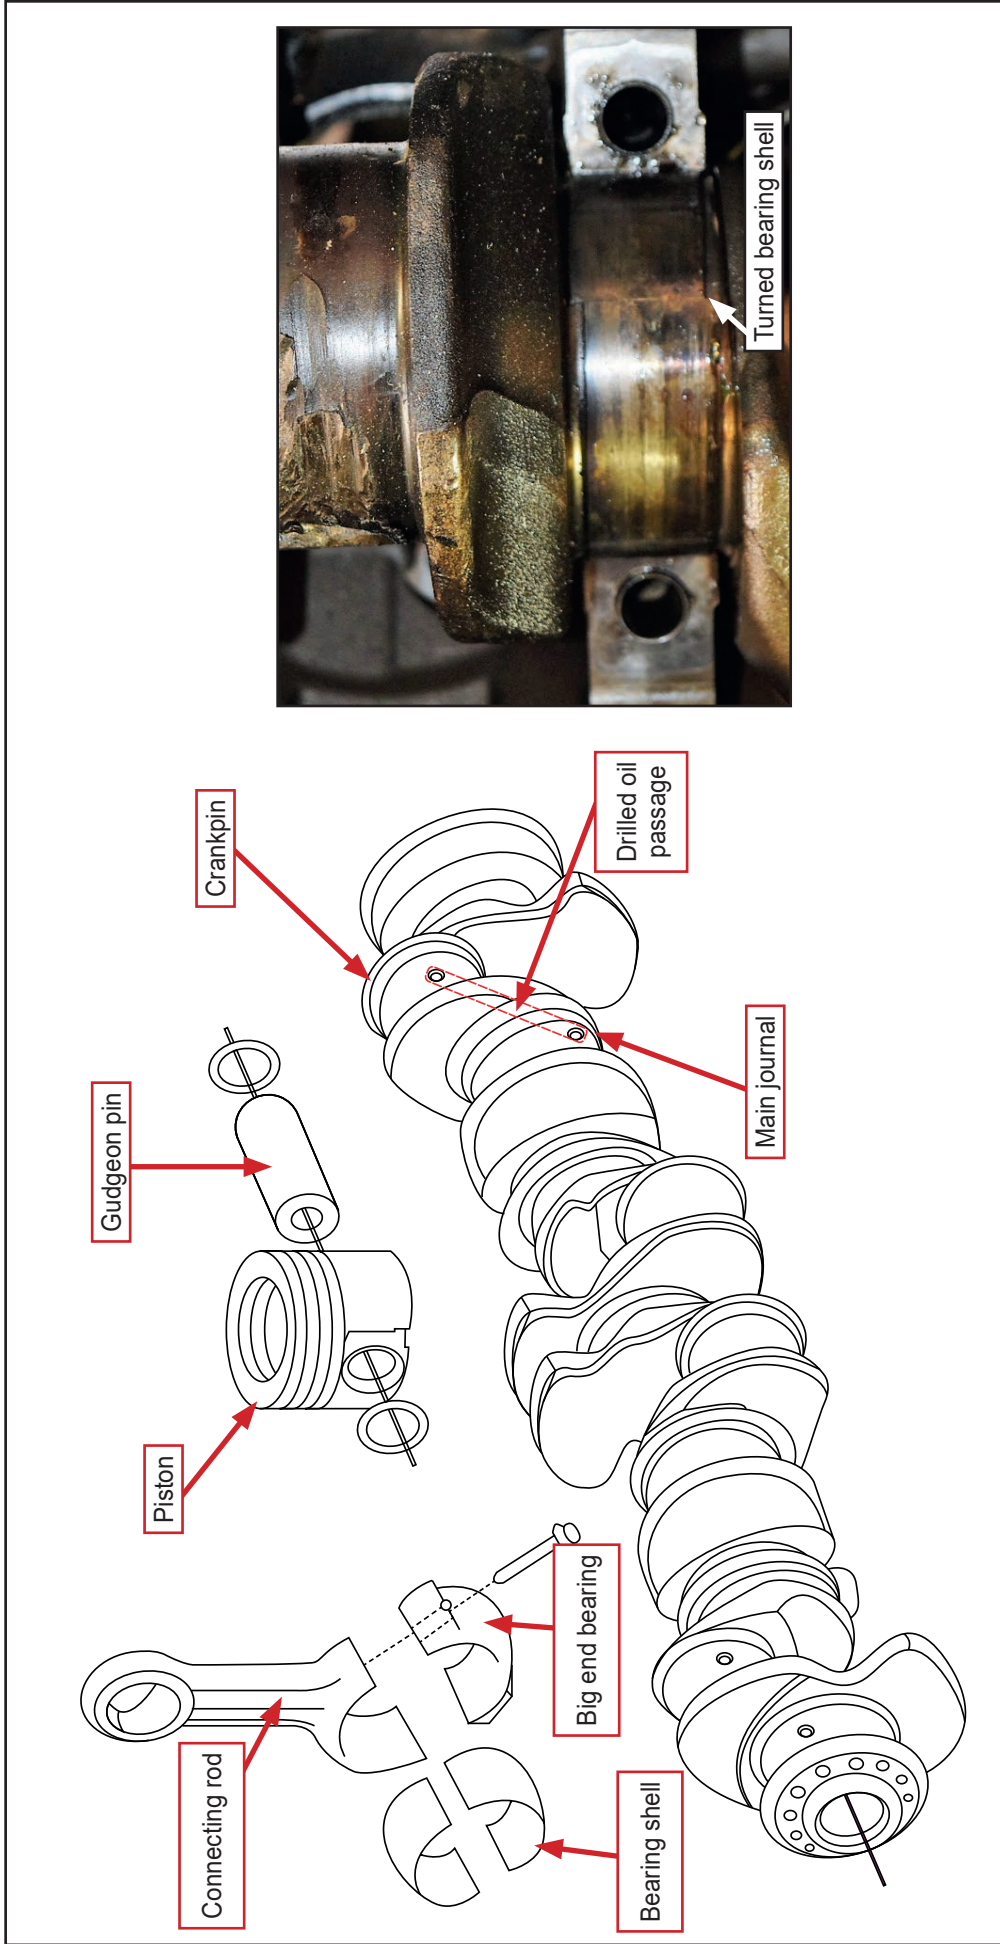
Figure 7: Schematic of crankshaft assembly

The investigation report by Volvo Penta concluded that, when the shells for main bearing 5 turned, they blocked the lubricating oil channel on the main journal leading from the journal to cylinder unit 4's crank pin. This caused the big end bearing to seize on the crank pin, leading to the failure of the bearing bolts. The rotating crankshaft then hit the unrestrained connecting rod, which impacted against the side of the crankcase, puncturing it and breaking the piston cooling oil gallery.

- When the shells of main bearing 5 turned, the lubrication supply to big end bearing 4 was blocked, resulting in destructive failure.
- Rebuilding the engine in a clean and controlled environment and transferring it complete into the engine room would have reduced the likelihood of debris ingress.
