M40 J4 / A404 Handy Cross Roundabout Economy Study

Produced for
Highways Agency

Prepared by
EnterpriseMouchel
Design Centre
1123 Mollison Avenue, Enfield EN3 7NJ

Report Title Economy Study

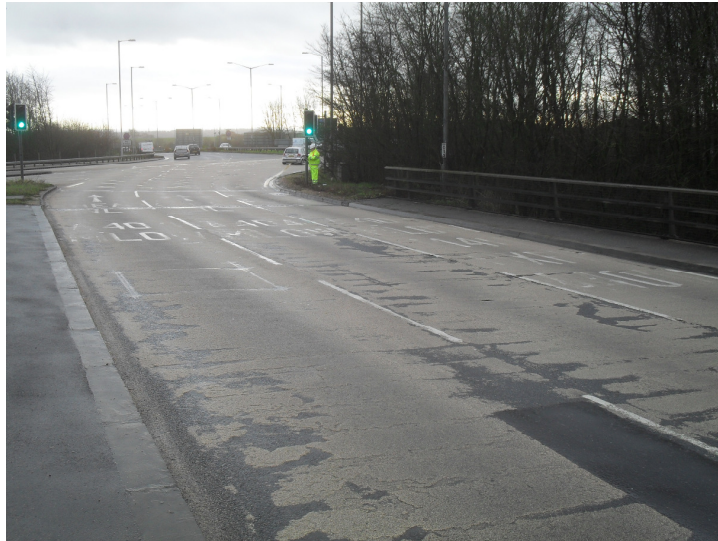
Figures 4.1 and 4.2 below show the very poor condition of the carriageway surface and lane markings on the link between nodes 1 and 7. Firstly, as there is very little contrast provided between the buff-coloured anti-skid surfacing and the road markings, conspicuity of the markings is poor. In addition, the anti-skid surfacing is badly delaminating from the bituminous surface below and the lane markings are particularly worn and not recognisable within the wheel tracks.

Furthermore, the lane destination markings on this link extend to 4 lines of text on lanes 1 & 2 and 5 lines on lane 3 (see Appendix A). It is felt that this amount of text on the road surface is too much for drivers to reasonably assimilate.

When all of these features are combined, drivers are presented with a largely illegible and confusing layout at a point where lane clarity, by destination, should be a primary objective.

**Figure 4.1 – Poor condition of existing anti-skid surfacing and road markings
(view looking south)**

- On the circulatory carriageway and roundabout approaches, provide a black-coloured road surface which meets DMRB Vol. 7 requirements to improve the current poor contrast between the buff-coloured HFS and the road markings.

- With the exception of the A404 southbound exit from the roundabout (see below), re-mark the existing road marking layout as shown on drawing no. 3/004973/DR/000/001 in Appendix A.

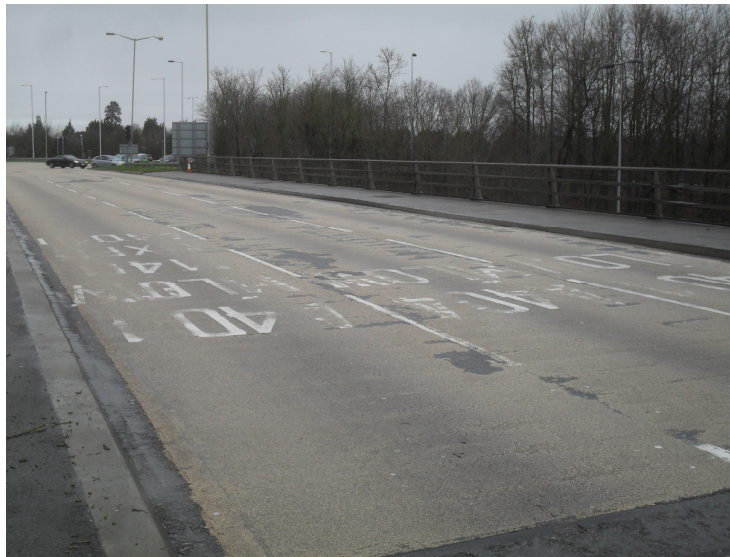
**Figure 4.2 - Poor condition of existing anti-skid surfacing and road markings
(view looking north)**

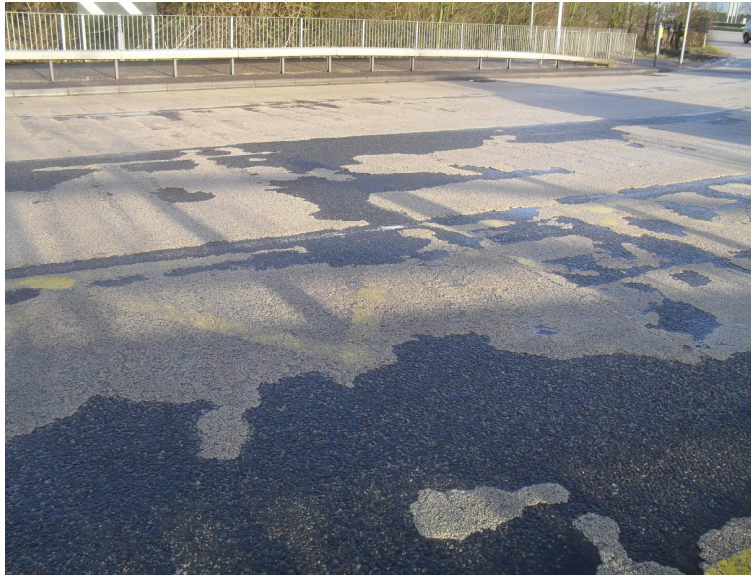
Two further examples of this are provided in Figures 4.3 and 4.4 below. Figure 4.3, taken on the circulatory between nodes 3 and 4, shows the extent of delamination of the anti skid surfacing from the bituminous carriageway below. Figure 4.4, taken on the circulatory between nodes 6 and 7, principally shows the poor road marking condition and in particular the destination markings which are illegible.

Figure 4.3 – Delamination of anti skid surfacing on circulatory carriageway

- Undertake appropriate remedial measures to rectify areas on the circulatory carriageway and roundabout approaches where the existing high-friction surfacing (HFS) has delaminated.

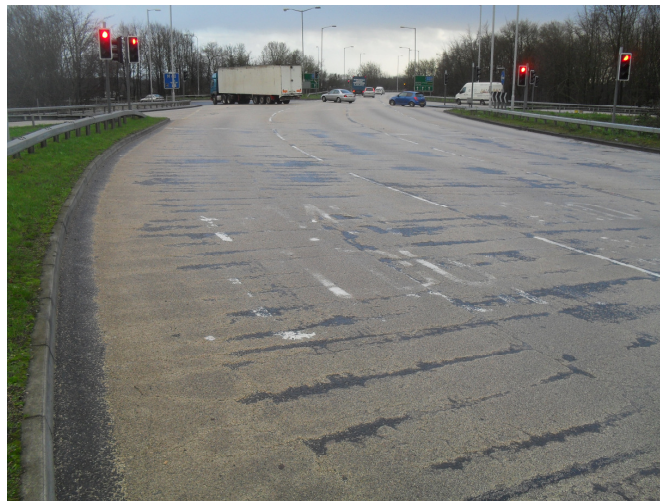
Figure 4.4 – Very poor condition of road markings on circulatory carriageway

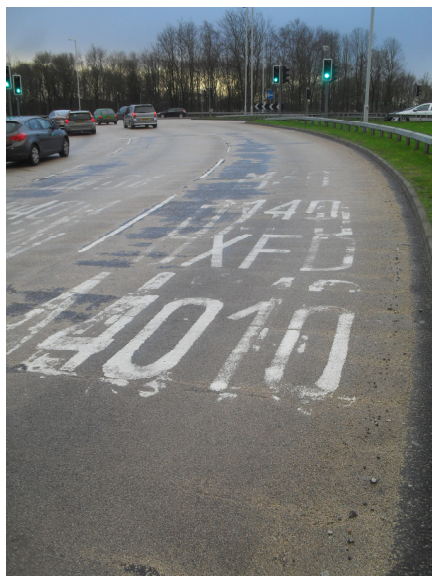
On the Arm B approach to the roundabout (see Figure 4.5), the anti skid has worn through to reveal a previous road marking layout applied on the carriageway below. Again, this results in a road marking layout which is illegible to approaching drivers.

Figure 4.5 – ‘Wear’ of anti skid revealing previously applied road markings

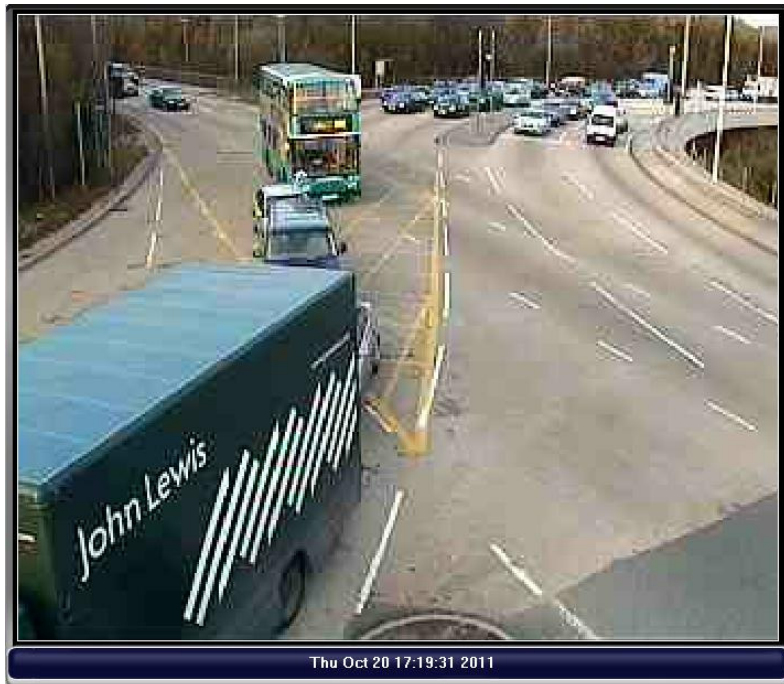
It can be seen that 139 PCU use lane 3 to travel ahead on the A404 southbound in the AM peak hour, while 205 PCU contravened the 'Ahead Only' markings and turned right from lane 2. An example of this is shown in Figure 4.6 below where a bus can be seen turning right from lane 2 to exit via the Burroughs Grove Hill/Wycombe Road arm. This is the conflict reported frequently in the HAIL enquiries summarised in Appendix B.

Figure 4.6 – Bus disobeying ‘Ahead Only’ markings & turning right from lane 2

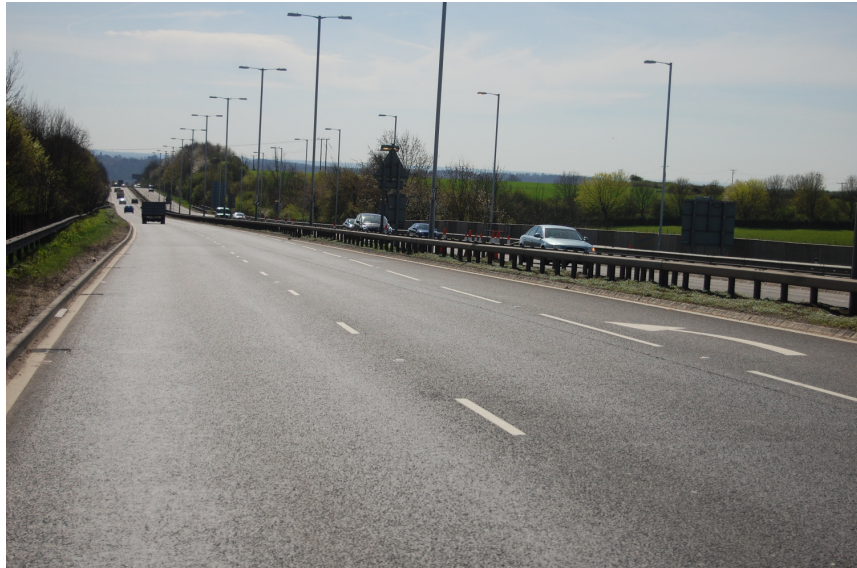
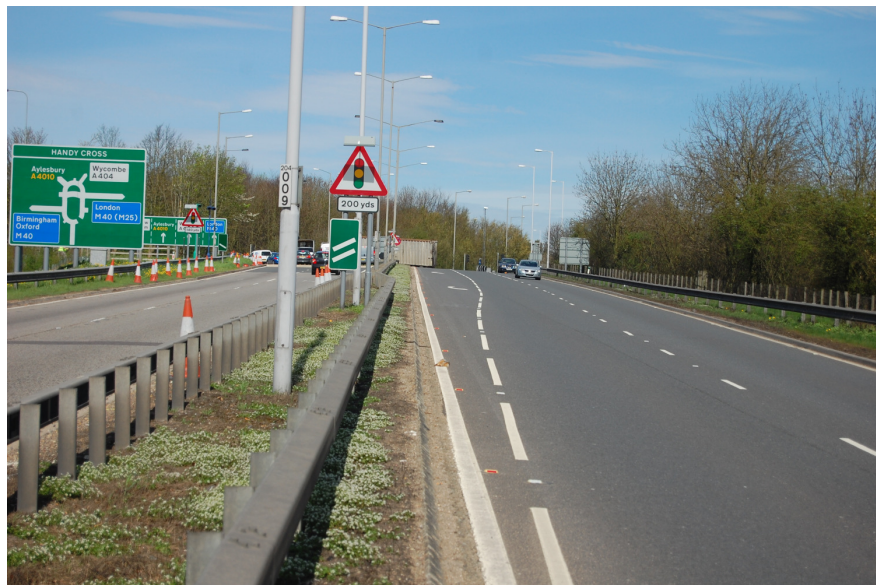
The southbound A404 exit from the roundabout is marked as 3 lanes which merge into 2 lanes approximately 215m south of the roundabout splitter island. Under this arrangement, the offside lane is lost. However, as can be seen from Figures 4.10 and 4.11, the lane markings in between lanes 2 and 3 continue up to the point where the lane width in lane 3 is zero. In the 5-year collision period examined in Appendix C, there have been 2 collisions which are possibly linked to this layout (Accident No's 39 & 53).

Figure 4.10 – A404 southbound looking away from Handy Cross Junction

Figure 4.11 – A404 southbound looking back towards Handy Cross Junction

As can be seen from Figures 4.10 & 4.11, the existing lane loss layout does not resemble either of the recommended layouts referred to above and may have contributed to 2 injury collisions which are recorded over the 5-year collision period investigated. The layout should be amended by removing all existing lane markings and studs between lanes 2 and 3 where the width of lane 3 is less than 2.5m and the deflection arrows (TSRGD Diagram 1014) should, if necessary, be remarked in accordance with TSM Chapter 5.

- Amend the existing lane loss layout on the A404 southbound by removing all existing lane markings and studs between lanes 2 and 3 where the width of lane 3 is less than 2.5m. If necessary, re-mark the TSRGD Diagram 1014 deflection arrows in accordance with TSM Chapter 5.

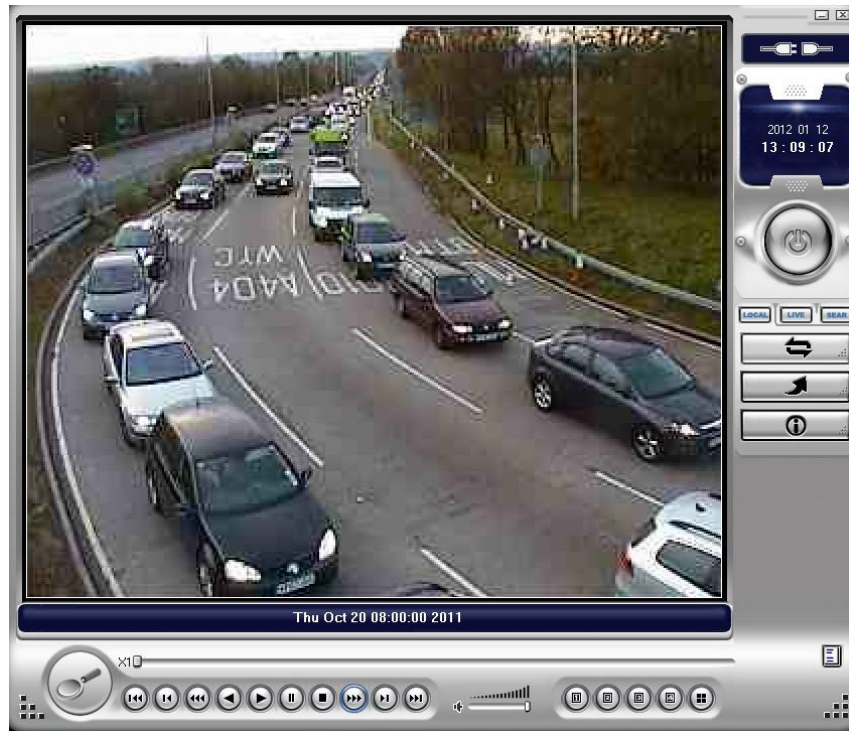
In addition, it was observed that lane 1 is very lightly used (only 1 vehicle per cycle) as it is signed for Marlow Bottom but lane 3 was very slow to access during the red stage of the signals, and frequently discharge started while still not full (see Figure 4.13). The under-utilisation of lane 3 is due to the layout of the existing lane markings where lane 3 is introduced and it is considered that a marginal capacity improvement of 2 PCU's per cycle during peak periods could be realised through a locally revised lane alignment.

Figure 4.13 – Underutilisation of lane 3 on A404 Northbound approach to roundabout
