# Rail Accident Report

## Freight train derailment at Ely West Junction 14 August 2017

Report 09/2018  
August 2018

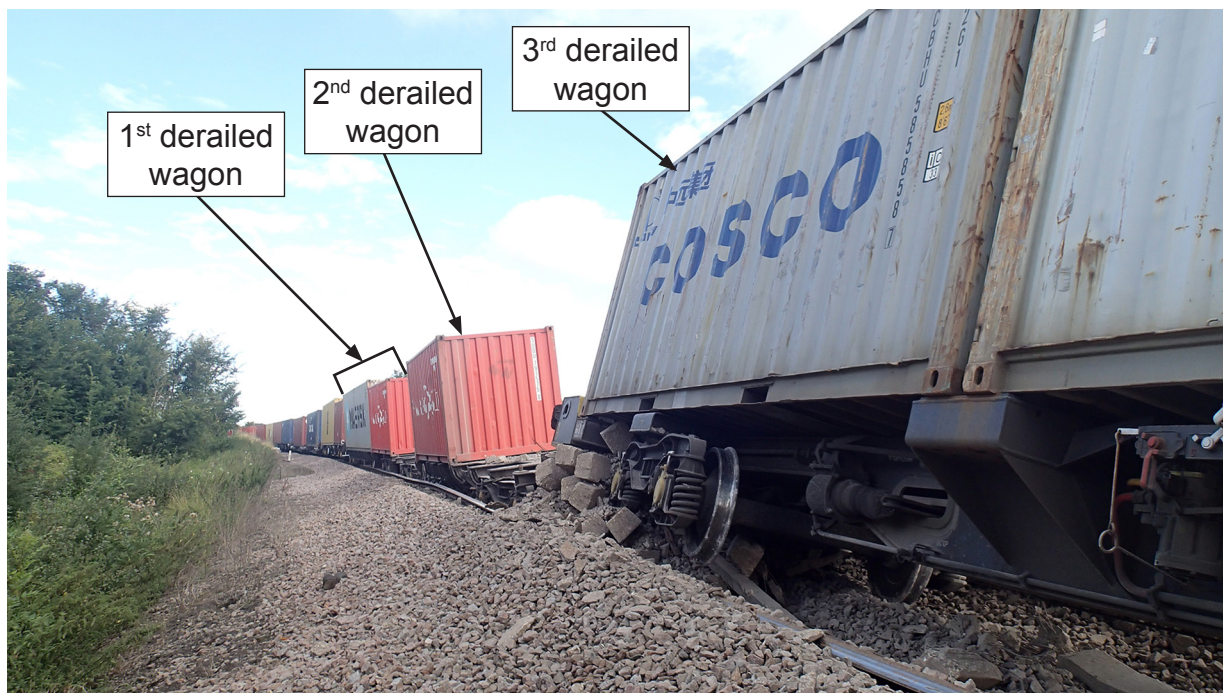
Figure 2: Derailed wagons on site

- 25 As wagon 630034 passed over the crossing nose of 1161A points, its leading wheelset veered further to the right away from the track centreline as its right-hand wheel was guided by the diverging crossing rail. This led to the derailment of the trailing wheelset of this bogie. Eventually the leading left-hand wheel came up against the six-foot rail and caused the crossing rail and six-foot rail to be squeezed together causing significant infrastructure damage. The damage caused the trailing bogie and all of the following wagons to derail. At 14:21:56 hrs, train 4Z33 came to a stop having run derailed for approximately 350 metres.

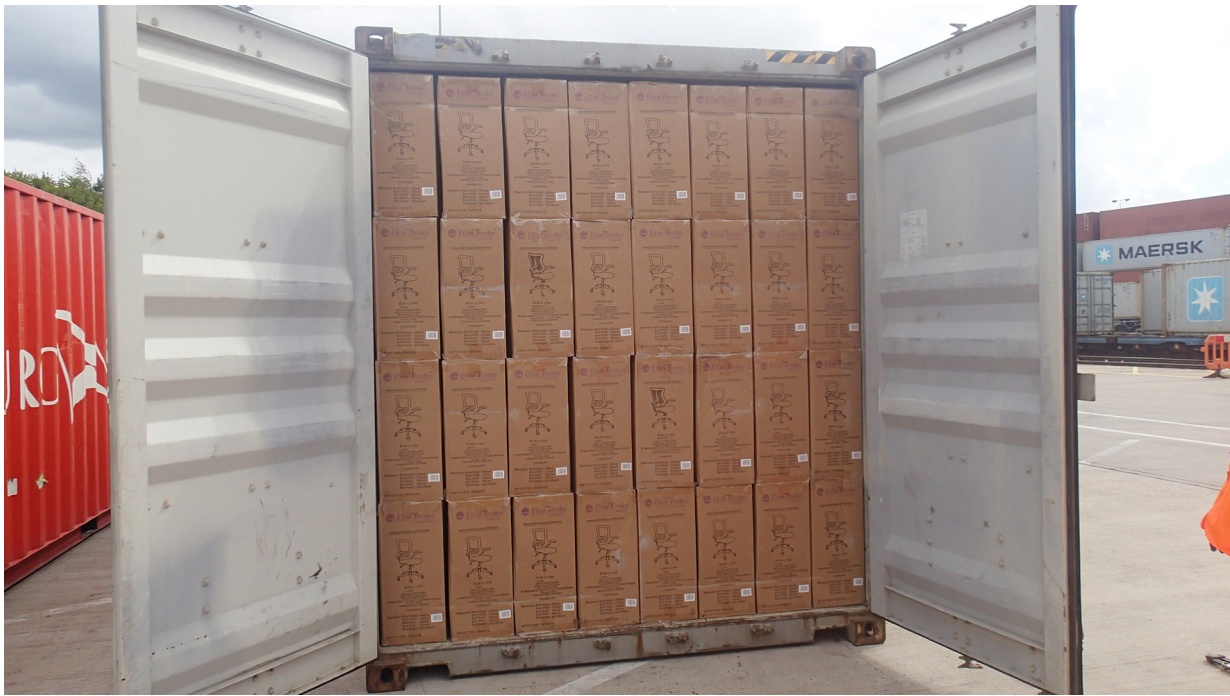
- 11 Wagon 630034 carried a 40 foot container in the leading position and a 20 foot container in the trailing position. Examination of these containers after the accident showed that the 40 foot container was packed with office furniture (figure 4) and the 20 foot container with pallets of floor tiles (figure 5). The mass of the 40 foot container was measured as 11.2 t and the 20 foot as 27.6 t. The payload in the 20 foot container was such that the centre of gravity of this container was offset both longitudinally and laterally. Photographic evidence showing the content of the container as it was packed in Izmir (Turkey) before coming to the UK demonstrated that the payload had moved marginally longitudinally and laterally, likely as a result of the derailment, between packing and post-accident inspection. The load position as recorded in Izmir was used during the investigation.

Figure 4: 40 foot container opened post-accident

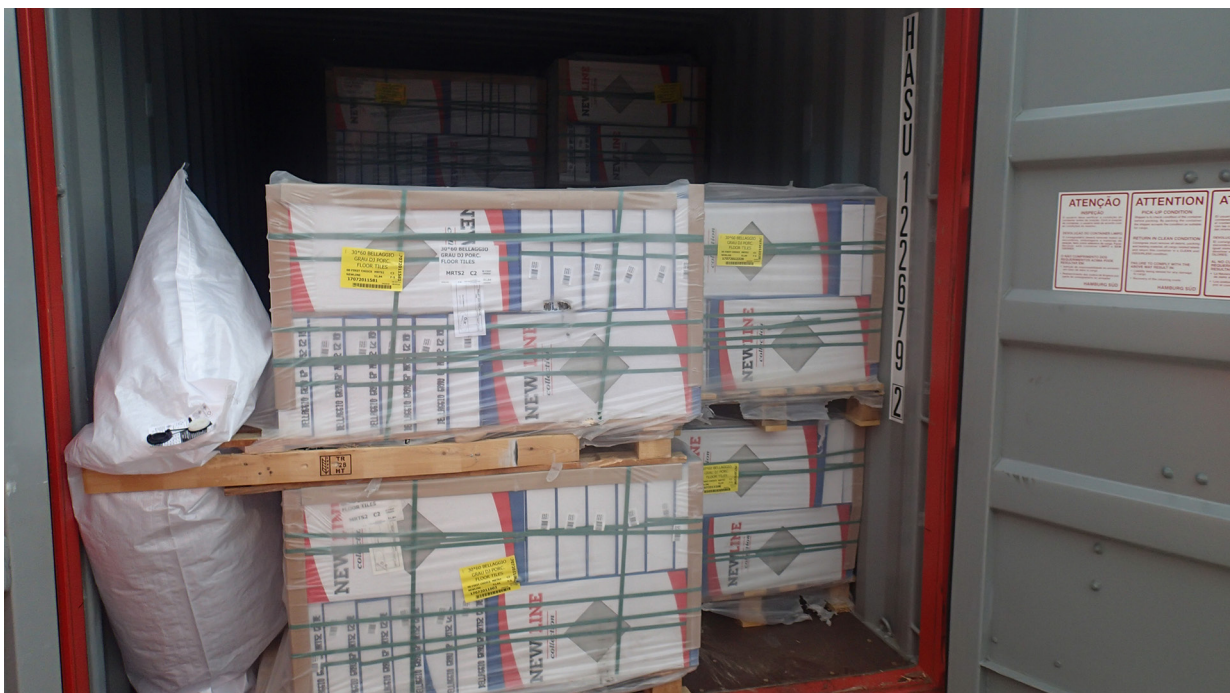
Figure 5: 20 foot container opened post-accident

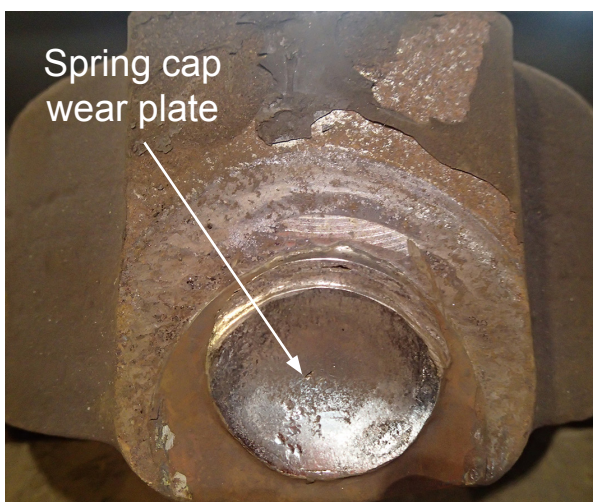
- 32 Wagon 630034 was examined at March depot after the derailment. The wagon underframe was lifted which enabled the bogies and their components to be examined. Of particular note was an unusual wear pattern on the spring cap wear plates (figure 9). This wear pattern suggested that:
- the spring cap wear plate had been sitting higher than the bush (figure 10); and
  - the spring cap wear plate had been pushing against the top of the bush instead of the plunger which suggests that the plunger was recessed inside the bush, instead of passing through and protruding from it (as shown on figure 11).

Figure 9: Wear pattern on incident spring cap wear plate

- 69 The RAIB ascertained the relative vertical position of the bush and spring cap wear plate centrelines using the dimensions contained in the VPI maintenance guidelines and standard bogie components drawings. As new, the centreline of the spring cap wear plate (diameter 36 mm) is aligned with the centreline of the bush (diameter 55 mm). As the damping components including the Lenoir links and trunnions wear, the spring cap moves up in relation to the bush position. The RAIB calculated that at the extreme of wear of the components<sup>15</sup>, the top of the spring cap wear plate may sit higher than the top of the bush. The physical evidence showed this was 4 mm in the incident axlebox (figure 9).

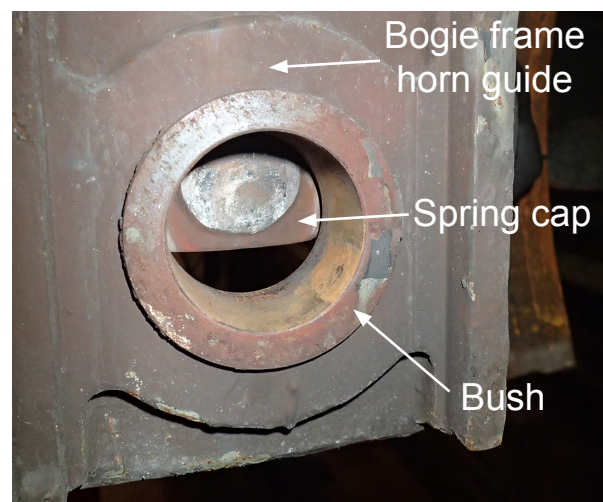
Figure 10: Position of spring cap wear plate relative to bush reconstructed on trailing axle of incident wagon (for illustrative purposes only)

33 The fact that the spring cap wear plate was sitting higher than the bush is demonstrated by the physical evidence. In order to establish whether the plunger had been sat recessed inside the bush, the RAIB took detailed measurements of the leading right-hand axlebox, the one associated with the wheel which first derailed, and its plunger. This enabled a comparison of the stacked length of these components with the measured distance between the bush and the horn guide wear plate. Table 1 shows the results.

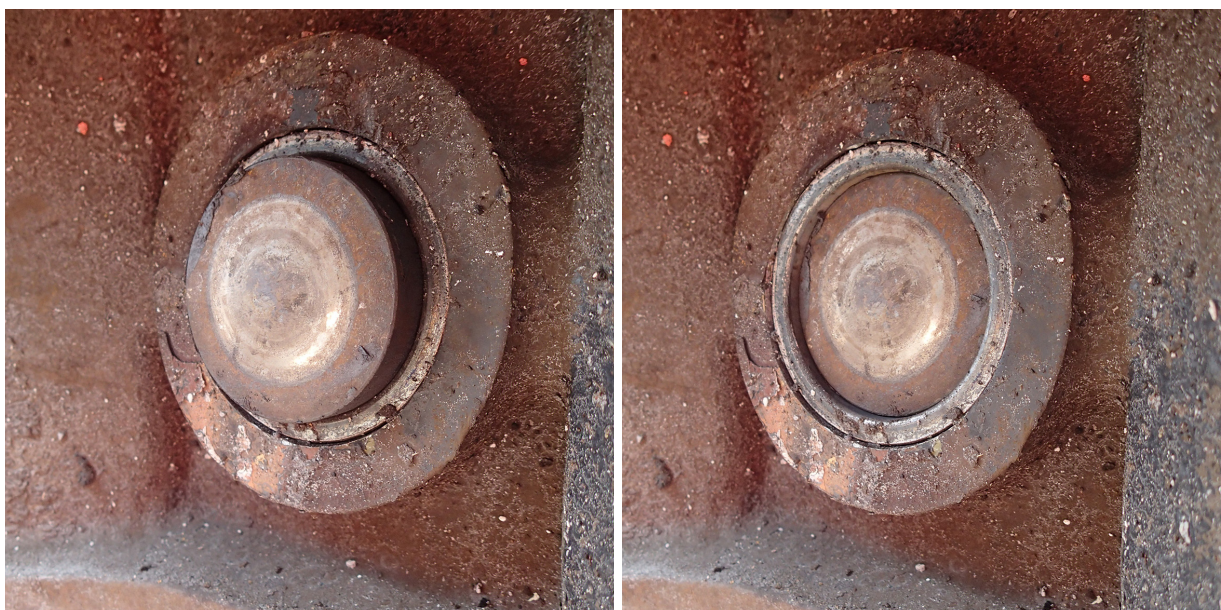
Figure 11: A plunger in normal position and in a recessed position - reconstructed on a different wagon for illustrative purposes

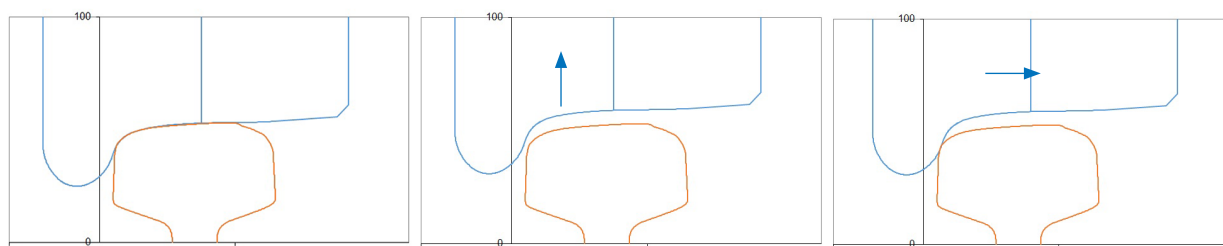
44 This simulation predicted that the leading right-hand wheel of wagon 630034 would fully unload at the point of derailment<sup>10</sup>. The leading right-hand wheel was predicted to lose contact with the railhead and to rise 6 mm (described as wheel flight) before re-contacting the rail in a partially climbed state (figure 12). At that point, the ratio of lateral load to vertical load applied to the wheel was also predicted to be high enough to continue to promote a derailment.

Figure 12: Wheel in contact with rail – normal condition (left), wheel in flight (middle), wheel landing in partially climbed state (right)

45 The level of partial climb predicted in the simulation (approximately 6 mm) is at a position at which the contact angle between the wheel flange and the rail starts to reduce. If the ratio of lateral load to vertical load is unfavourable, as was the case in the simulation<sup>11</sup>, the wheel will likely continue to climb and eventually lead to a derailment. The RAIB therefore concluded that the simulation predicted a high risk of derailment at the point at which the leading right-hand wheel actually derailed.

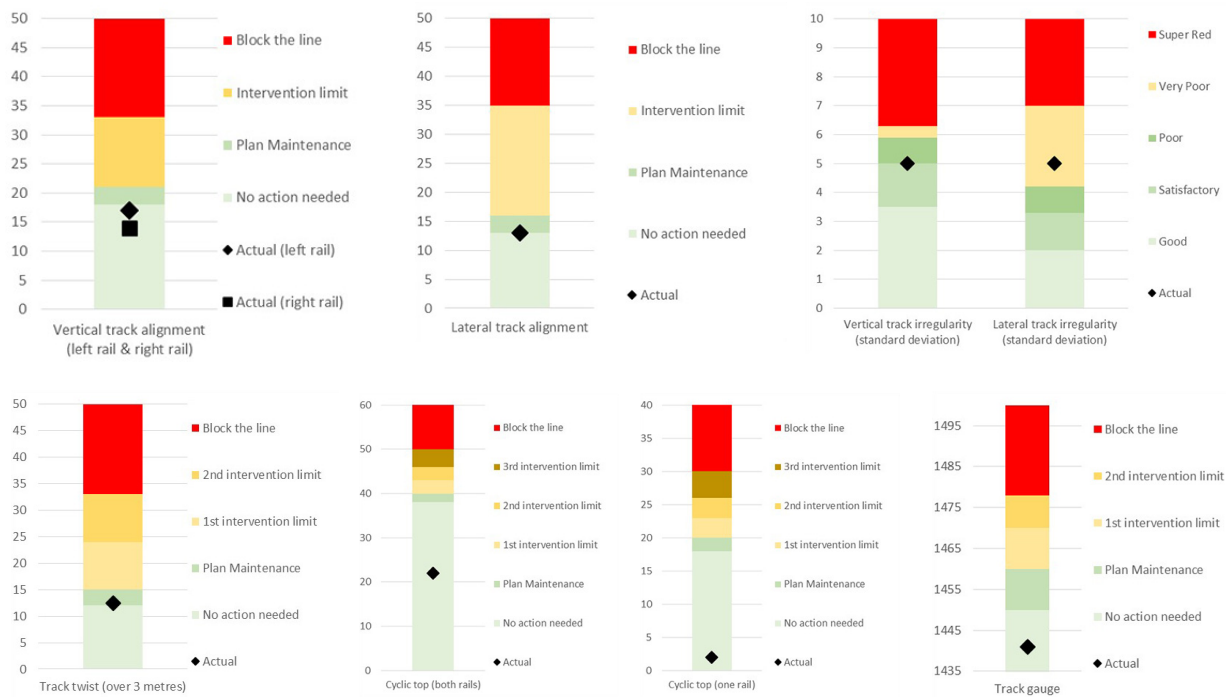
- 51 A 'poor' rating does not trigger any required action by Network Rail whereas a 'very poor' rating requires the people in charge of track maintenance to review what might be driving this rating and, where necessary, to take corrective actions. As such, the level of lateral irregularity was included in the sensitivity study. All other track factors were found to be within alert limits and hence were not included in the study. Figure 13 shows the input parameters and compares their values against the limits.

Figure 13: Track input parameters

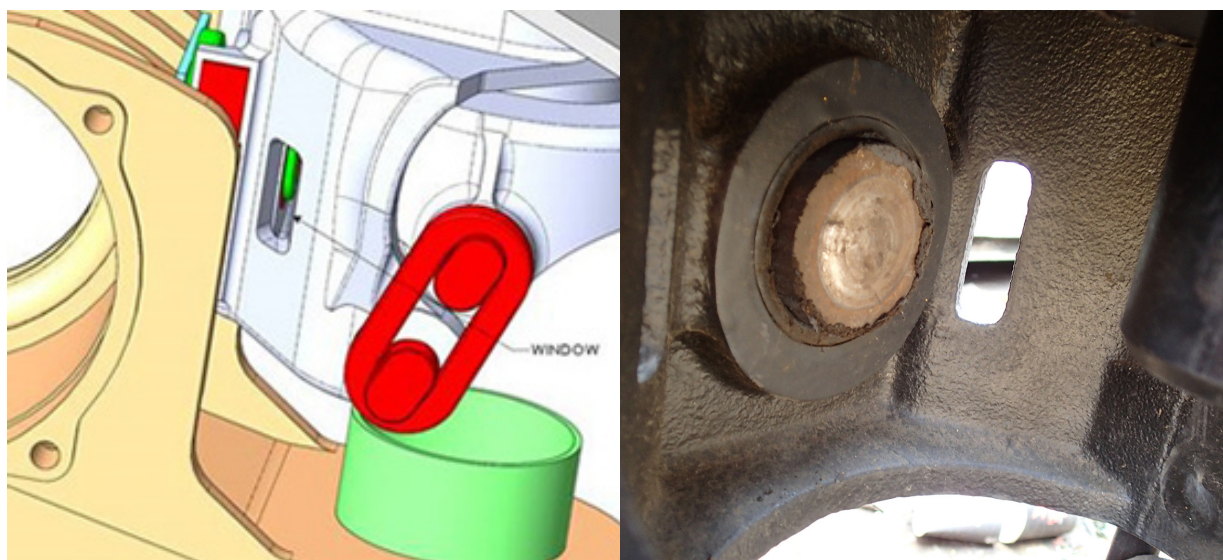
- 75 **GBRf did not make use of the inspection window provided on other Y-series bogies.**
- 76 Some bogies of the Y-series family are equipped with a window allowing visibility of the plunger and the spring cap (figure 14). The origin of this window could not be traced, but its purpose is almost certainly to provide a means to inspect the position of the spring cap wear plate relative to the plunger and bush (paragraph 61).

Figure 14: Inspection window on Y-series bogies (outside and inside view)

- 77 The bogies fitted to the FEA-A wagons are not provided with this inspection window. However, other Y-series bogies operated and maintained by GBRf, but supplied by different manufacturers, are equipped with the window. A review of the associated maintenance documentation shows that GBRf does not make use of the windows. It is therefore unlikely that it would have made any difference had a window been provided on the Techni-Industrie bogies.
