Fatal man overboard from the fishing vessel *Illustris* (B119) Royal Quays Marina, North Shields 12 November 2017

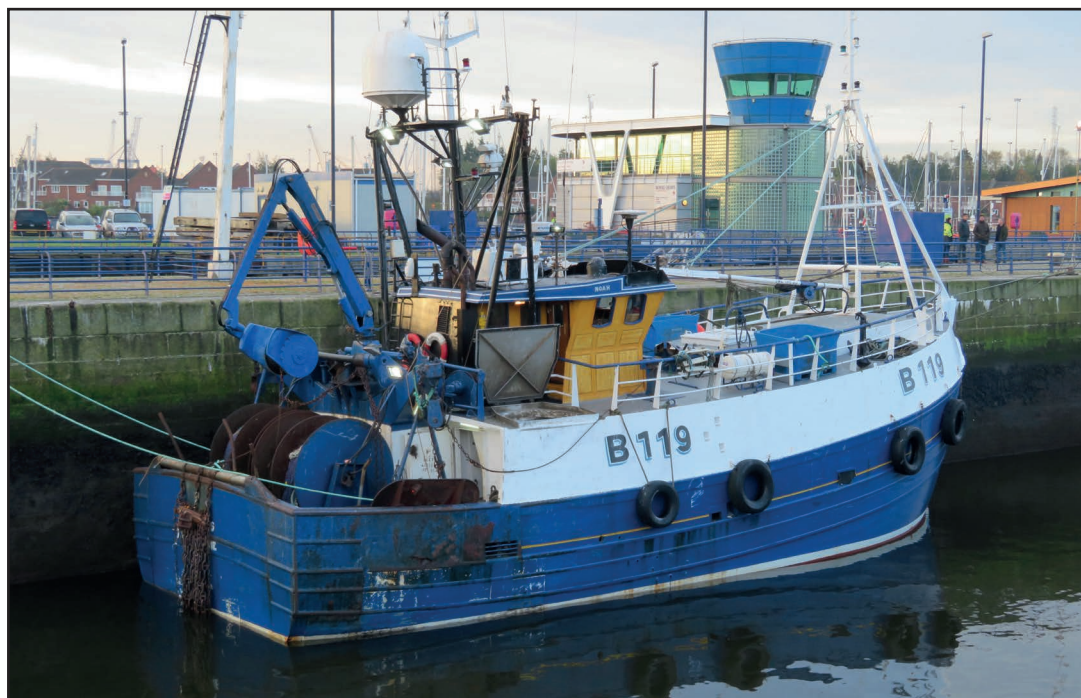
Figure 1: *Illustris*

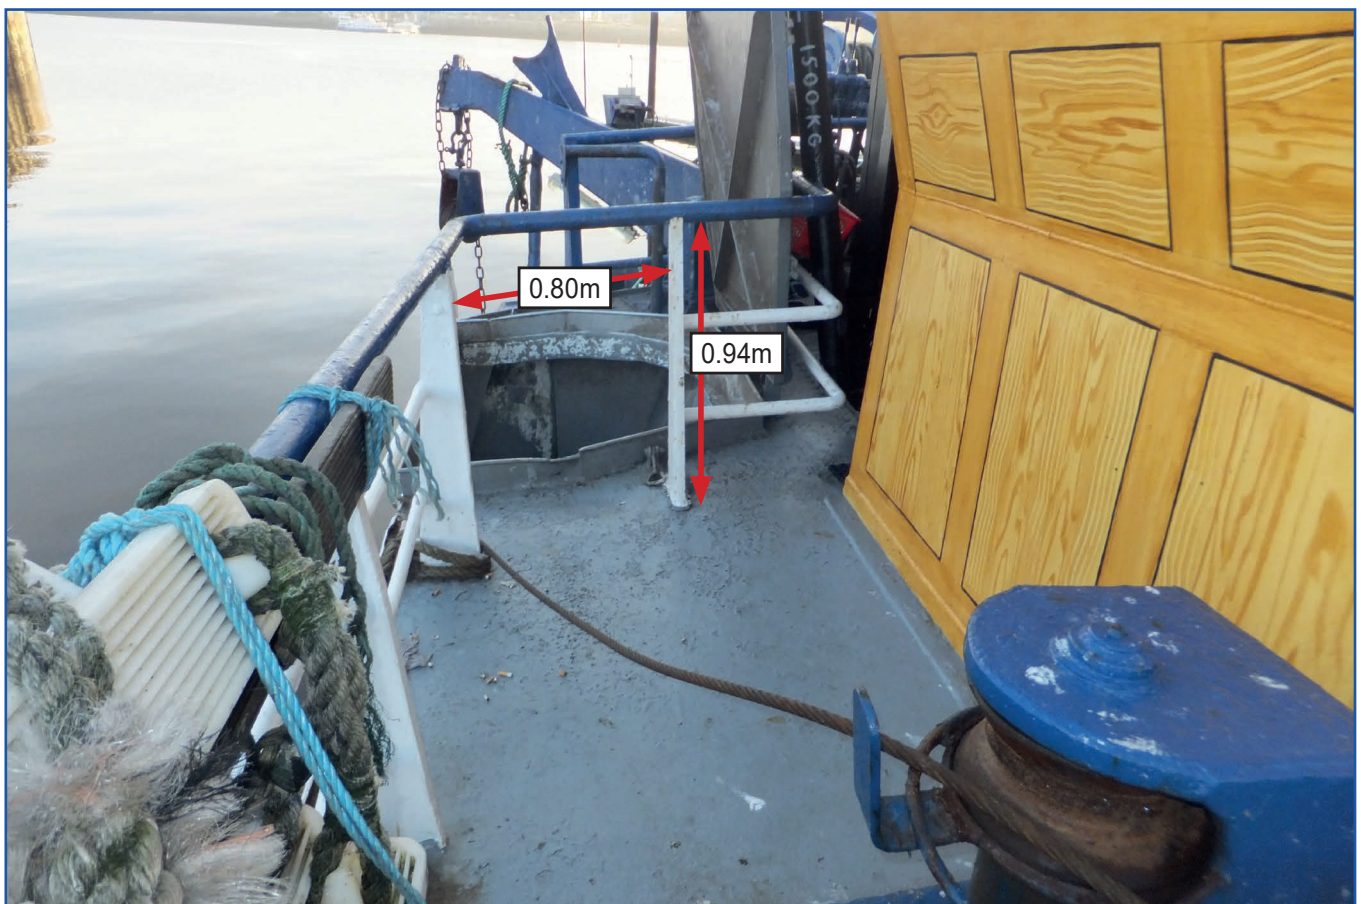
Illustris's shelter deck was enclosed by guardrails that extended to a height of 940mm above the deck. At the aft end on each side there was a gap in the guardrails to allow running of the trawl wires. The gap on the starboard side was 800mm wide and 940mm high, and was located directly above the fish hopper and adjacent to the wheelhouse door (**Figure 2**).

Figure 2: *Illustris's* guardrails and trawl wire gap dimensions

Because Robert entered the water rather than the fish hopper, it is unlikely that he had passed through the gap in the guardrails. Furthermore, as the guardrails extended to a height of 940mm above the deck, it is unlikely that he passed over the top of them from a standing position on the shelter deck.

The postmortem examination noted that Robert's bladder was full, and an examination of his clothing noted that two buttons on his trouser fly were undone. It is therefore possible that he stepped up onto the lower guardrail with the intention of urinating over the upper guardrail, and then overbalanced and/or slipped on the wet surface of the lower guardrail, causing him to fall overboard.

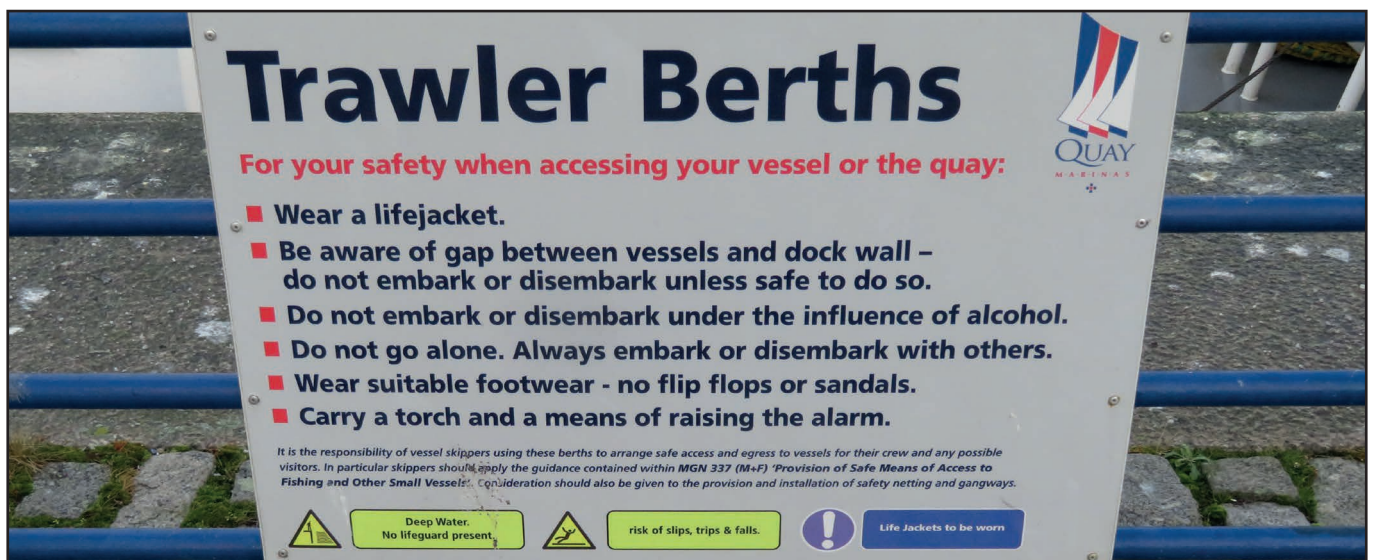
Royal Quays Marina was one of seven UK marinas owned by Quay Marinas Ltd. Large commercial fishing vessels such as *Illustris* were berthed in an area designated the 'Trawler Berths'. A sign located on the quay provided safety advice for fishermen engaged in accessing their vessel or the quay, including 'Do not embark or disembark under the influence of alcohol' (Figure 3).

Figure 3: Safety sign at the Trawler Berths
