ACCIDENT

Aircraft Type and Registration:	Piper PA-28RT-201 Cherokee Arrow IV, G-BHAY	
No & Type of Engines:	1 Lycoming IO-360-C1C6 piston engine	
Year of Manufacture:	1979 (Serial no: 28R-7918213)	
Date & Time (UTC):	11 September 2017 at 0956 hrs	
Location:	Wolferton, Norfolk	
Type of Flight:	Private	
Persons on Board:	Crew - 1	Passengers - 1
Injuries:	Crew - 1 (Fatal)	Passengers - 1 (Fatal)
Nature of Damage:	Engine front fuselage, wings and landing gear severely disrupted	
Commander's Licence:	Private Pilot's Licence	
Commander's Age:	58 years	
Commander's Flying Experience:	1,129 hours (of which 406 were on type) Last 90 days - 15 hours Last 28 days - 10 hours	
Information Source:	AAIB Field Investigation

Synopsis

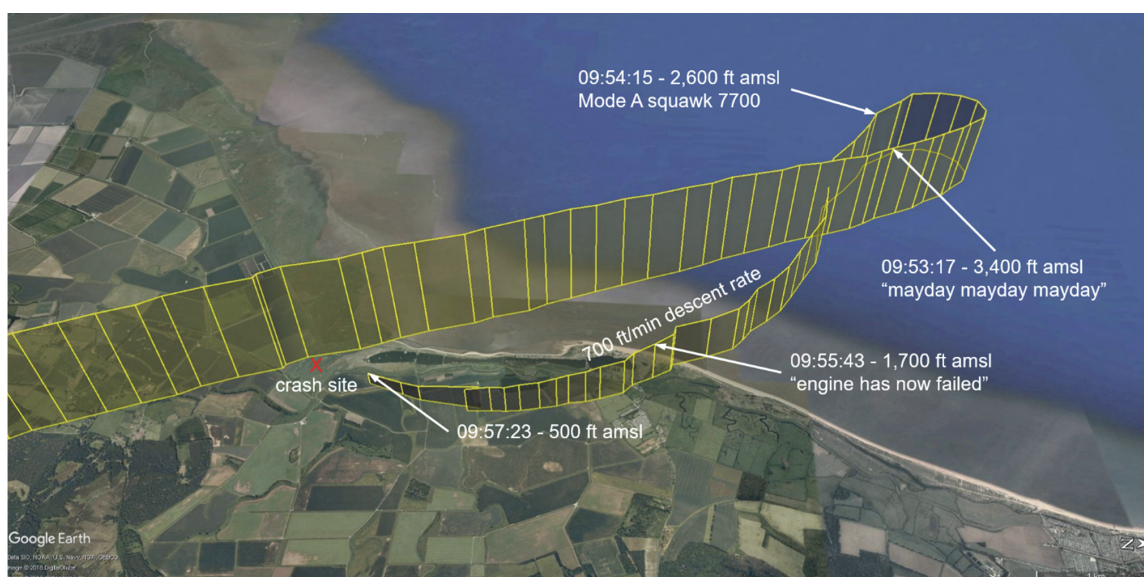
Figure 1

View looking to the west of last seven minutes of the radar track
(altitudes are Mode C \pm 50 ft, corrected to the QNH 988 hPa)

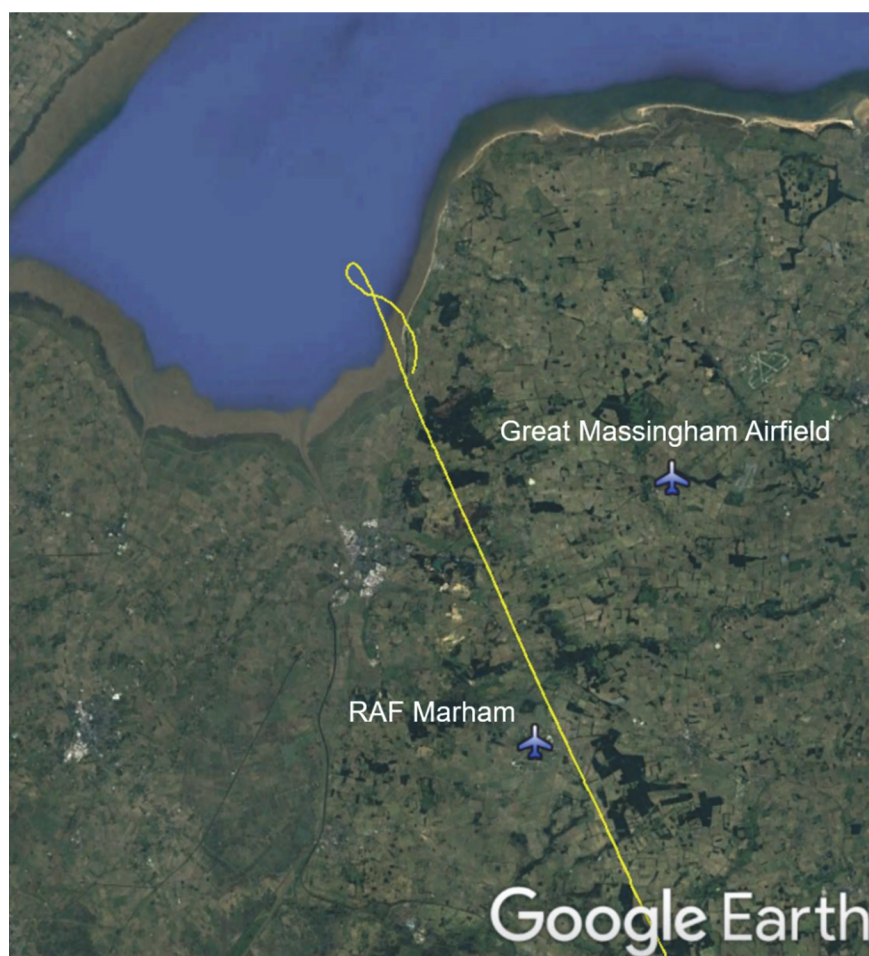
Figure 2

Portion of radar track of G-BHAY – final 17 minutes

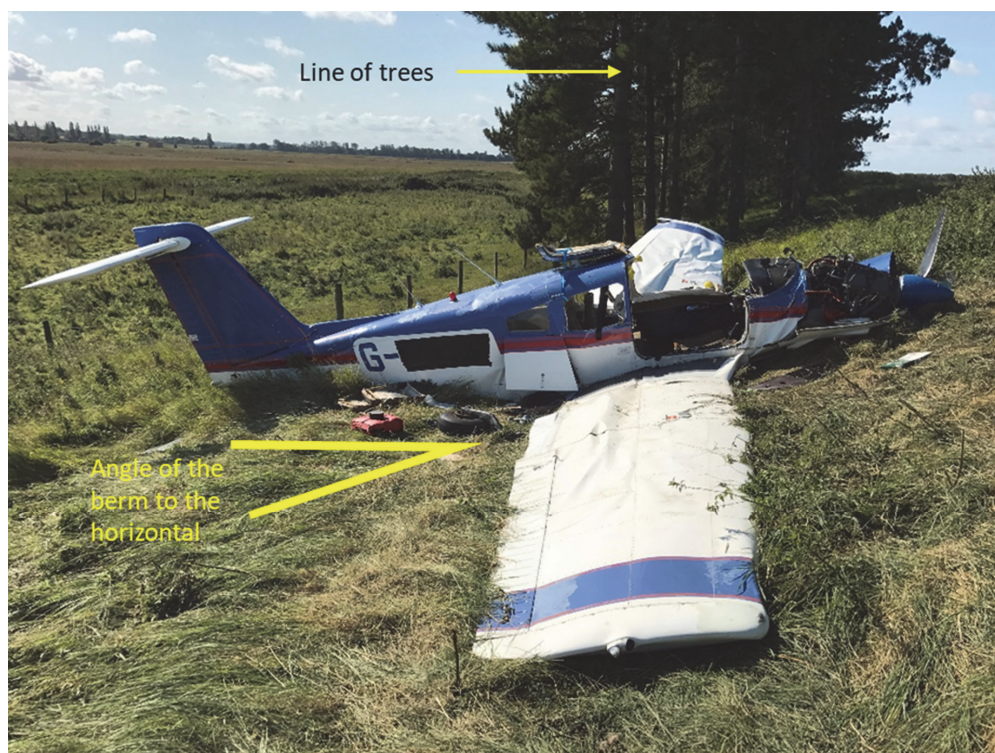
Figure 3
Accident site

The accident site was on private agricultural land towards the top of a berm (the old sea wall) which formed part of the secondary inland sea defences on the north Norfolk coast. There was a line of coniferous trees to the west of the accident site, visible in Figure 3; these were about 25 ft high.

The pilot was found in the left front seat and his passenger in the right front seat and the aircraft was upright on a northerly heading, complete except for the upper engine cowling which had detached during the impact and landed nearby. The windscreen had fragmented and the fuselage distorted in the severe vertical deceleration, so that the door frames and roof section were cut and folded back by the emergency services to release the pilot and passenger. The landing gear had been in the down position but the nose gear had been forced back up into its bay by the impact. The right main landing gear had been forced rearwards and detached from the wing whilst the left had remained attached but was also distorted rearwards.

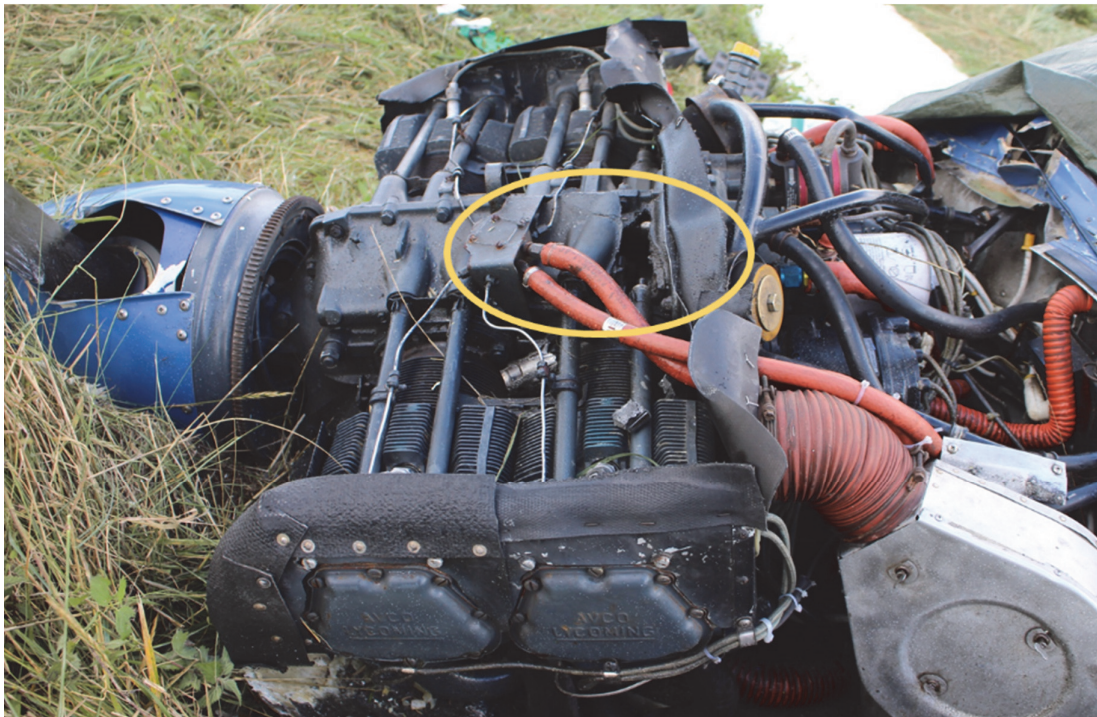
Figure 4
Crankcase damage

Both wing tanks contained fuel and approximately 40 imp gal (48 US gal) were drained from the fuel tanks at the accident site. The top of the engine was exposed and the crankcase had a large hole near the base of the No 4 cylinder, exposing the remains of the No 4 piston connecting rod. Figure 4 shows the damage to the crankcase.

In general, big-end bearings are the first to suffer as a lubricating system starts to fail. In this case, the No 4 big-end loosened as its bearing overheated, disintegrated and induced stresses in the half-cap bolts, which failed, allowing the connecting rod to detach from the crankshaft. This allowed the connecting rod free to flail as the engine continued to run for its last few seconds, with the No 4 big-end half-cap, bolts and bearing remains becoming caught up in the bobweight damper sweeping them around between it and the No 3 big-end and connecting rod, causing it to disintegrate. The No 4 connecting rod eventually forced its way out of the crankcase and the engine stopped.

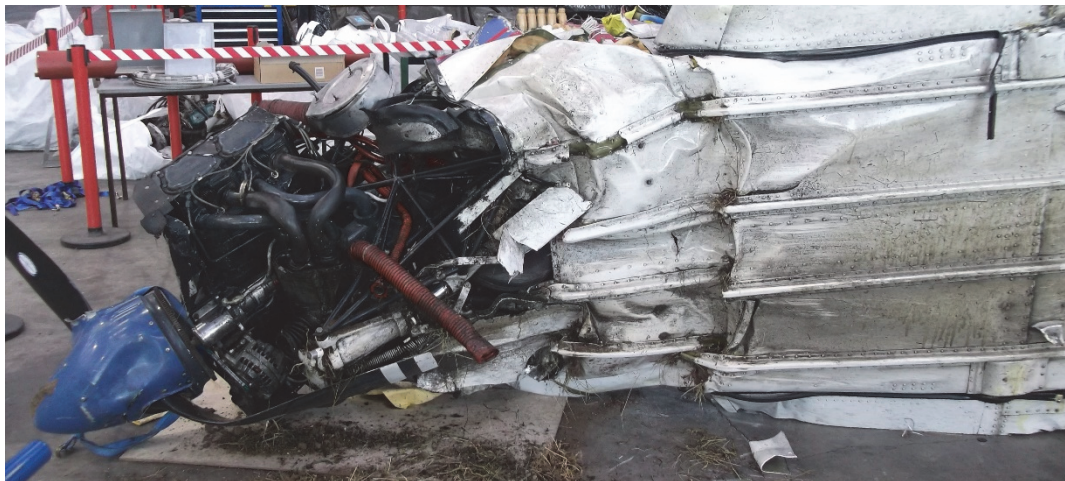
Detailed examination showed that the rudder, tailplane and elevator were attached correctly and relatively undamaged but that the area beneath the engine and cockpit around the fire wall was crushed and severely buckled upwards and rearwards by the vertical deceleration when the aircraft struck the berm. The entire underside of the fuselage was covered in engine oil and oil was still seeping from fuselage skin joints and seams. Figure 5 shows the condition of the forward underside of the fuselage and Figure 6 shows oil seeping from the fuselage skin joints.

Forward underside of the fuselage

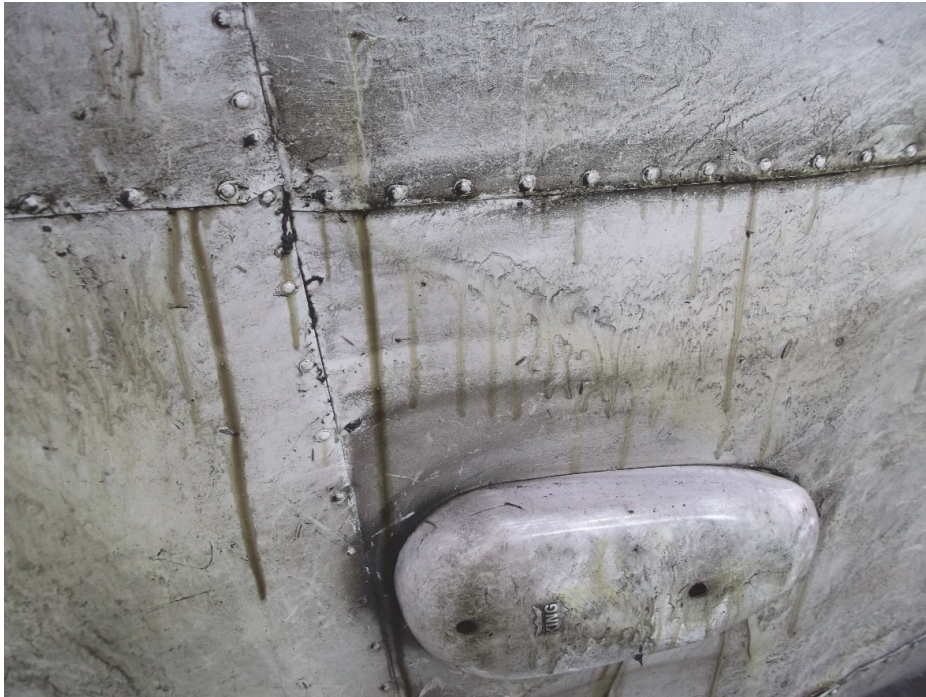
Figure 6

Oil seeping from the fuselage skin joints

The No 1 and No 2 pistons show significant exhaust 'blow-by' and contamination of the oil control rings and this led to the severe fouling of the No 2 cylinder spark plugs. This was probably the point where the pilot detected the engine rough running and prompted his MAYDAY call. It is known that blow-by can cause pressurisation of the crankcase which in turn causes oil to be ejected from the breather. The breather exit tube is situated behind the nose landing gear bay on the underside of the aircraft and excessive oil loss through the breather tends to cover the area behind the breather and be carried by the airflow rearwards, consistent with the oil-soaked fuselage underside in this case.

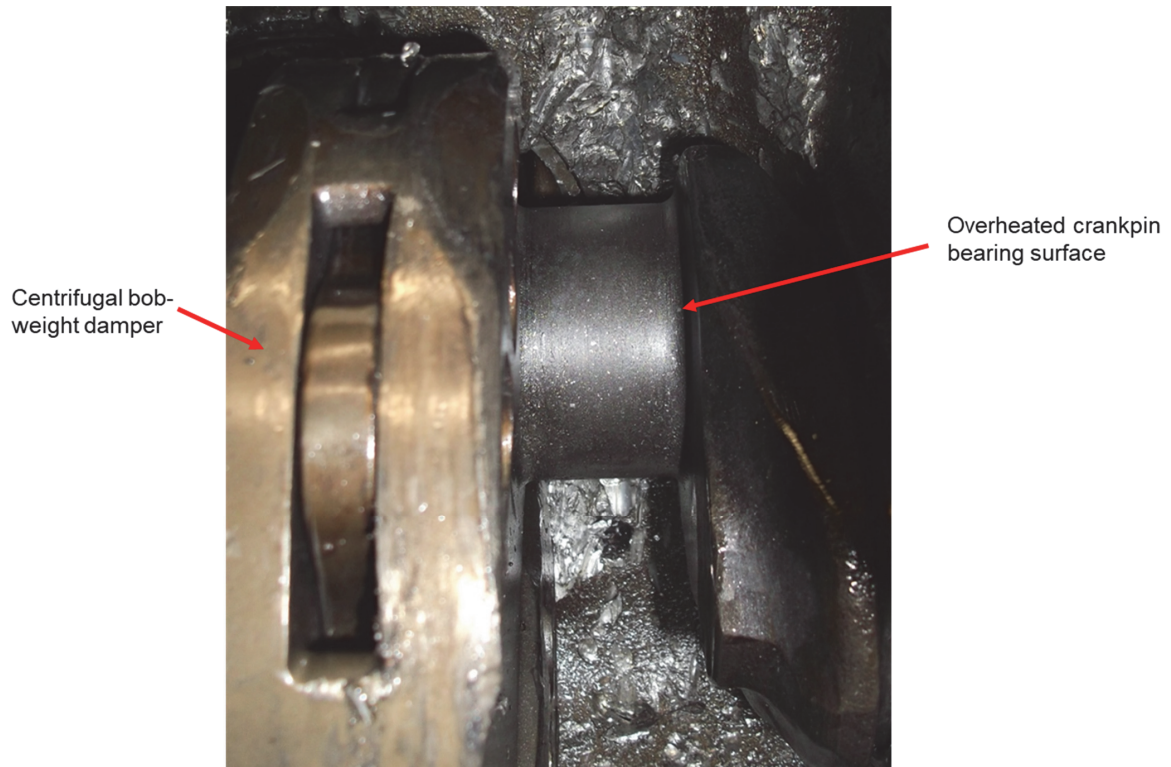
The crankshaft was in one piece and but showed signs of rubbing and discolouration due to excessive heat on the rear main journal, the No 4 crankpin and the No 2 crankpin. There were also debris impact marks on the surfaces of the No 3 and No 4 crankpin surfaces. Figure 7 shows the overheated condition of the No 4 crankpin.

No 4 crankpin condition

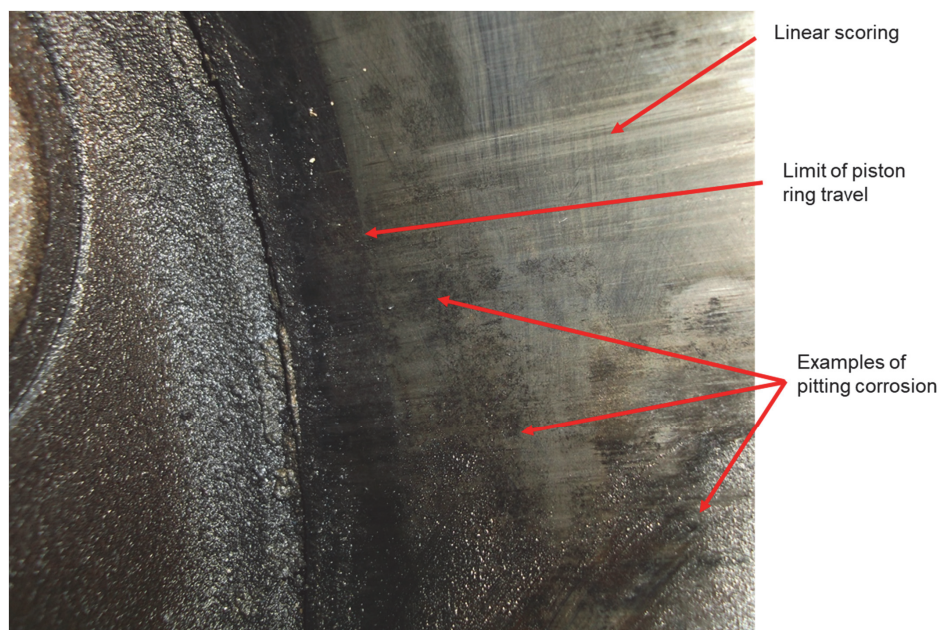
The No 1 and No 2 cylinder liners had linear scoring within the piston-swept area. There was heavier localised scoring where debris had been picked up on the piston skirt and small areas of pitting corrosion were present in both cylinders, were smoothed by the action of the piston and oil control rings. The pitting corrosion was more prevalent in the No 2 cylinder and heavier pitting corrosion was present at the top of both cylinders, outside the piston-swept area. Figure 8 shows the corrosion in the No 2 cylinder.

An example of the pitting corrosion in the No 2 cylinder

Between November 2015 and July 2016 the aircraft was parked outside at Newcastle International Airport, nine miles from the sea and in inclement weather conditions. There is no evidence that the engine had been inhibited during the aircraft's period of inactivity and it is likely that corrosion took hold during this period. This was evident in the No 1 and No 2 cylinder walls, with localised pitting corrosion at the top of the cylinder and within the piston-swept area. The engine manufacturer's Service Letter (Number L180B, dated 13 November 2001) is clear on the actions to be taken to prevent engine deterioration and notes that active corrosion can occur in a short period of time.

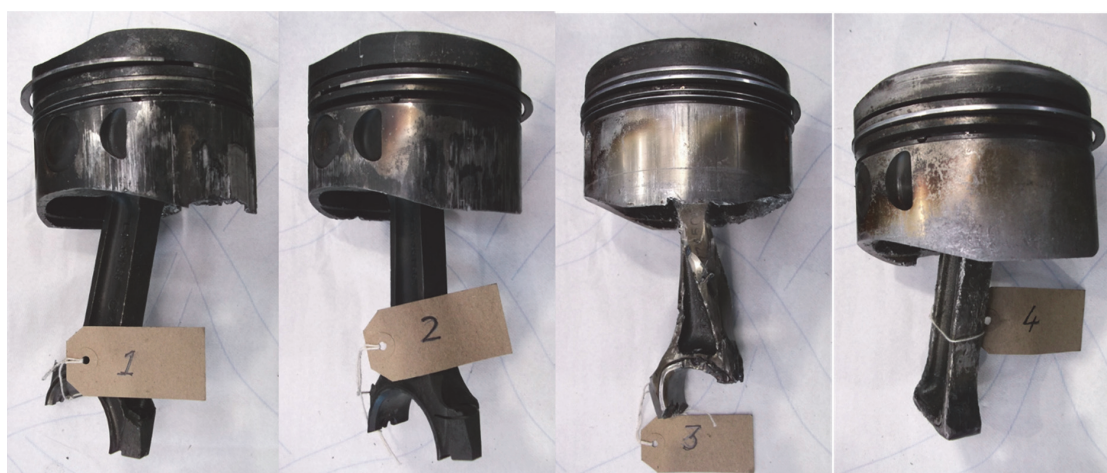
By contrast the No 3 and No 4 pistons were in better condition and had stopped in their respective cylinders when their big ends detached from the crankshaft. There was no evidence of blow-by and no scoring of the piston skirts. However, the underside of the pistons was covered in multiple debris strike marks and the No 3 connecting rod was bent and twisted and its half-cap, end bolts and bearing shells pulverised. The No 4 connecting rod and associated parts had similar damage and fragments of the No 3 and No 4 bearings had evidence of excessive heating and swaging whilst under load. Figure 9 shows the condition of the pistons and damage to the connecting rods.

Pistons and connecting rods
