ACCIDENT

Aircraft Type and Registration:	DH82A Tiger Moth, G-AXBW	
No & Type of Engines:	1 De Havilland Gipsy Major 1C piston engine	
Year of Manufacture:	1940 (Serial no: 83595)	
Date & Time (UTC):	17 April 2018 at 1100 hrs	
Location:	Wishanger Park, Frensham, Surrey	
Type of Flight:	Private	
Persons on Board:	Crew - 2	Passengers - None
Injuries:	Crew - None	Passengers - N/A
Nature of Damage:	Damage to landing gear, wings, propeller and engine cowling	
Commander's Licence:	Private Pilot's Licence	
Commander's Age:	79 years	
Commander's Flying Experience:	23,043 hours (of which 114 were on type) Last 90 days - 1 hour Last 28 days - 0 hours	
Information Source:	Aircraft Accident Report Form submitted by the pilot

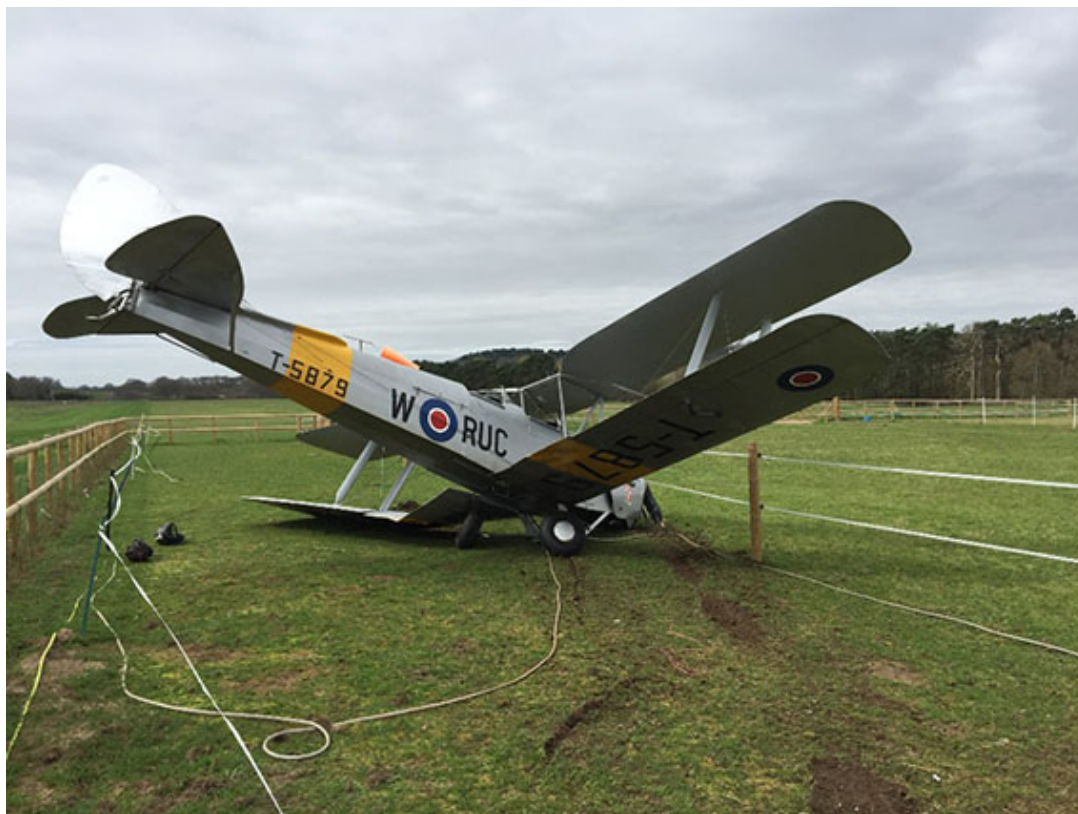
Figure 1

The pilot in command (PIC), flying in the front seat, was providing familiarisation training for a new syndicate member, who was in the rear seat. The wind was assessed to be approximately 12 kt at 25° from the left; within, but close to, the crosswind limit for the takeoff. The PIC was satisfied that the new syndicate member was a capable pilot and allowed him to have control for the takeoff. During the takeoff roll, the aircraft became airborne 5 kt below the normal 'unstick' speed. At this time, the PIC called "airspeed" and was about to take control when a gust lifted the left wing. The right wing stalled, causing the aircraft to descend and turn to the right from a height of approximately 10 ft. The aircraft struck a wooden fence running parallel to the grass runway and came to rest on its nose with a buckled landing gear (Figure 1).

The PIC considered that, although the new syndicate member showed good confidence in being able to cope with gusty conditions, he should have demonstrated a gusty crosswind takeoff before allowing the less experienced pilot to take off in such conditions.

G-AXBW where it came to rest to the right of the grass strip
