## ACCIDENT

<b>Aircraft Type and Registration:</b>	Piper PA-18-150 Super Cub, G-RWCA	
<b>No &amp; Type of Engines:</b>	1 Lycoming O-320-A2B piston engine	
<b>Year of Manufacture:</b>	1982 (Serial no: 18-8309010)	
<b>Date &amp; Time (UTC):</b>	7 April 2018 at 1225 hrs	
<b>Location:</b>	Beccles Airfield, Suffolk	
<b>Type of Flight:</b>	Private	
<b>Persons on Board:</b>	Crew - 1	Passengers - None
<b>Injuries:</b>	Crew - None	Passengers - N/A
<b>Nature of Damage:</b>	Propeller blade bent, engine shock-loaded and damage to wings, fin, rudder and windscreen	
<b>Commander's Licence:</b>	Private Pilot's Licence	
<b>Commander's Age:</b>	54 years	
<b>Commander's Flying Experience:</b>	188 hours (of which 9 were on type) Last 90 days - 7 hours Last 28 days - 3 hours	
<b>Information Source:</b>	Aircraft Accident Report Form submitted by the pilot

## Synopsis

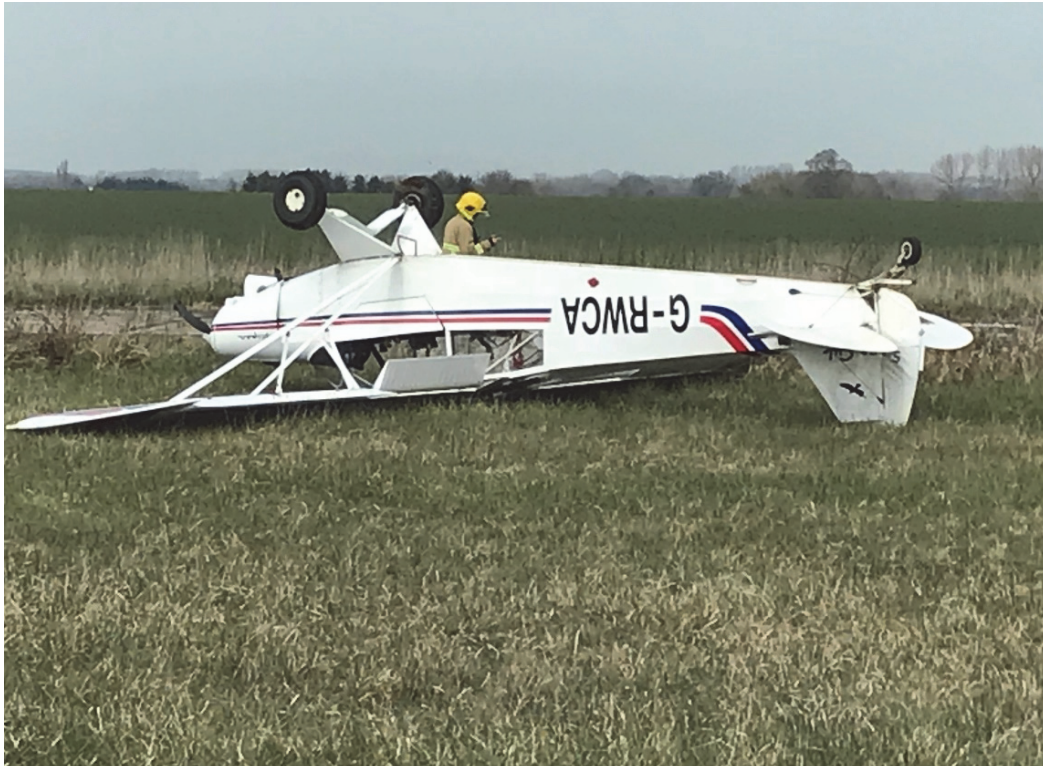
**Figure 1**

The pilot made a precautionary landing at Beccles Airfield following an engine oil leak and a reduction in oil pressure. This was the first time that the pilot had landed a tailwheel aircraft on a hard surface. During the ground run the aircraft started to ground loop, then nosed over and came to rest inverted.

Accident site  
(photograph by permission of the pilot)

The pilot reported that there was a 10 kt crosswind and he was slightly fast and high as he crossed the threshold with full flap selected. The aircraft floated for some distance and bounced following the initial touch down before settling down in a three-point landing attitude. The pilot was aware of the end of the concrete section of the runway approaching and attempted to correct a yaw to the right by the application of full left rudder; he did not apply the wheel brakes. However, as the aircraft decelerated it yawed to the right and the main wheels ran onto the grass and the soft ground at the edge of the runway, causing the aircraft to slowly nose over and come to rest in an inverted attitude. The pilot was uninjured.
