ACCIDENT

Aircraft Type and Registration: P&M Aviation PulsR, G-FFFA

Date & Time (UTC): 18 April 2018 at 0900 hrs

Location: Manton Airfield, Wiltshire

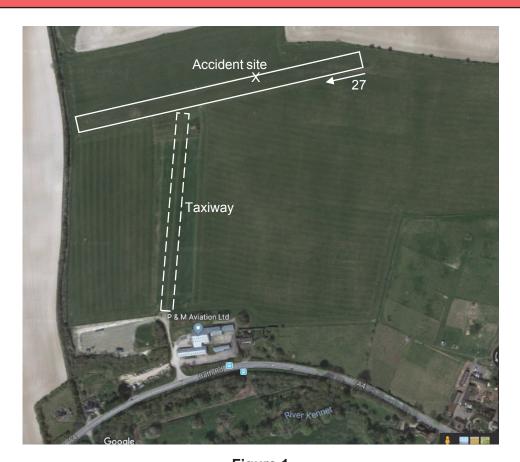
The pilot flew a low pass at approximately 100 ft to ensure the runway was clear and then proceeded to land normally. After approximately 100 m of the landing roll and at 30 kt, the left wheel struck the edge of a hollow, which caused the aircraft to bounce and roll to the right. The right wingtip touched the ground and the aircraft pirouetted almost 180° before coming to rest on its right side (Figure 2). The pilot made the aircraft safe and exited from the cockpit uninjured. It was later noted by the manufacturer that ground near the threshold of Runway 27 may have been disturbed by animal activity.

Figure 1
Accident site – Manton Airfield, Wiltshire

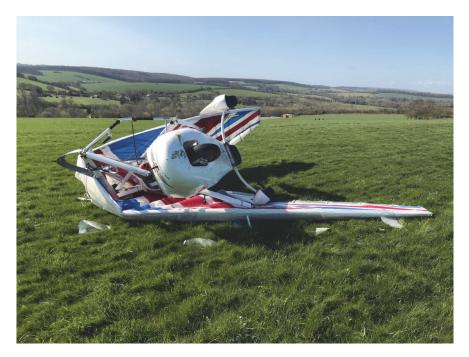
During landing, the left wheel struck the edge of a hollow which caused the aircraft to bounce and roll to the right. The right wingtip touched the ground and the aircraft pirouetted almost 180° before coming to rest on its right side.

Figure 2G-FFFA after landing
