SERIOUS INCIDENT

Aircraft Type and Registration:	Boeing 747-8R7F, LX-VCF	
No & Type of Engines:	4 x GEnx-2B67 turbofan engines	
Year of Manufacture:	2012	
Date & Time (UTC):	30 March 2017 at 1216 hrs	
Location:	En route from Houston to Prestwick	
Type of Flight:	Commercial Air Transport (Cargo)	
Persons on Board:	Crew - 3	Passengers - None
Injuries:	Crew - None	Passengers - N/A
Nature of Damage:	Extensive fuel contamination of aircraft interior and wiring	
Commander's Licence:	Airline Transport Pilot's Licence	
Commander's Age:	52 years	
Commander's Flying Experience:	12,900 hours (of which 9,200 were on type) Last 90 days - 164 hours Last 28 days - 47 hours	
Information Source:	AAIB Field Investigation

Synopsis

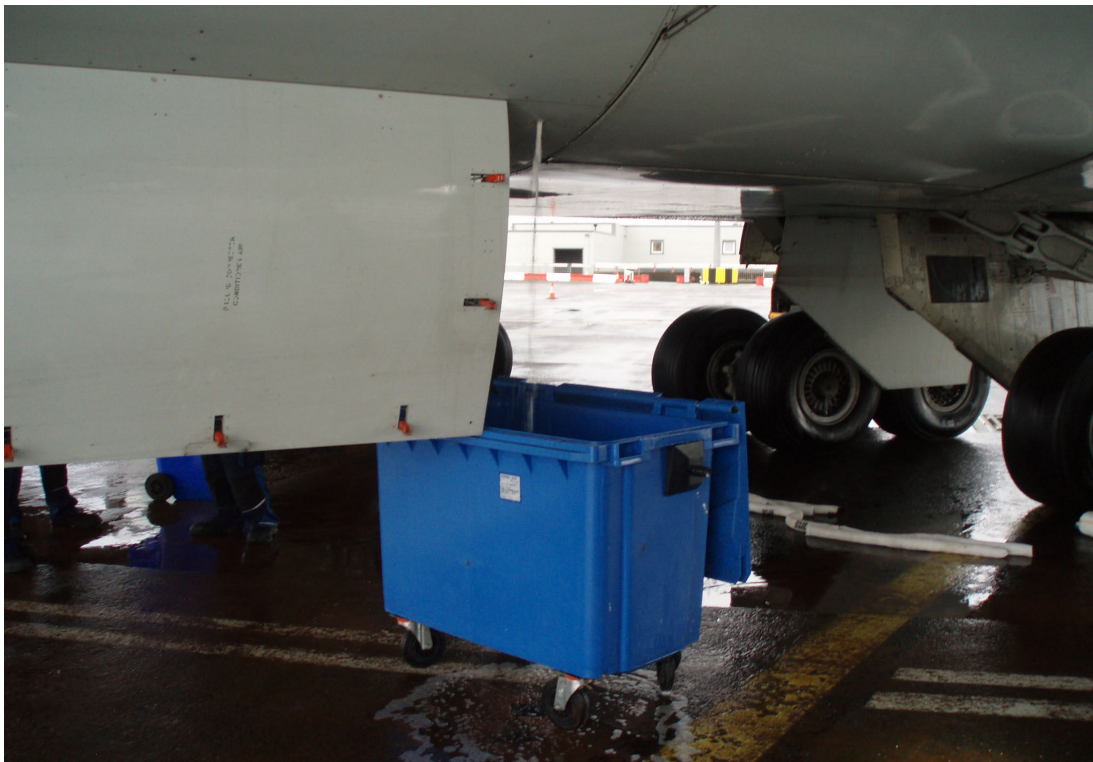
Figure 1

flight crew were shutting down the engines they smelled fuel. When the ground operations agent entered the aircraft via the main deck door to commence unloading operations, he too detected a strong smell of aviation fuel and heard the sound of running liquid. He identified the source as a Bell 412EP helicopter, which was being shipped as cargo on the main deck of the aircraft and noted that fuel appeared to be leaking from a vent on the forward right-hand side of the helicopter. The ground operations agent reported the situation to the flight crew. The Airport Authority and RFFS were notified and the airport emergency response plan was activated. The flight crew shut down the aircraft and opened the escape hatch and upper deck service door to ventilate the aircraft. Upon arrival at the aircraft the RFFS noted that fuel was coming out of the bottom of LX-VCF's fuselage, close to the left body landing gear, having leaked through the main deck, lower deck and avionics bay and was pooling on the apron beneath the aircraft (Figure 1). The aircraft was evacuated, electrically isolated and quarantined by the RFFS. The RFFS subsequently stated that the measured fuel vapour levels indicated a high risk of explosion and that the fuel flammability limits were potentially in range. After the aircraft had been made safe, all cargo, including the helicopter, was offloaded manually.

Fuel exiting lower fuselage of LX-VCF

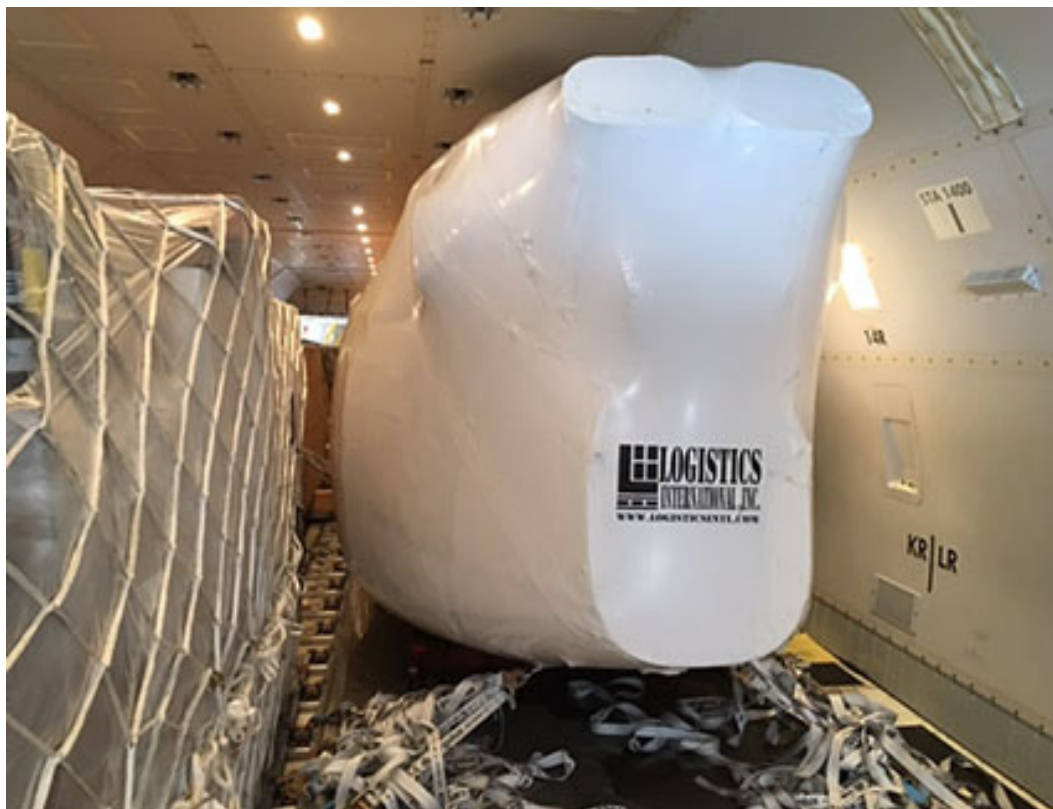
Figure 2

The helicopter was encased in strong white plastic shrink-wrap and had been secured to a cargo pallet for the flight, which occupied three loading positions on the right side of the aircraft's main cargo deck (Figure 2). During the aircraft examination, some fuel was present in the wells of the pallet and the securing straps were soaked with fuel.

Bell 412-EP fuselage, wrapped in shrink-wrap, on main deck of LX-VCF prior to being offloaded at Prestwick

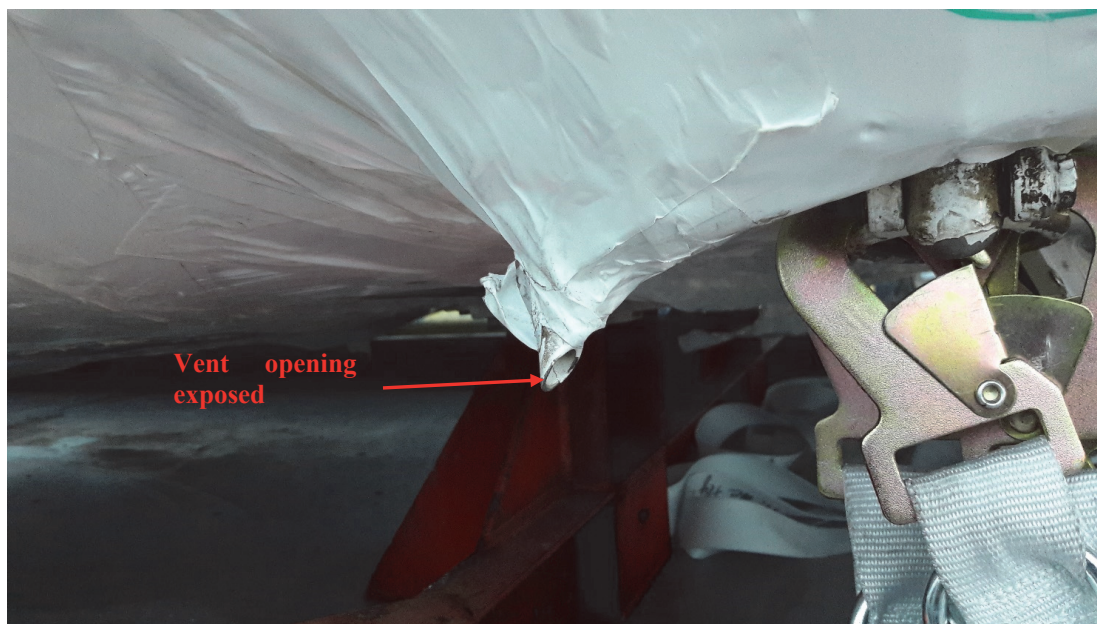
**Fig 3**

In the area of the helicopter's forward right-hand fuel vent, from which fuel was reported to have leaked, the shrink-wrap had been applied so that the opening of the vent was exposed (Figure 3). White tape had been applied on top of the shrink-wrap in the vicinity of the vent.

Forward right-hand fuel vent on Bell 412-EP helicopter

When the aircraft arrived in Prestwick, the ground operations agent who first entered the aircraft observed that fuel appeared to be escaping via a vent tube on the forward right-hand side of the helicopter. Subsequent inspection of the helicopter identified that the shrink-wrap in which the helicopter had been encased had been applied such that the opening in the forward right-hand fuel vent tube was exposed, while that on the forward left-hand vent was completely sealed.

and lower middle cell is permanently connected to its opposite side cell via the interconnect lines and fuel can pass freely from the left to right side and vice versa. The manner in which the helicopter was shrink-wrapped created a seal over the forward left vent tube; this may have prevented the pressure within the four forward fuel cells from equalising in response to aircraft cabin pressure changes during the descent into Prestwick. In the absence of any other defects which could account for the escape of fuel, the investigation considered that this wrapping of the vents may have induced a siphon-like effect, or caused the flexible fuel cells to temporarily deform, as the aircraft's cabin pressure equalised during the descent to land at Prestwick, causing fuel to be ejected via the forward right-hand vent tube.

It is recommended that Bristow US LLC review their procedures relating to the preparation of helicopters for air transportation to ensure that they are defuelled.

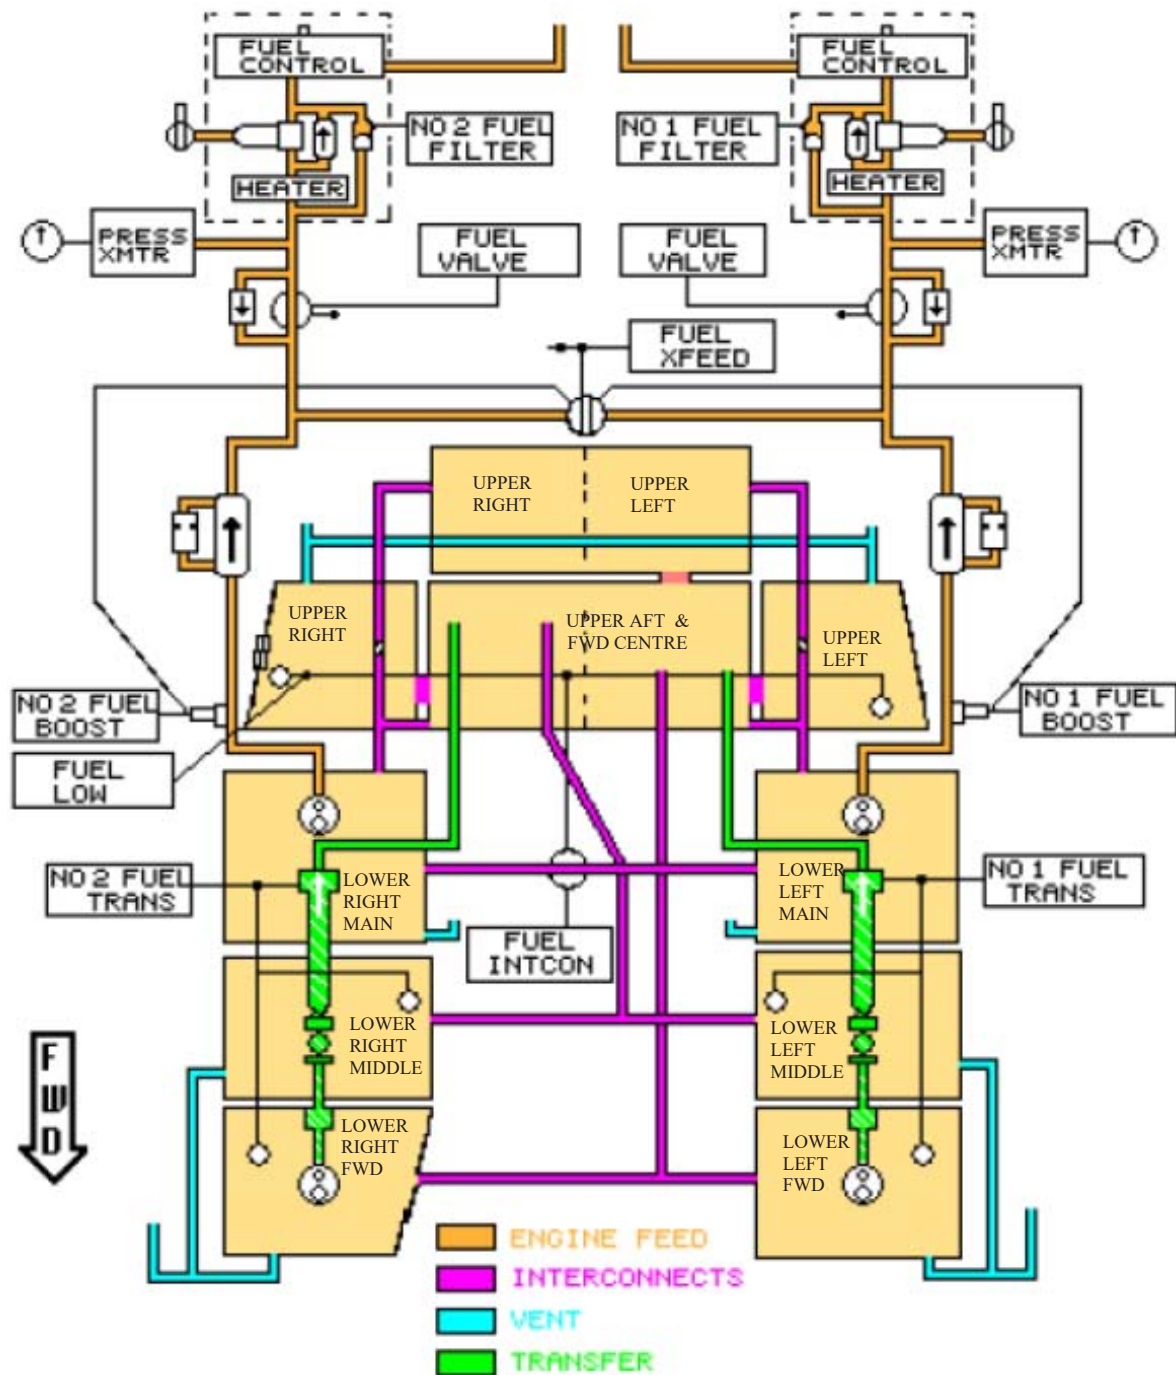
Figure 4

Bell 412EP Simplified fuel system schematic (Note: auxiliary tank not shown)

During the post-incident inspection at Prestwick, the helicopter battery was observed to be disconnected; therefore, none of the helicopter fuel pumps could have operated during the incident flight. The investigation considered that possible routes for fuel to escape from the helicopter could have included: via the sump drain valves, defuelling valves, the fuel vent lines or a loose connection in a fuel system interconnect line.

Only the upper right fuel cell can be visually inspected on the Bell 412EP and during the post-incident inspection in Prestwick this cell was observed to be approximately half full. The fuel distribution within the remaining cells was not determined. The total indicated fuel quantity was noted as 1,440 lb, symmetrically distributed between the left and right cells. When the helicopter was refuelled, 467 litres were required to reach the fully fuelled condition. Given the helicopter's total fuel capacity of 1,587 litres, the post-incident volume of fuel was determined to have been 1,120 litres. Taking into account the approximate 322 litres which escaped, the fuel state prior to transportation of the helicopter was calculated to have been approximately 1,442 litres. At this fuel state, all the lower fuel cells would have been full.
