# ***AAIB Bulletin***

***7/2018***

<b>Aircraft Type and Registration:</b>	Boeing 747-8R7F, LX-VCF	
<b>No &amp; Type of Engines:</b>	4 x GEnx-2B67 turbofan engines	
<b>Year of Manufacture:</b>	2012	
<b>Date &amp; Time (UTC):</b>	30 March 2017 at 1216 hrs	
<b>Location:</b>	En route from Houston to Prestwick	
<b>Type of Flight:</b>	Commercial Air Transport (Cargo)	
<b>Persons on Board:</b>	Crew - 3	Passengers - None
<b>Injuries:</b>	Crew - None	Passengers - N/A
<b>Nature of Damage:</b>	Extensive fuel contamination of aircraft interior and wiring	
<b>Commander's Licence:</b>	Airline Transport Pilot's Licence	
<b>Commander's Age:</b>	52 years	
<b>Commander's Flying Experience:</b>	12,900 hours (of which 9,200 were on type) Last 90 days - 164 hours Last 28 days - 47 hours	
<b>Information Source:</b>	AAIB Field Investigation

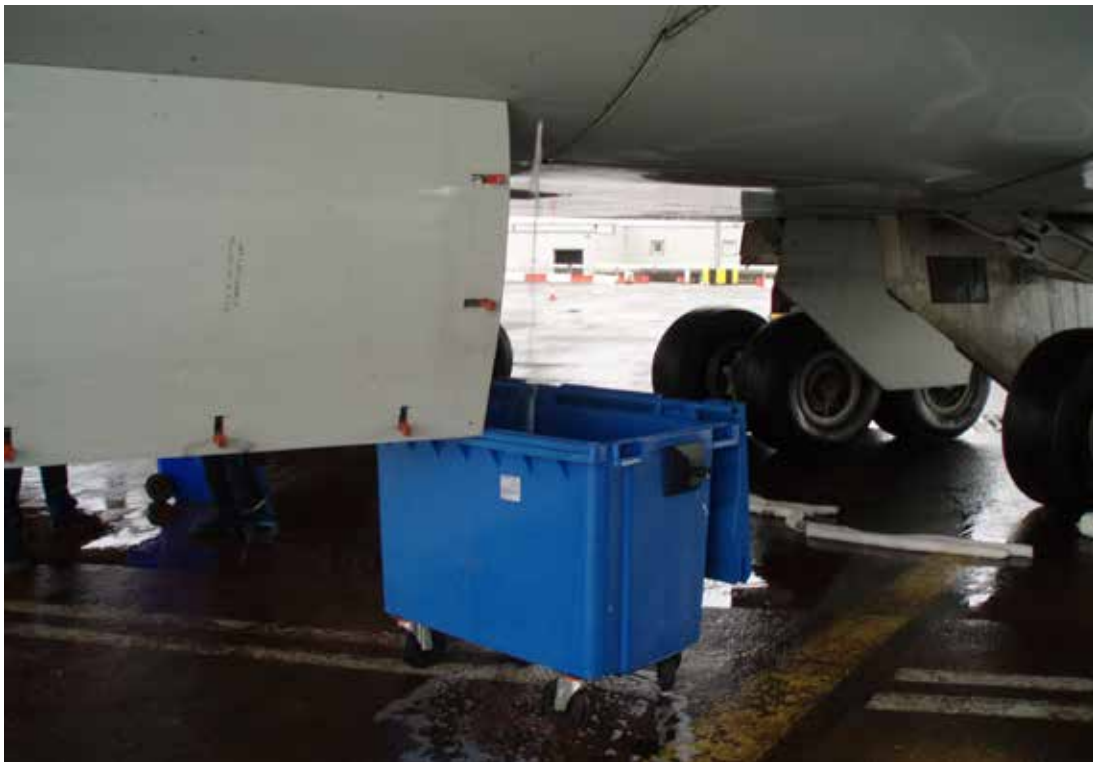
**Figure 1**

Fuel exiting lower fuselage of LX-VCF

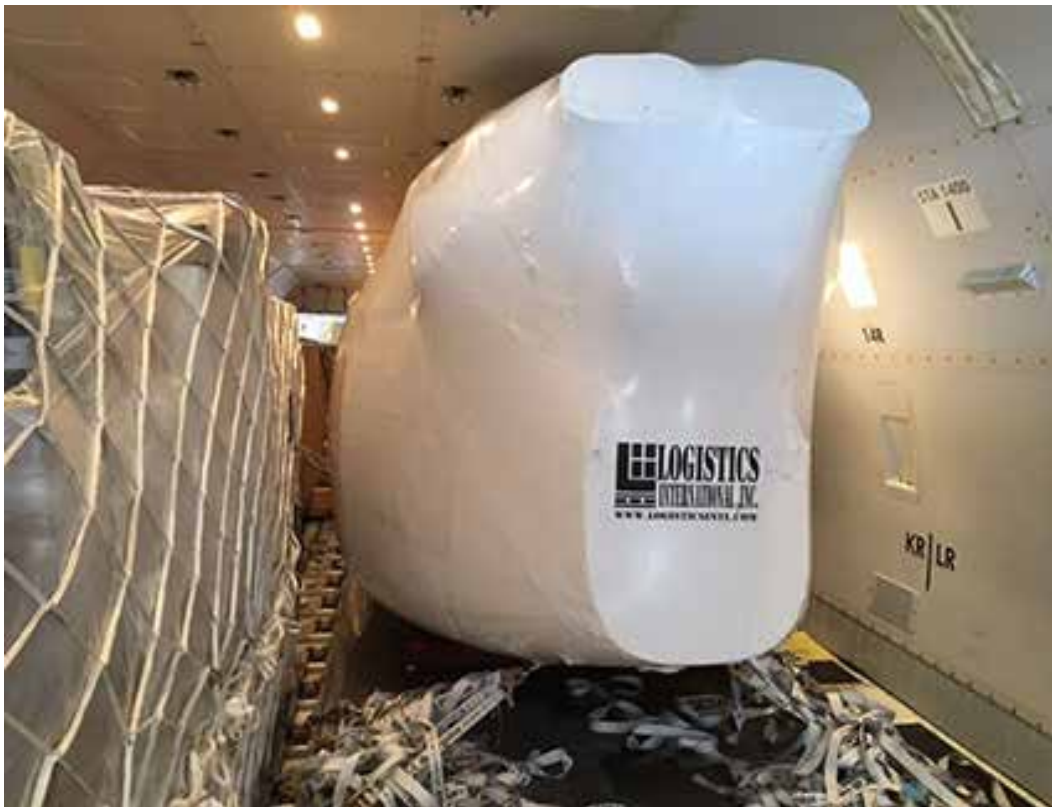
**Figure 2**

The helicopter was encased in strong white plastic shrink-wrap and had been secured to a cargo pallet for the flight, which occupied three loading positions on the right side of the aircraft's main cargo deck (Figure 2). During the aircraft examination, some fuel was present in the wells of the pallet and the securing straps were soaked with fuel.

Bell 412-EP fuselage, wrapped in shrink-wrap, on main deck of LX-VCF prior to being offloaded at Prestwick

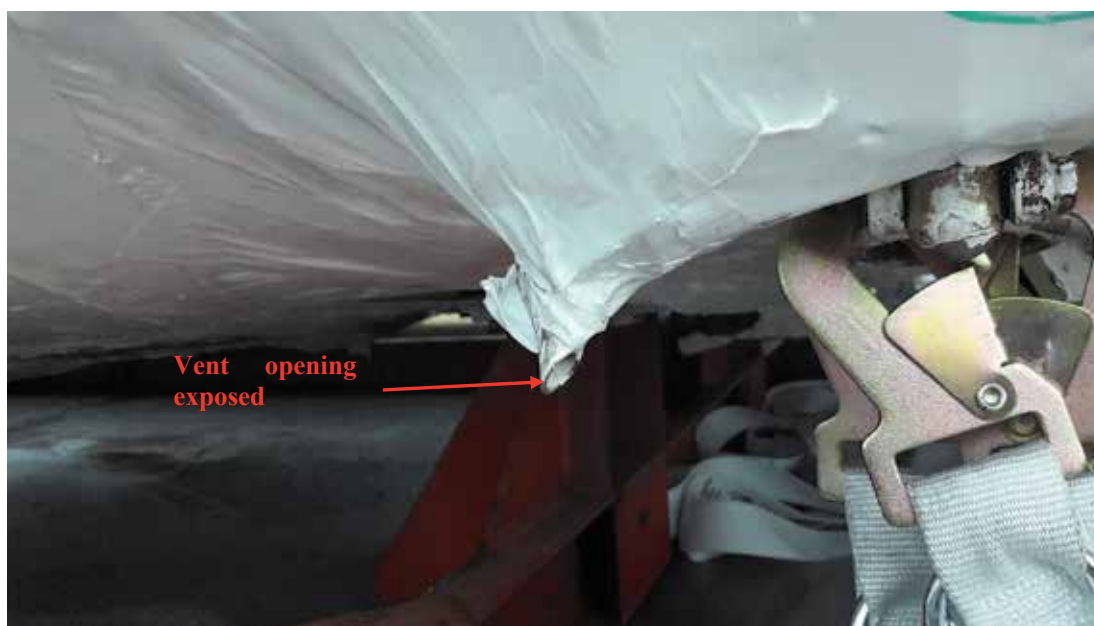
**Fig 3**

In the area of the helicopter's forward right-hand fuel vent, from which fuel was reported to have leaked, the shrink-wrap had been applied so that the opening of the vent was exposed (Figure 3). White tape had been applied on top of the shrink-wrap in the vicinity of the vent.

Forward right-hand fuel vent on Bell 412-EP helicopter

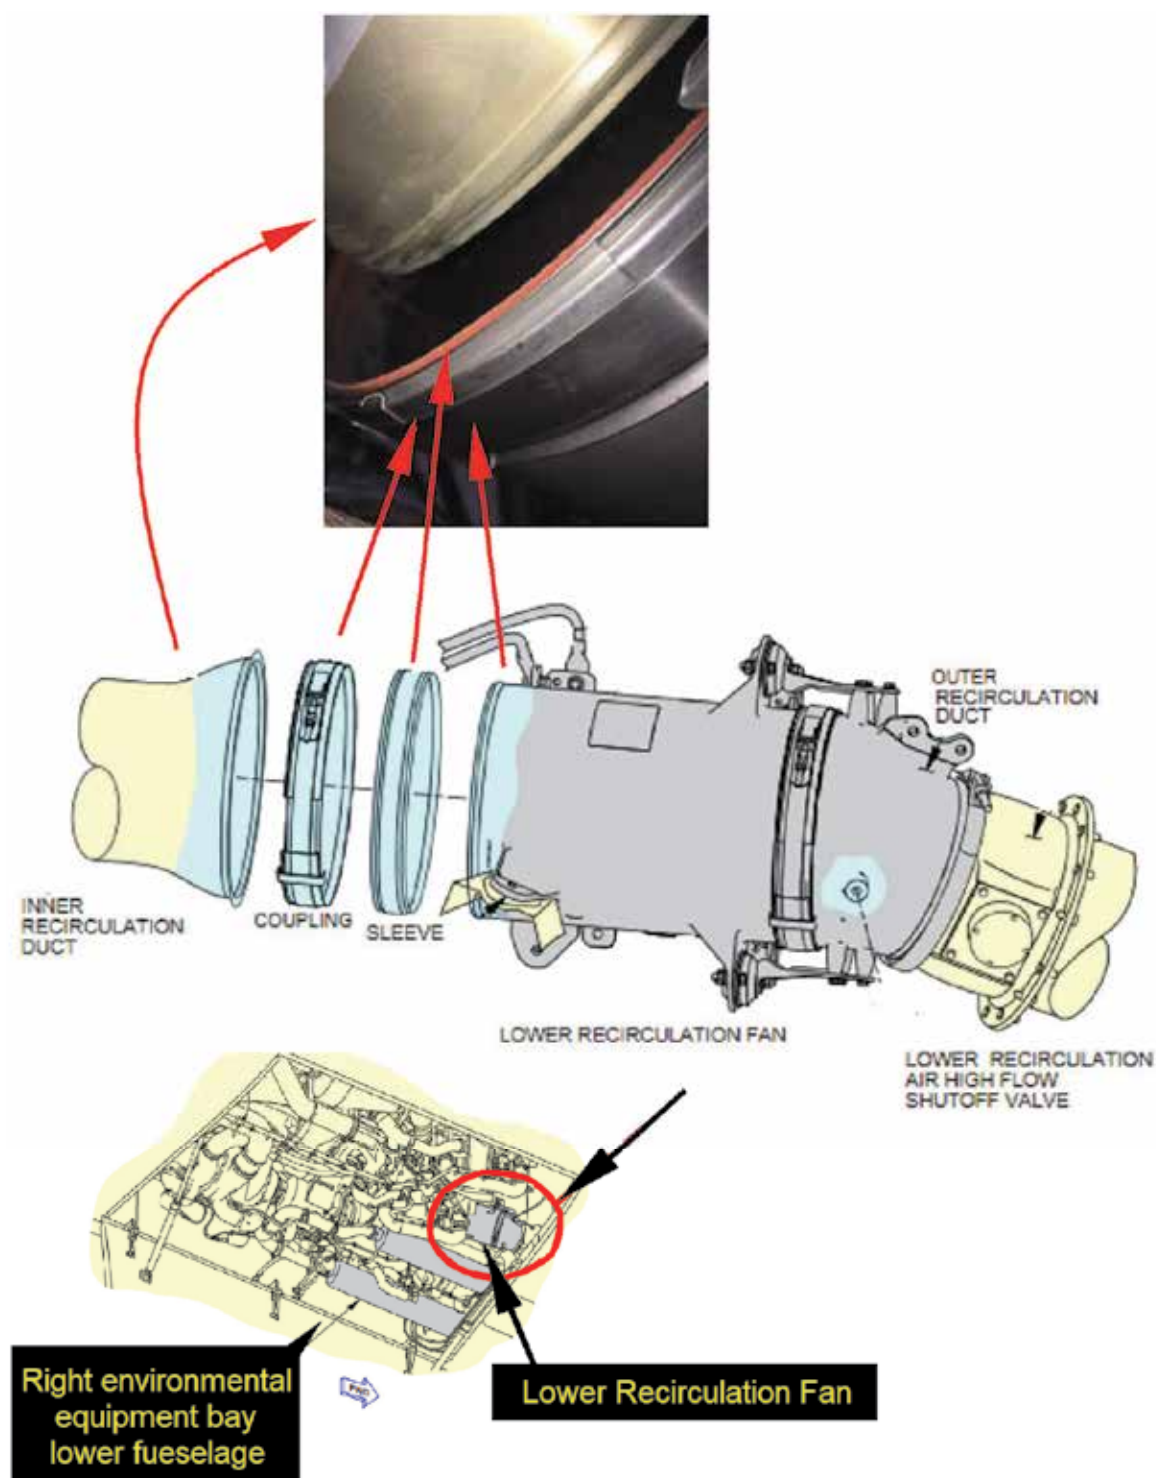
**Figure 3**

Following the return of the aircraft to Heathrow after the incident, an examination took place monitored by the AAIB. It was found that the right-hand inner recirculation duct was disconnected from the lower right-hand recirculation fan (Figure 3). Once the duct and fan unit were removed, there was evidence that the coupling and seal joining the two had been incorrectly aligned when last assembled. The V-band clamp joining the other end of the duct to the heat exchanger was correctly fitted.

Examination of the coupling system used to connect the recirculation fan to the inner duct showed that if the coupling were not installed correctly, there was less visible evidence and a reduced tactile feel compared to that of the V-band clamp used at the opposite end of the duct. The connection of the right-hand recirculation fan is located in a position that requires reaching through an extensive system of ducting and components to install it. Viewing of the connection between the duct and fan is also restricted. Figure 3 shows the relative position of the recirculation fan and the disconnected duct.

Position of Right Lower Recirculation Fan and photograph of disconnected duct

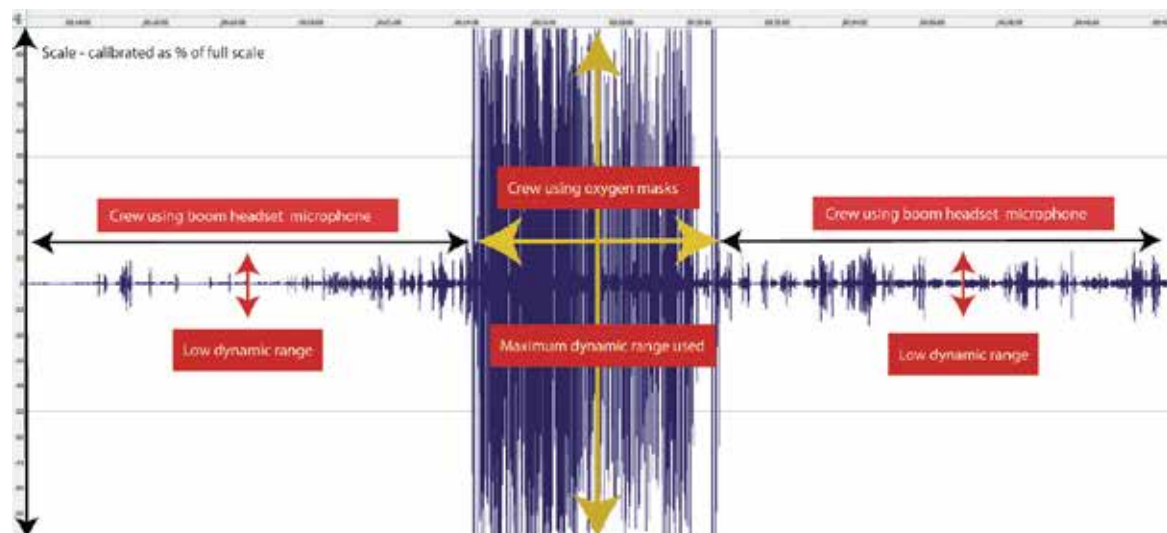
**Figure 4**

Further to the previous findings of the NTSB, the AAIB also identified that when the flight crew of G-ZBKF had used their oxygen masks, the full dynamic recording range of the crew CVR channels was used, with occasional clipping of the signal. Figure 4 reflects the difference in dynamic recording range when the flight crew used the headset and oxygen mask microphones.

G-ZBKF – CVR waveform of crew channel showing difference in use of available dynamic recording range between headset and oxygen mask microphone signals

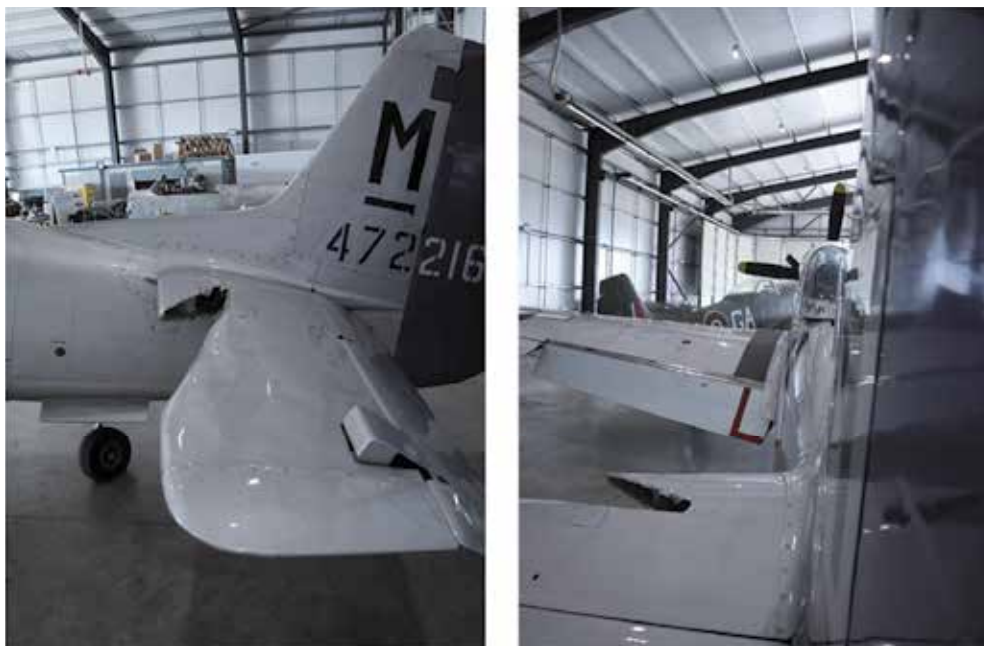
**Figure 3**

Damage was present on both aircraft from contact between the propeller blades of G-SHWN with the left horizontal stabiliser of G-BIXL (Figures 3 and 4). The blade strike on the horizontal stabiliser was within a few centimetres of the control cables for the elevator trim system, but resulted in structural damage only. The propeller blades all exhibited scuffing to the paint, but no visible structural damage.

Damage to horizontal stabiliser of G-BIXL

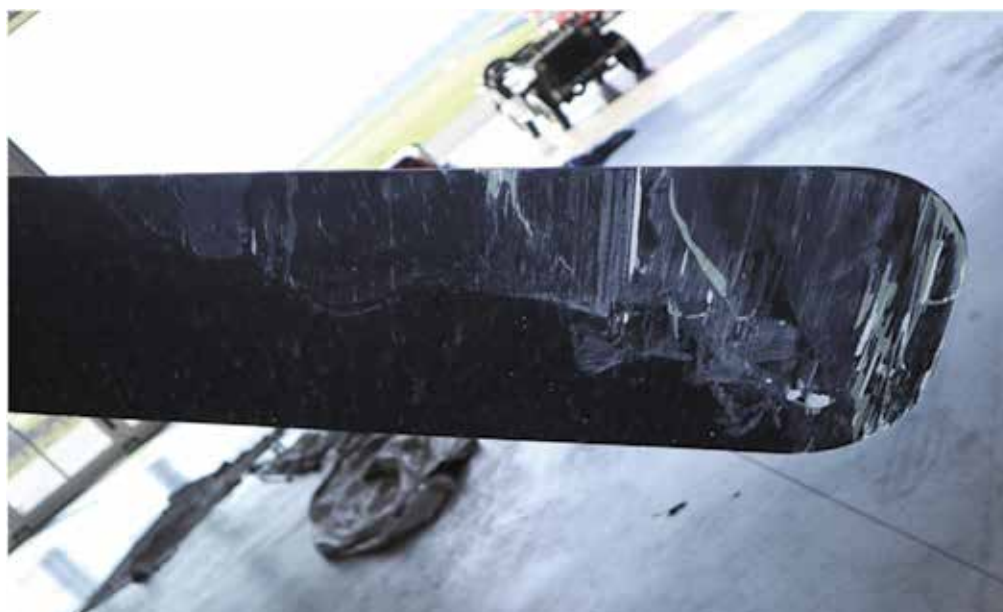
**Figure 4**

Damage to rear face of G-SHWN propeller blade

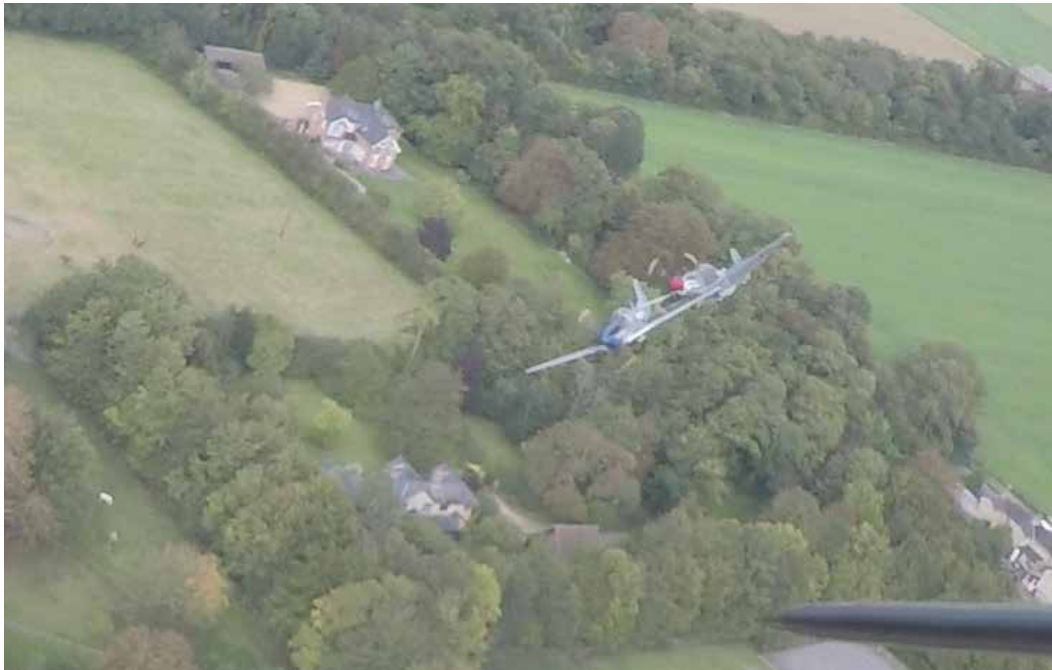
**Figure 5**

Video still showing the collision

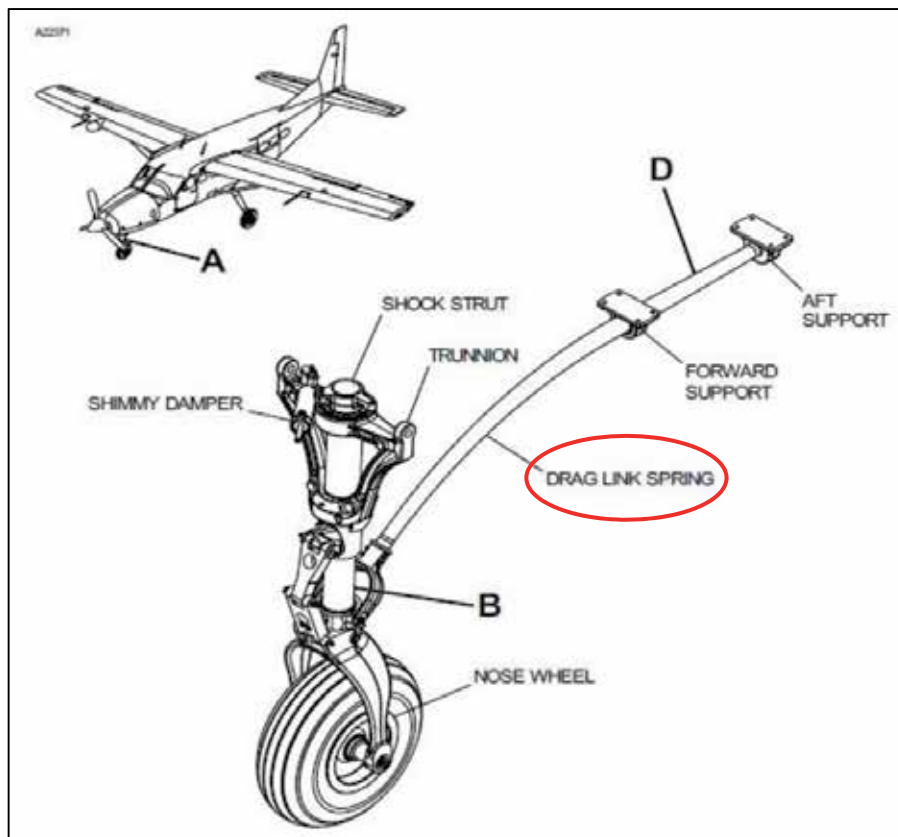
**Figure 1**

A detailed analysis of the failed part, carried out on behalf of the operator, indicated that the failure was most likely due to damage to the protective coating which had allowed the high-strength steel material to be exposed to moisture. A corrosion fatigue mechanism then led to the crack which resulted in the failure.

General arrangement of nose landing gear

The failure is being dealt with through normal continued airworthiness processes.

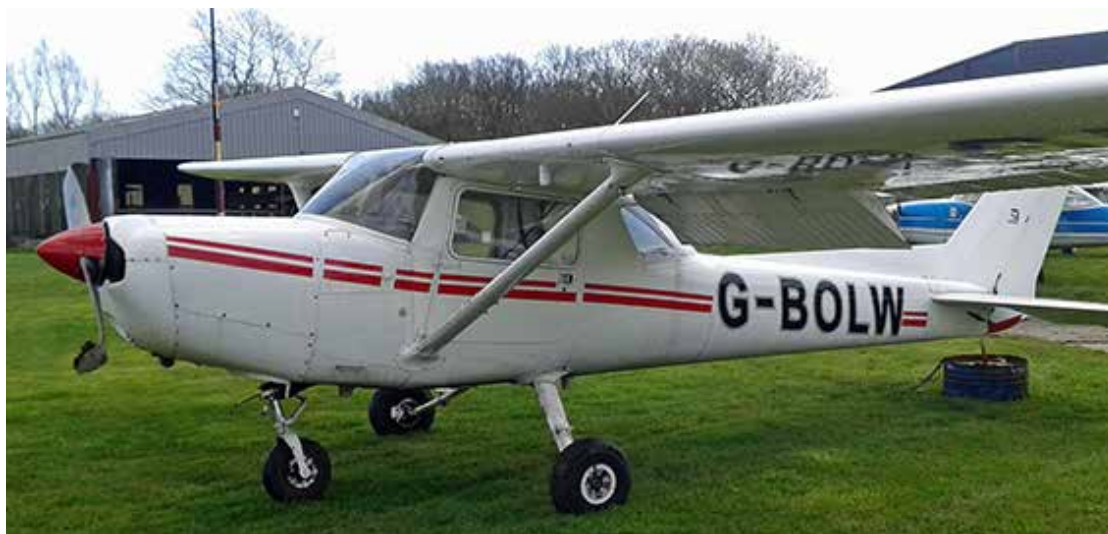
**Figure 1**

G-BOLW with the nose landing gear angled rearwards and the propeller tips bent

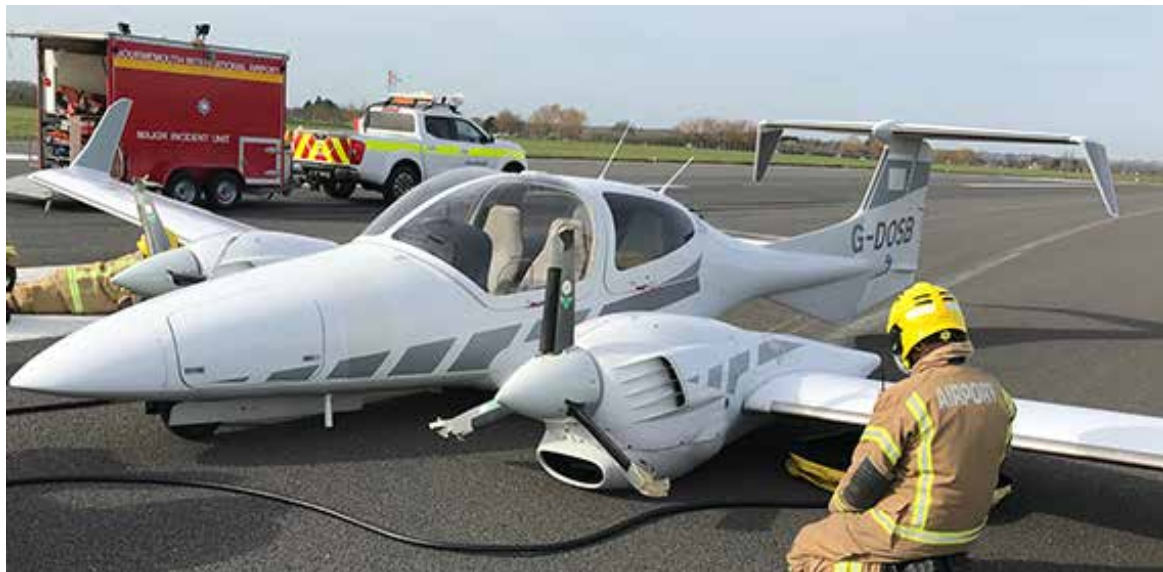
**Figure 1**

G-DOSB prior to an attempt to raise it using airbags.  
The nose landing gear doors are open and the nosewheel appears to rest on the runway

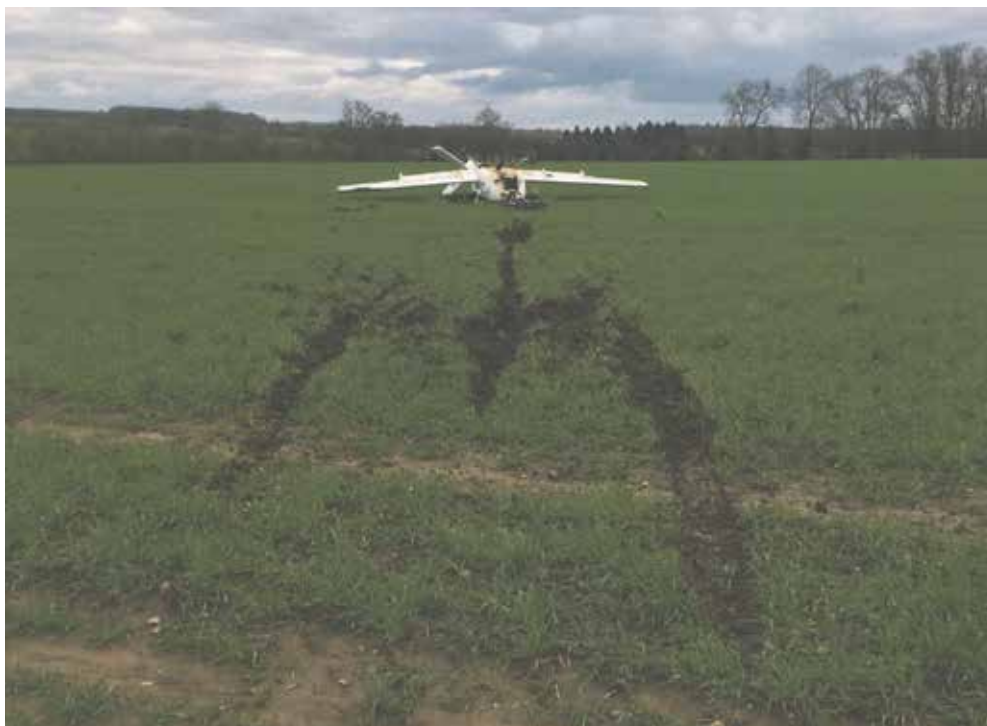
**Figure 1**

He sustained minor injuries and stated that he found egress from the aircraft difficult due to damage to the upper fuselage and the broken canopy. He recalled hearing the sound of at least one of the aircraft's electric fuel pumps running whilst he was in the aircraft, prior to his egress, and stated that all of the aircraft's switches were in the normal positions for flight.

Accident site

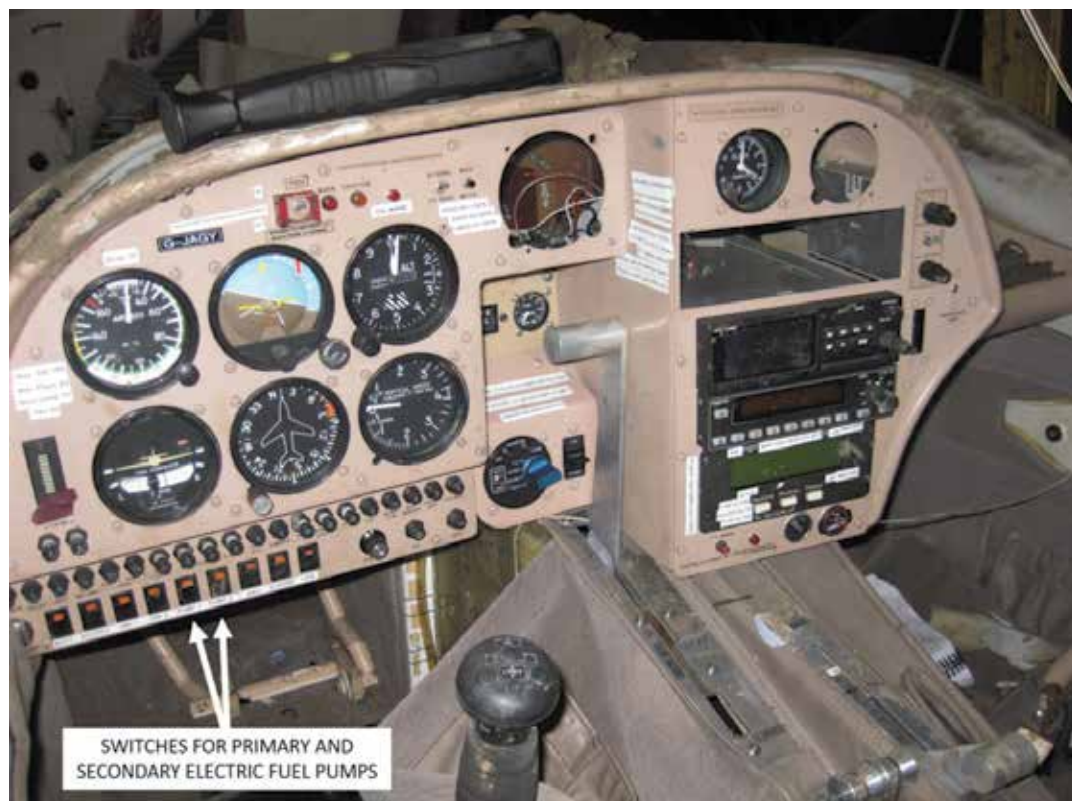
**Figure 2**  
Fuel pump switches

The LAA aircraft examination identified that the aircraft's instrument panel featured switches to control electrical power to each of the aircraft's electric fuel pumps (Figure 2).

This arrangement is contrary to the Europa XS build manual, which requires that the primary electric fuel pump is powered directly from the engine's alternator with overload protection provided by a 5 amp circuit breaker. This design ensures that the primary fuel pump is powered whenever the engine is running.

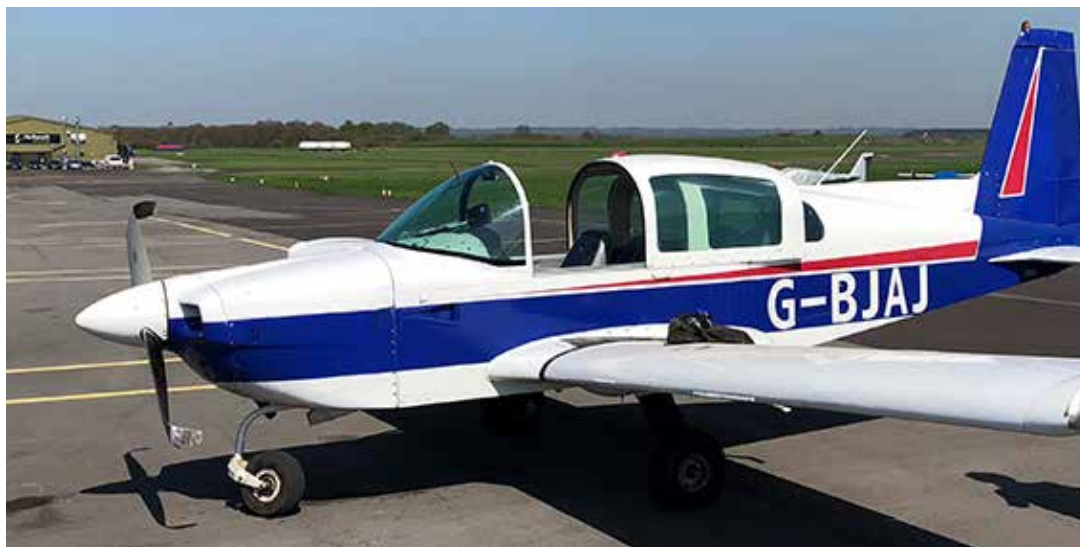
**Figure 1**

G-BJAJ with damage to the propeller and the nose leg

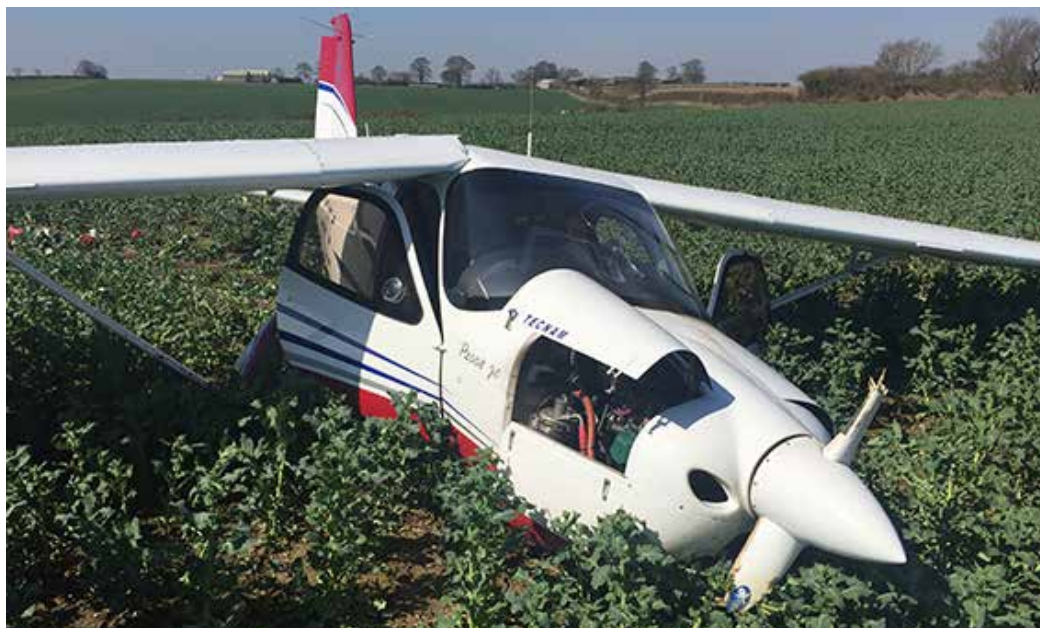
**Figure 1**

G-HRLE after the accident, with the airfield background left

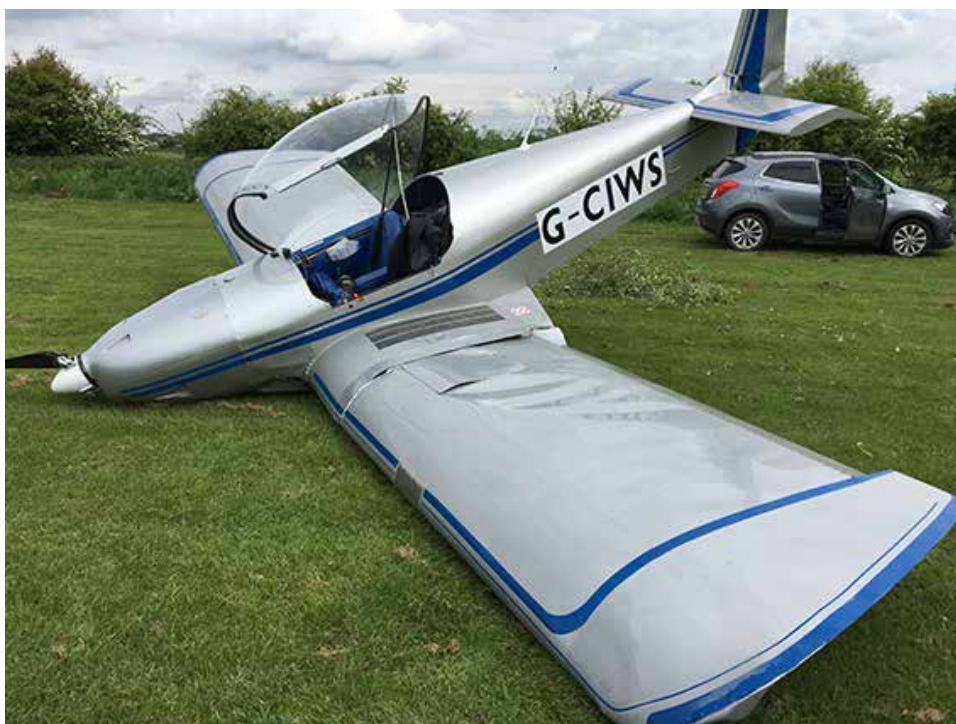
**Figure 1**

G-CIWS near the vehicle that it missed and with the hedge visible behind
