Published 13 September 2018

**CONTENTS****SPECIAL BULLETINS / INTERIM REPORTS**

Boeing 737-800	EI-DLV	15-Sep-17	3
----------------	--------	-----------	---

HPH Glasflugel 304 eS	G-GSGS	10-Aug-17	18
-----------------------	--------	-----------	----

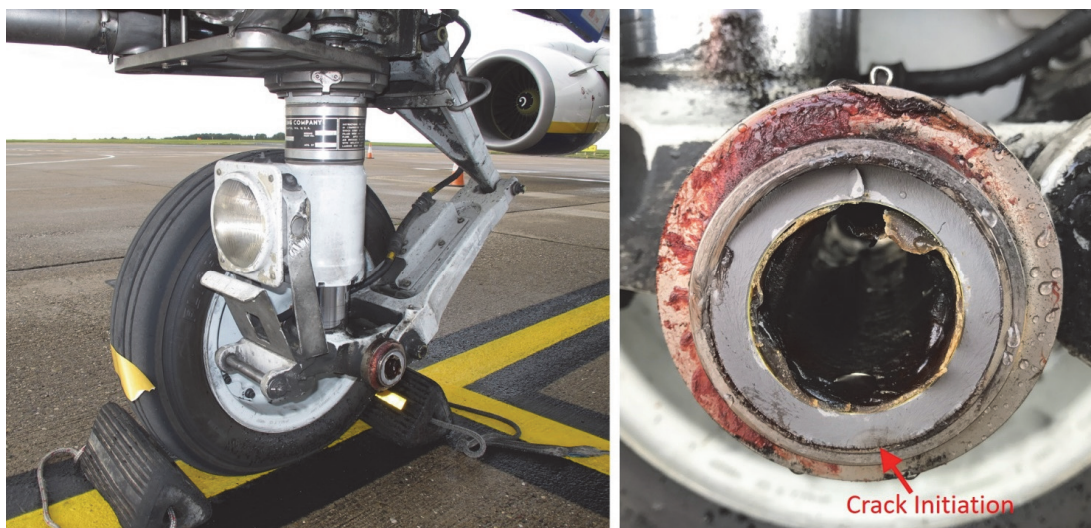
**Figure 2**

The aircraft was examined after it arrived at East Midlands Airport. The left axle of the nose landing gear (NLG) inner cylinder had failed at the inboard journal location (Figure 2). The wheel bearing spacer was still in place and in good condition. On the axle fracture face, near the 6 o'clock position, there were visible bands consistent with fatigue cracking. The separated nosewheel, axle and wheel bearings were recovered from Stansted Airport and, other than the break in the axle, no anomalies were found with these components.

Left nosewheel axle failure at inboard journal.  
Bands of fatigue visible near the 6 o'clock position (right image)

The NLG axle failed as a result of a crack that had initiated near the 6 o'clock position of the left inboard journal and had then propagated over time via fatigue and SCC until the remaining material failed in overload. The final failure occurred as EI-DLV turned onto the runway prior to takeoff.

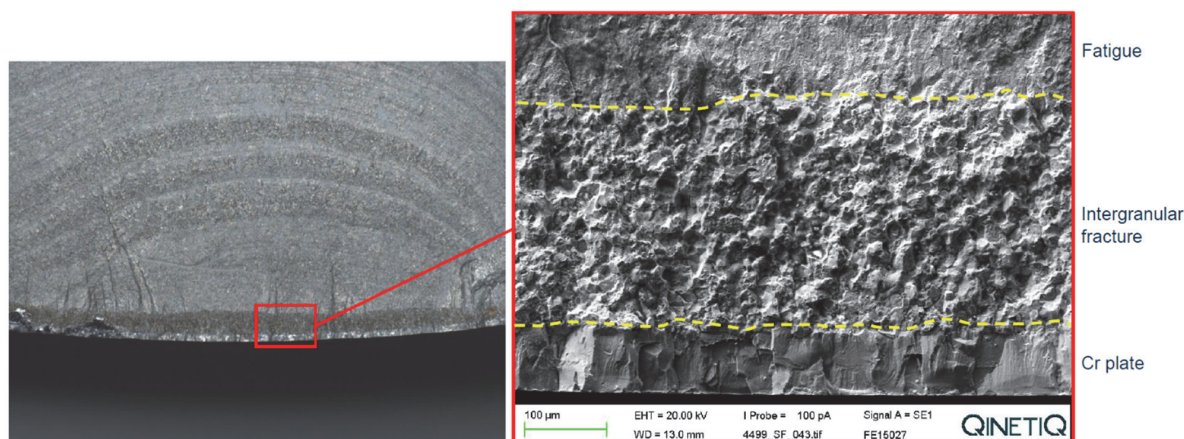
**Figure 4**

The NLG cylinder was taken to a metallurgical lab for detailed examination. This revealed multiple crack initiation points on the lower circumference of the axle around a total length of about 47 mm; however, the dominant crack was near the 6 o'clock position as shown in Figure 2 (right image). A magnified image of this area is shown in Figure 4. Underneath an approximately 80  $\mu\text{m}$  (0.003 inches) layer of chrome plating there was an area of intergranular fracture, about 250  $\mu\text{m}$  thick, which was consistent with either stress corrosion cracking (SCC) or hydrogen embrittlement cracking. Underneath this area was an area characteristic of fatigue cracking, followed by alternating bands of SCC and fatigue. The fracture surfaces outside the banded region were all typical of overload failure.

Scanning Electron Microscope image of primary crack initiation site (near 6 o'clock position)

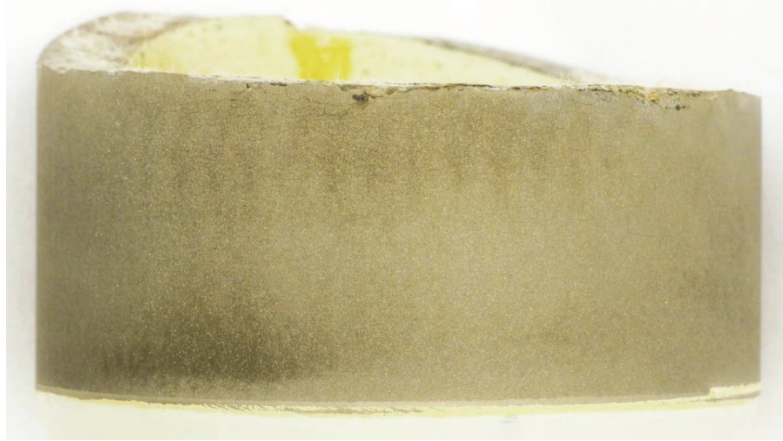
**Figure 5**

An examination of the wheel bearings showed that they were in good condition and rotated freely indicating that bearing deterioration did not contribute to the heating of the axle bearing journals. The bearing covers about half the width of the axle bearing journal and yet the heat damage expanded nearly the entire width of the journal. Given this information, the aircraft manufacturer concluded that the only explanation for the base metal heat damage was that it had occurred during post-plating grinding.

Lower face of the failed axle after chrome removal.  
The dark areas are evidence of heat damage

When the base metal becomes overtempered from abusive grinding, there is a softening of the material and its strength reduces. The heating also causes a significant change in residual stress from compressive stresses on the surface to tensile stresses which increase the part's susceptibility to cracking. During an abusive grinding event there is rapid localised heating followed by rapid cooling which results in thermal strain that can cause heat-induced cracking. During subsequent cadmium plating of other parts of the inner cylinder, hydrogen can diffuse into areas of tensile stress causing hydrogen embrittlement cracking. This can occur during the period between the cadmium plating and the stress relief bake which removes the hydrogen. These cracks can then propagate in service due to SCC or fatigue or both.

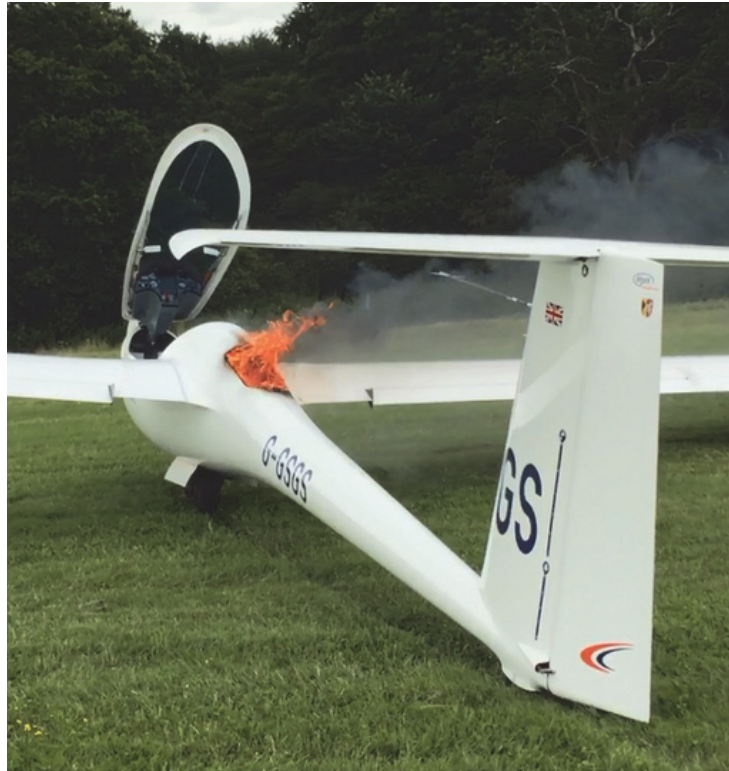
**Figure 1**

Fire in the FES battery compartment following the landing roll

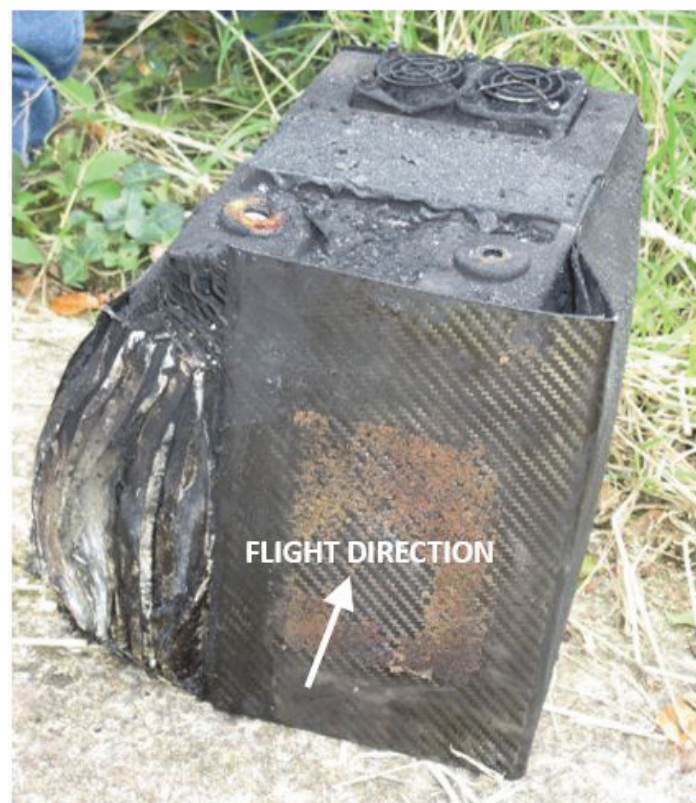
**Figure 5**

The origin of the fire was the forward FES battery; its battery box was ruptured along the rear left corner and the battery assembly was heavily fire damaged (Figure 5). The rear battery box suffered from external fire damage although the internal components were only slightly damaged and the cells remained charged.

Fire damage to the forward FES battery

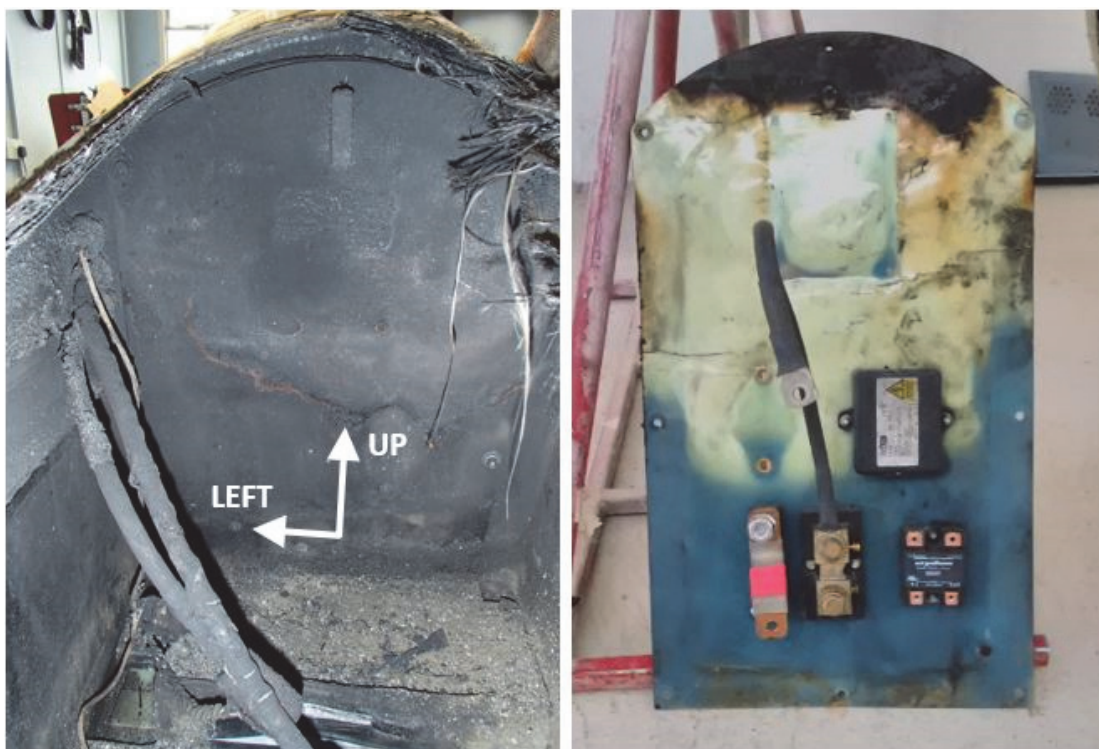
**Figure 6**

The FES battery compartment was heavily fire damaged with burning of the composite material's resin on the internal faces of the battery compartment and around the external cut-out in the upper fuselage skin. The top edge of the removable access panel that forms the front panel of the battery compartment (Figure 6) was also burned on its forward face and the FES electrical components in the equipment bay between the cockpit and the battery compartment were covered in soot deposits, demonstrating that the battery compartment had not contained all of the smoke and fumes released by the FES battery fire.

Fire damage to the FES battery compartment front access panel (left image, looking forwards), and to the forward face of the front access panel (right image, looking aft)

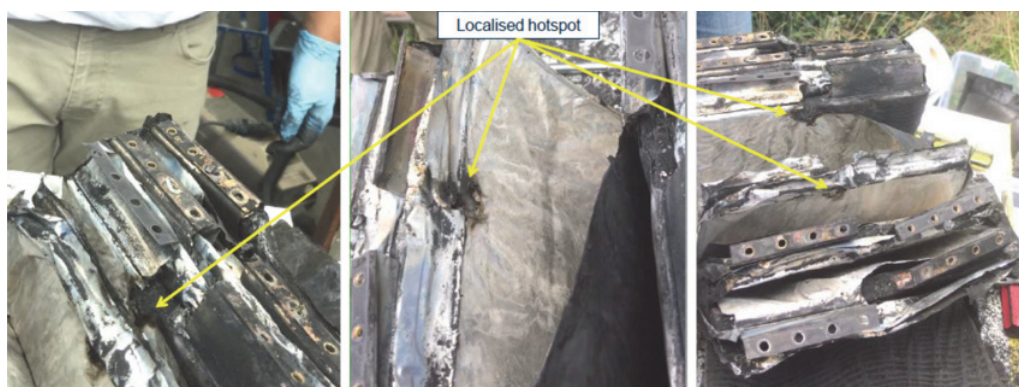
**Figure 7**

A localised hot-spot was observed between cells 5 and 6 on the upper edge of the cells in between the electrode tabs (Figures 7 and 8). The hot-spot was observed on the cell pouches and a number of the internal sheet electrodes were also exposed. The hot-spot did not appear to penetrate the whole cell pack thickness.

Localised hot-spot between cells 5 and 6 apparent during initial disassembly of the battery (courtesy British Gliding Association)

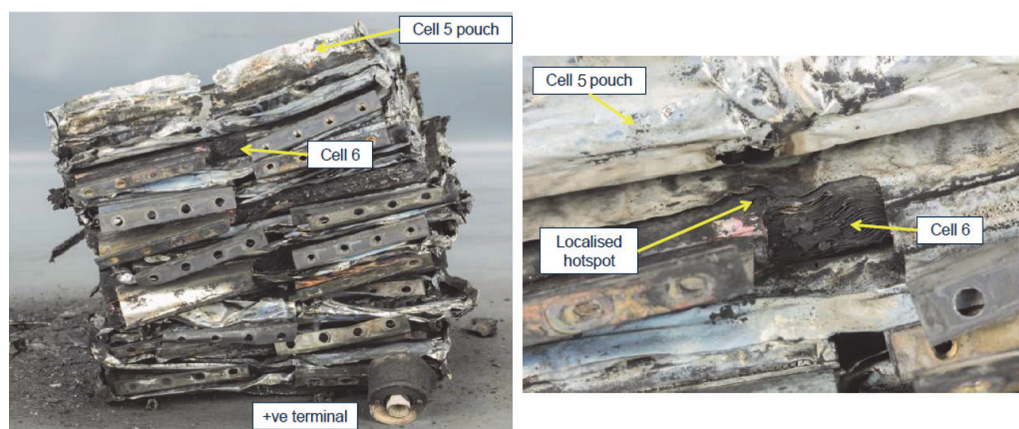
**Figure 8**

Localised hot-spot between cells 5 and 6 (courtesy QinetiQ)

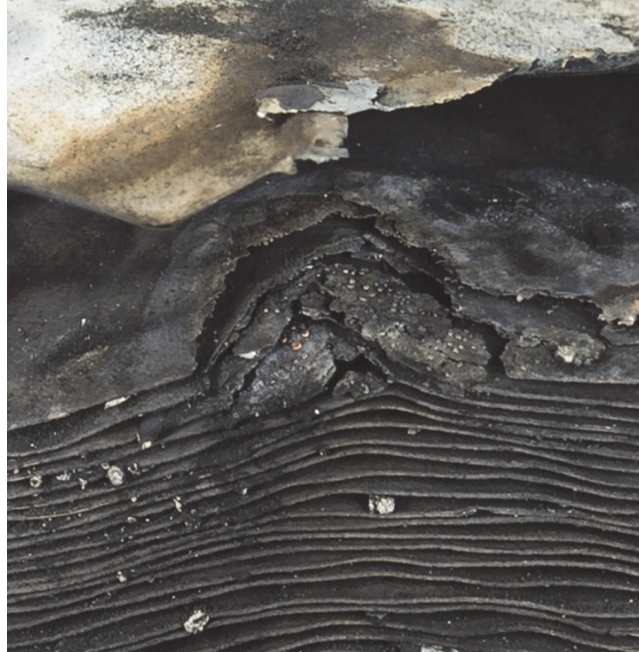
**Figure 9**

Examination of the hot-spot at cell 6 revealed localised melting of both the aluminium cathode and copper anode electrode sheets (Figure 9) indicating that the temperature at the hot-spot had exceeded 1,085°C, the melting point of copper. The presence of solidified molten copper was further confirmed by examination of the hot-spot location using a scanning electron microscope, and energy dispersive X-ray analysis of the molten copper deposits.

Localised hot-spot at cell 6, with solidified molten copper present  
(courtesy QinetiQ)

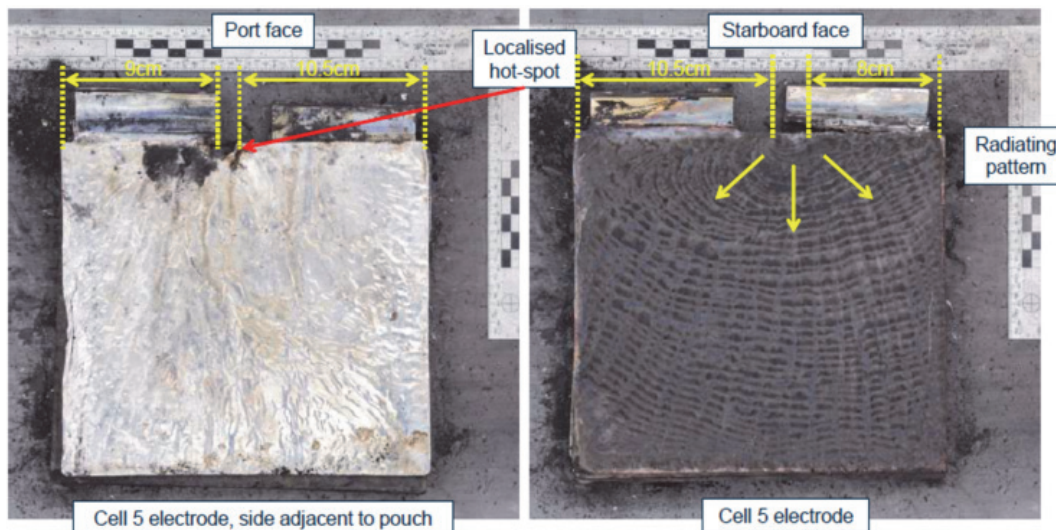
**Figure 10**

When cell 5 was disassembled, a radiating pattern of combustion-deposit ‘beachmarks’ was apparent, originating at the hot-spot (Figure 10). This indicated that ignition of the cell’s gel polymer electrolyte had begun at the hot-spot location before burning downwards through the cell. Detailed examination of the hot-spot sites did not reveal the presence of any foreign objects at these locations. There was no evidence of ‘welding’ of the individual cell electrodes; the cell packs appeared to be fused together with combustion products, most likely the gel electrolyte residues.

Combustion front 'beachmarks' evident on cell 5 electrodes (courtesy QinetiQ)

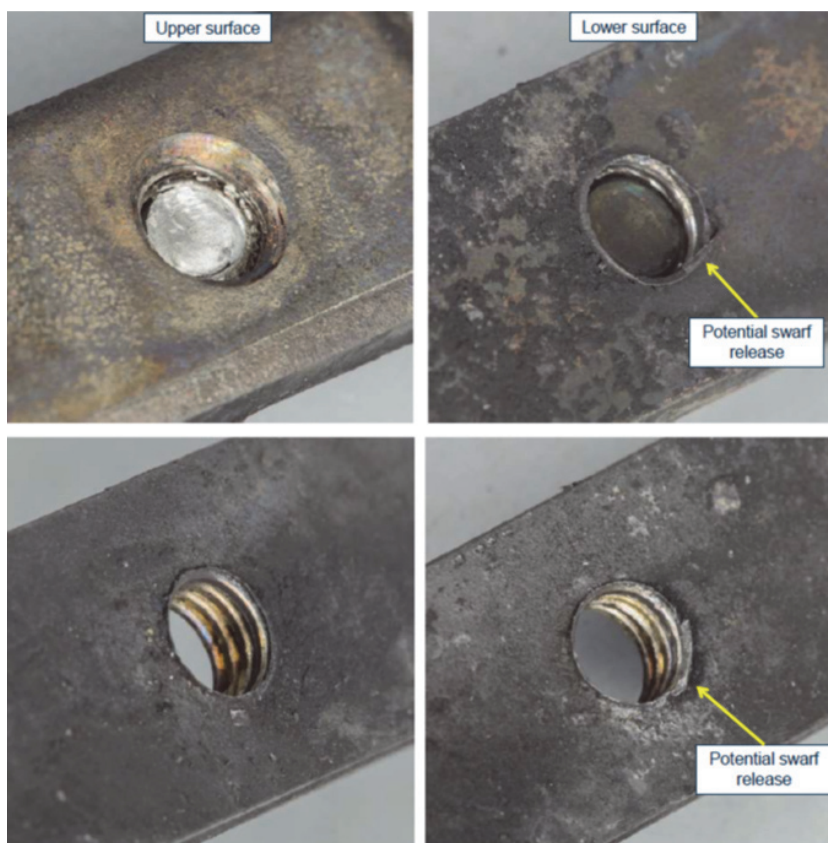
**Figure 11**

Examination of the lower stainless steel cell connector plates showed a burr present on a number of the drilled and threaded holes, on the lower surface of the plates (Figure 11). The visual examination also showed the potential formation of swarf from these burrs.

Thread-cutting swarf present on the lower surface of the connector bars (courtesy QinetiQ)

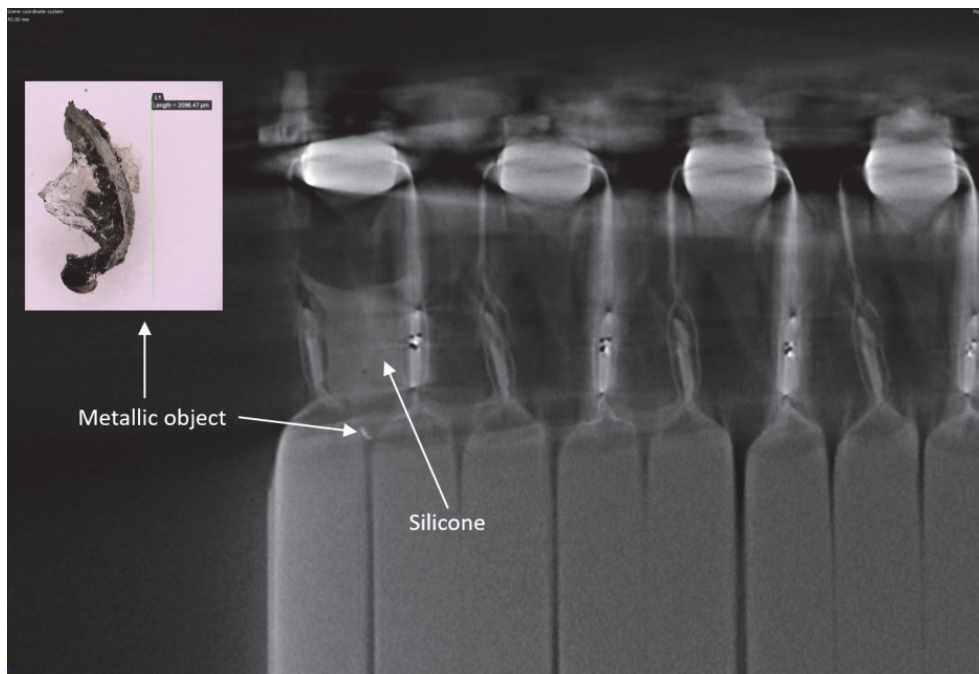
**Figure 14**

The battery pack was disassembled and the metallic object was recovered. The object was a piece of metal swarf, 2 mm in length, with a distinctive curved shape consistent with the swarf generated during the thread-cutting process of the connector plates.

Metallic swarf debris within battery pack 080-B (courtesy QinetiQ)

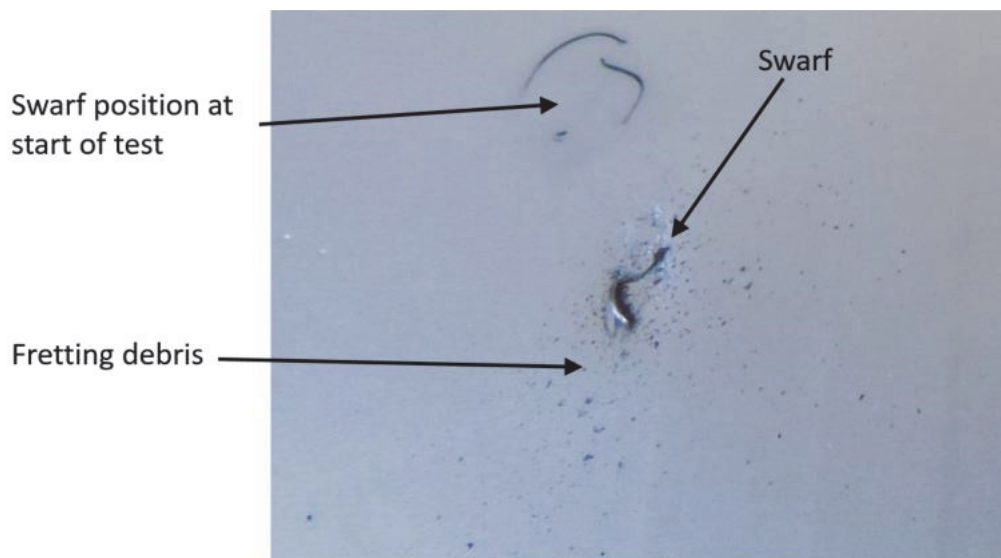
**Figure 16**

A second test was conducted with 3.0 mm lengths of steel swarf inserted between the cells (Figure 16). The cells were vibrated in the horizontal axis for 30 minutes at a resonant frequency of 20 Hz, during which there were no signs of fire, smoke or unusual odours. Following this test, the cell fixture was disassembled and it was noted that there had been migration of the swarf within the cell fixture and some fretting of the cell pouch material due to contact with the swarf, but the fretting depth had not exceeded the pouch thickness and no electrolyte had been released.

Cell pouch fretting during vibration testing with metal swarf present

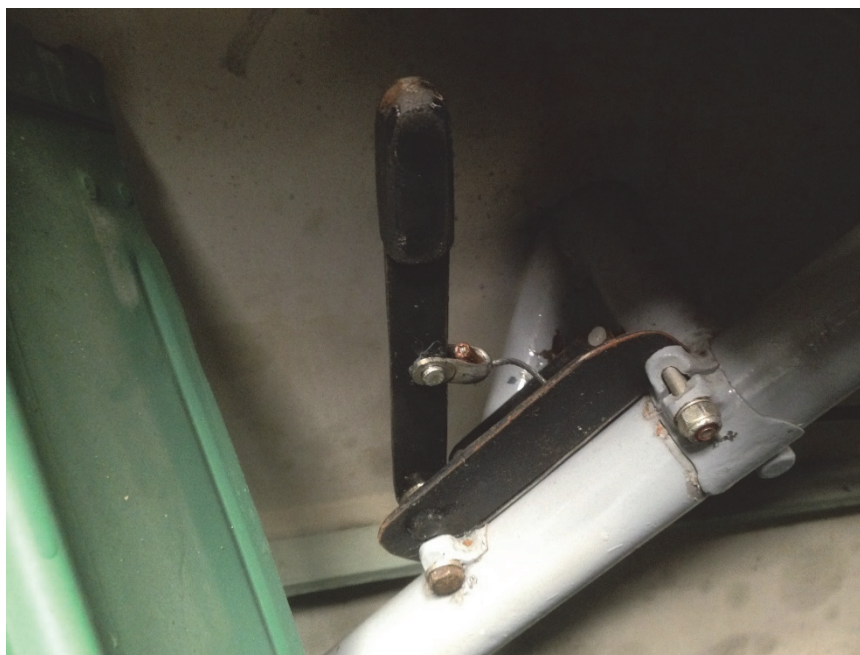
**Figure 3**

Priming lever as found in the cockpit of G-BZNK

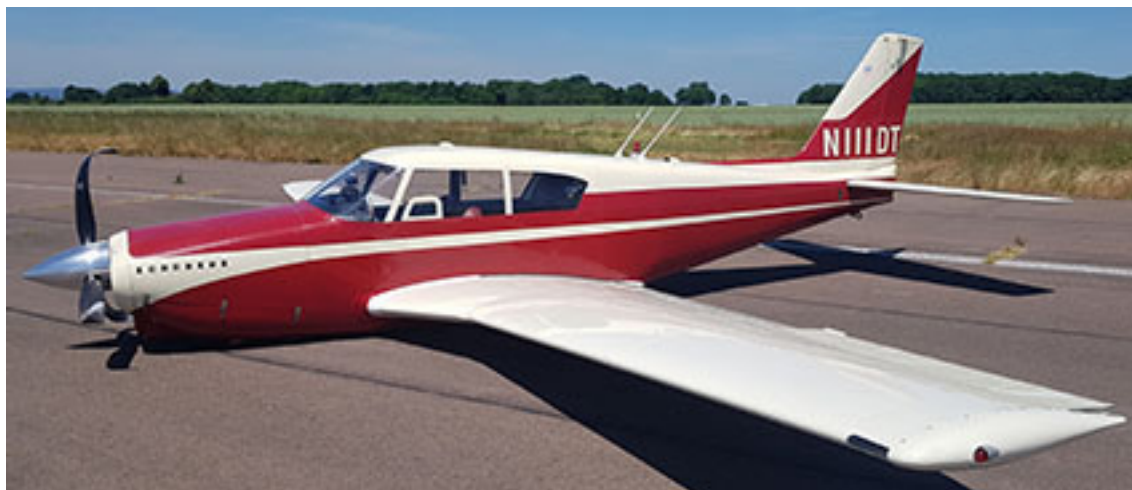
**Figure 1**

N111DT on the runway at Leicester Airport after the wheels-up landing

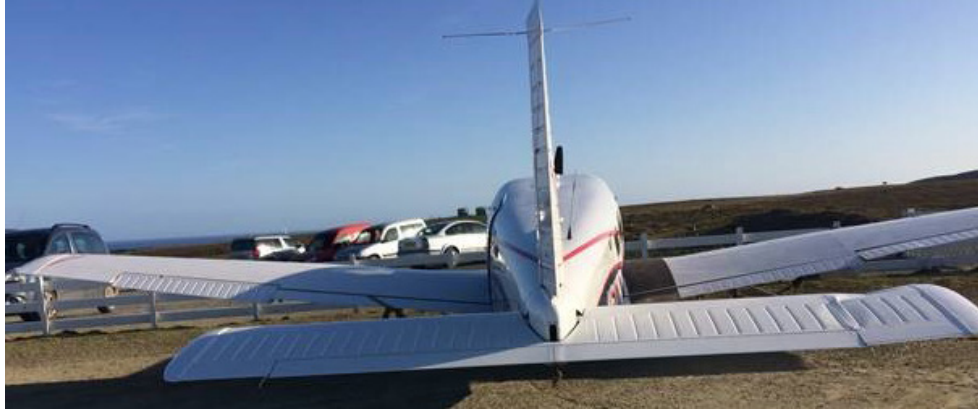
**Figure 1**

N517FD after being moved to a parking area and with the right stabilator bent upwards  
(Picture used with permission)

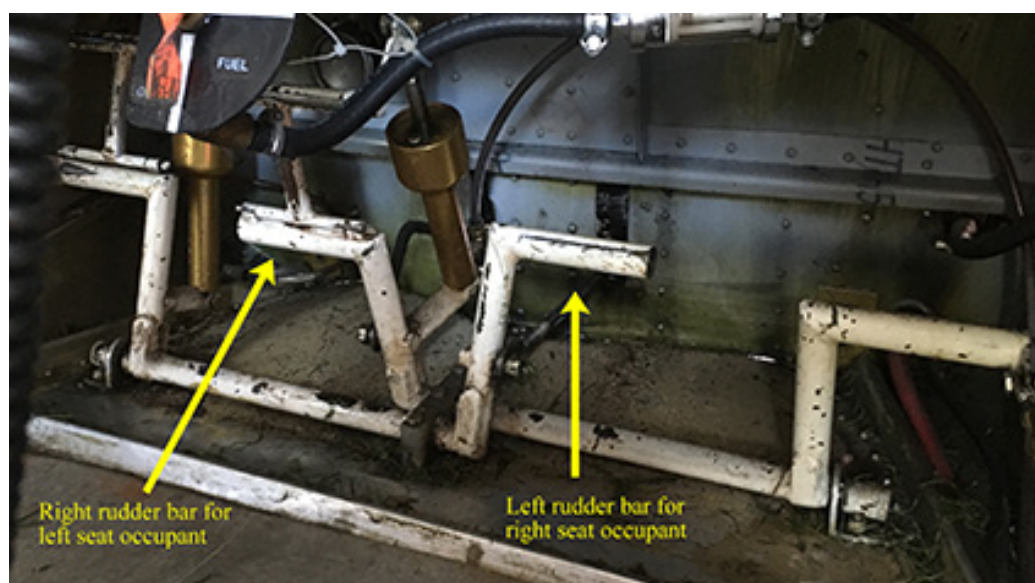
**Figure 1**

Post-flight inspection of the rudder bars led the pilot to believe that during the second landing, his right foot had slipped and was resting on the left rudder bar which is installed for a pilot in the right seat. Thus when he pressed with his right foot, he had moved the rudder bar in the opposite direction to that intended. All his previous SEP flying had been on types equipped with rudder pedals rather than rudder bars. On this aircraft the right rudder bar for the left seat occupant is situated close to the left rudder bar for the right seat occupant (Figure 1) and the pilot had not identified this before flight. He also noted that space in this cockpit is restricted and that his legs, being fairly long, may not have been positioned ideally.

Rudder bars in G-EOIN, with left rudder applied
