Rail Accident Investigation Branch

# Rail Accident Report

## **Near miss with track workers at Pelaw North Junction 21 February 2018**

Report 13/2018  
August 2018

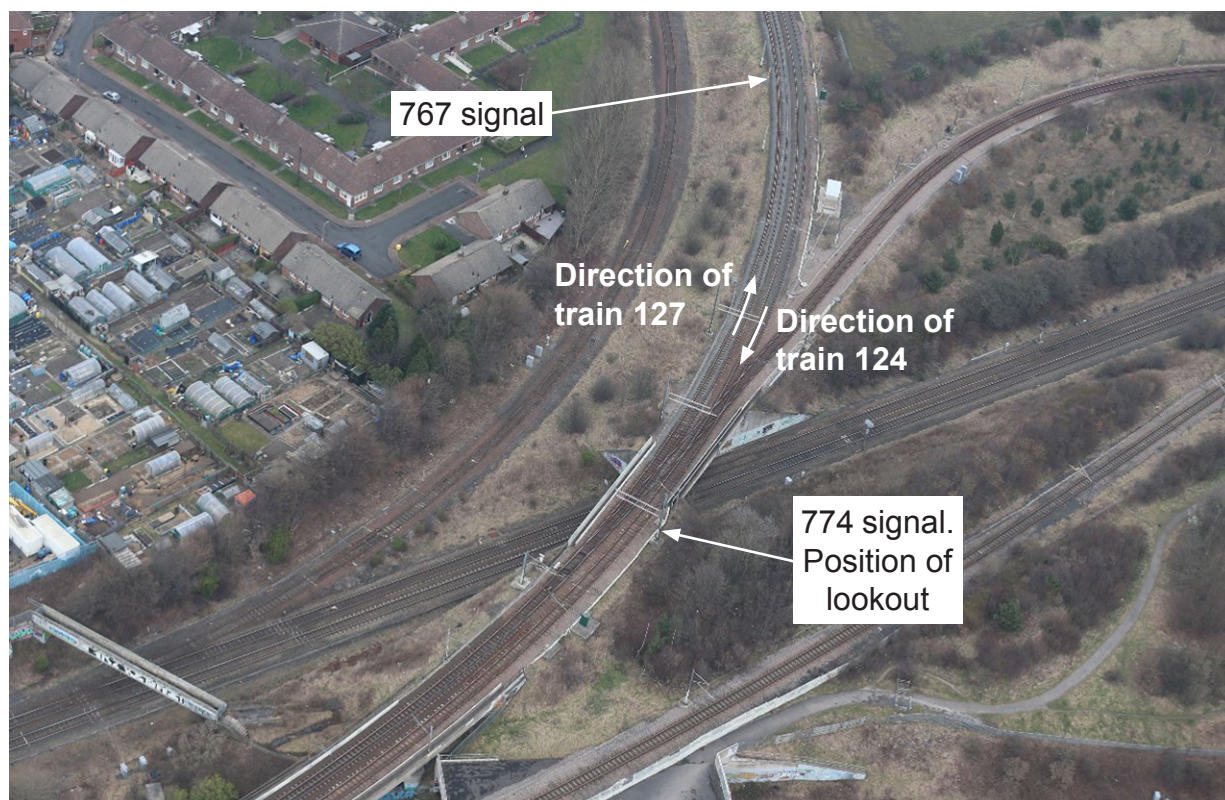
Figure 5: Image from the Network Rail Routeview system of Pelaw North Junction (courtesy of Network Rail)

- 34 CCTV evidence from train 124 shows that the WSC and the lookout became visible to the driver six seconds before the train reached their location. When the driver of train 124 saw the WSC and the lookout in the path of his train, he sounded the train's warning horn and applied the emergency brake. The WSC and the lookout moved clear of the train when alerted, by the horn, to the train's approach. The lookout moved to a position of safety in the cress of the outbound line, close to 774 signal (figure 5). The WSC moved into the four foot of the inbound line. They managed to move clear of train 124 approximately two seconds before the train passed them. When the driver saw that the WSC and the lookout had moved clear of the train's path, he released the emergency brake<sup>6</sup>. The train did not come to a stand, but continued to its next station stop at Pelaw.

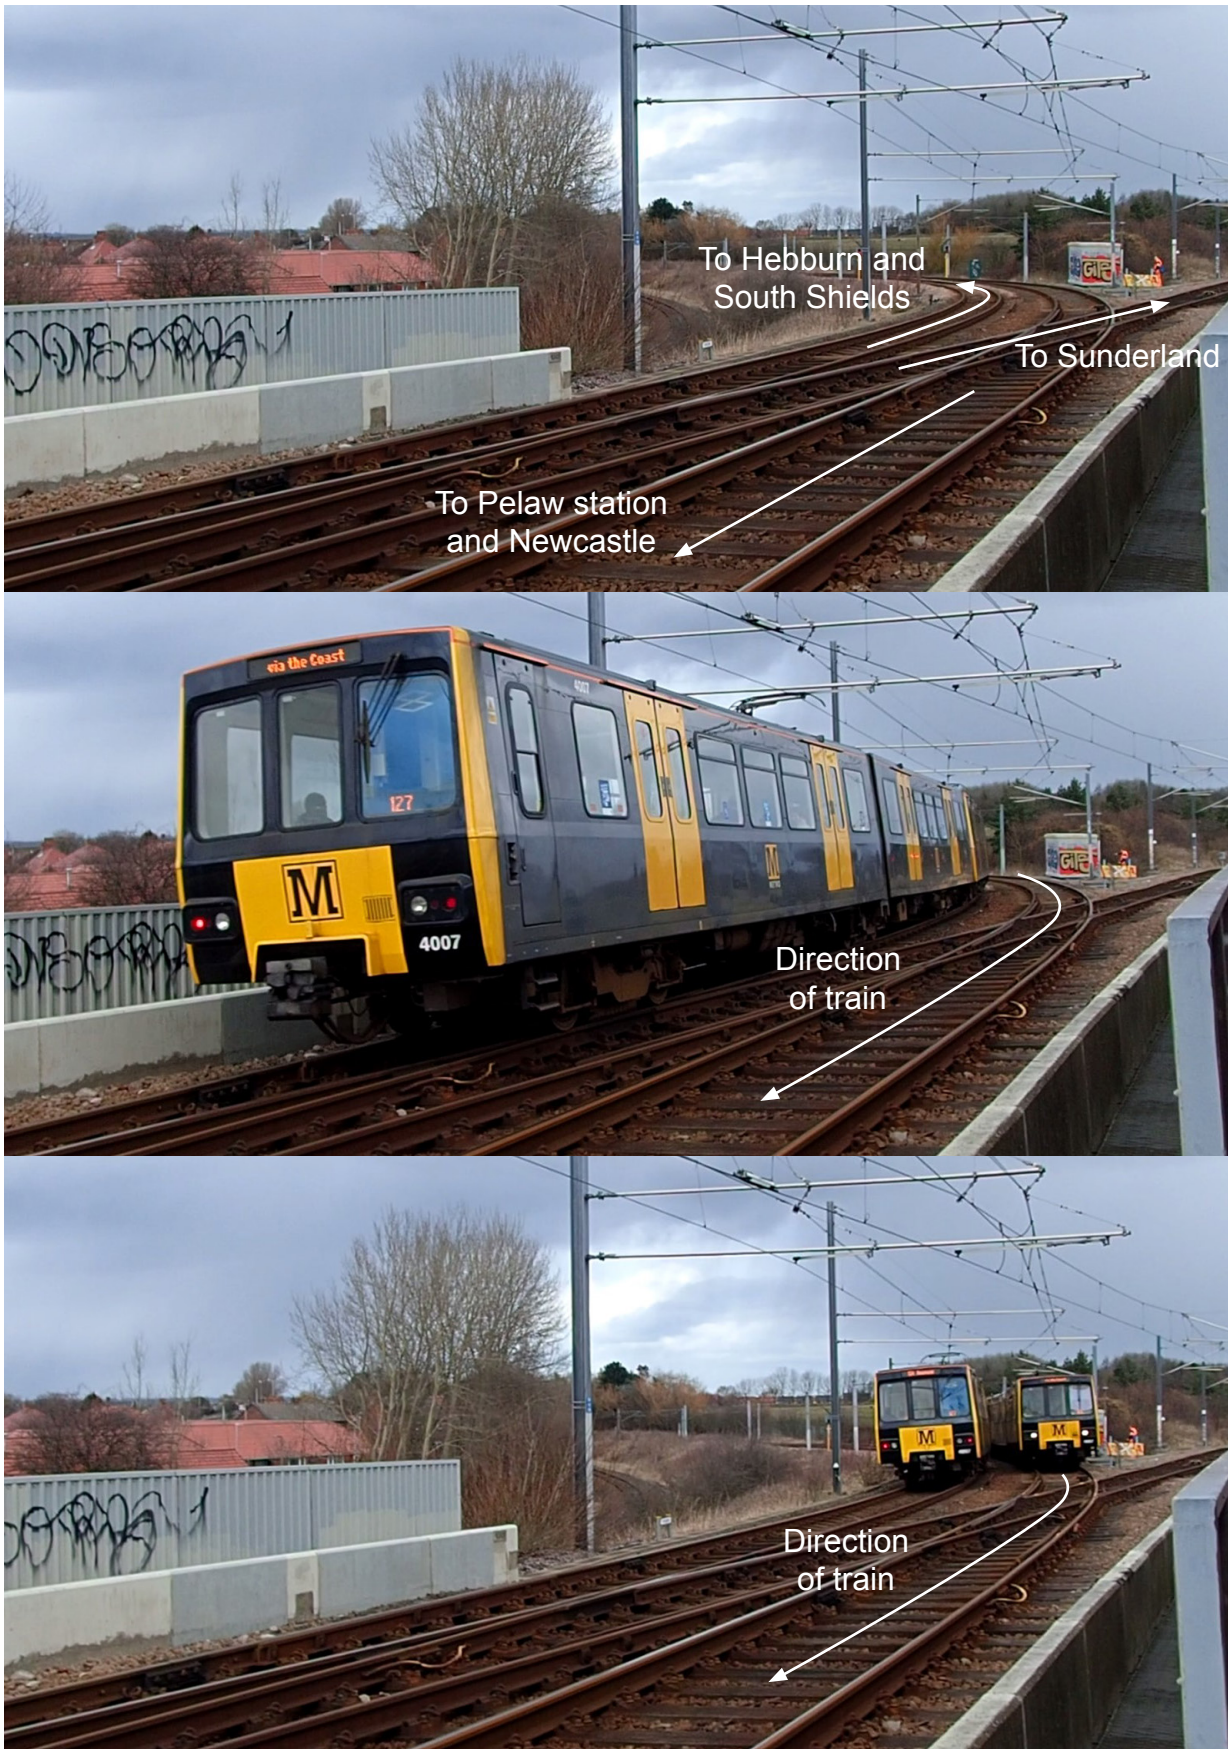
Figure 6: Images taken from the approximate location of the lookout at the time of the incident. It can be seen how an inbound train (second image) obscures the view of an oncoming outbound train (visible in third image).

67 The lookout's actions immediately prior to the incident suggest that he lost situational awareness and his perception of hazards from moving trains. Possible reasons for this include a lack of experience and distraction by interest in the technical work being carried out by the WSC.

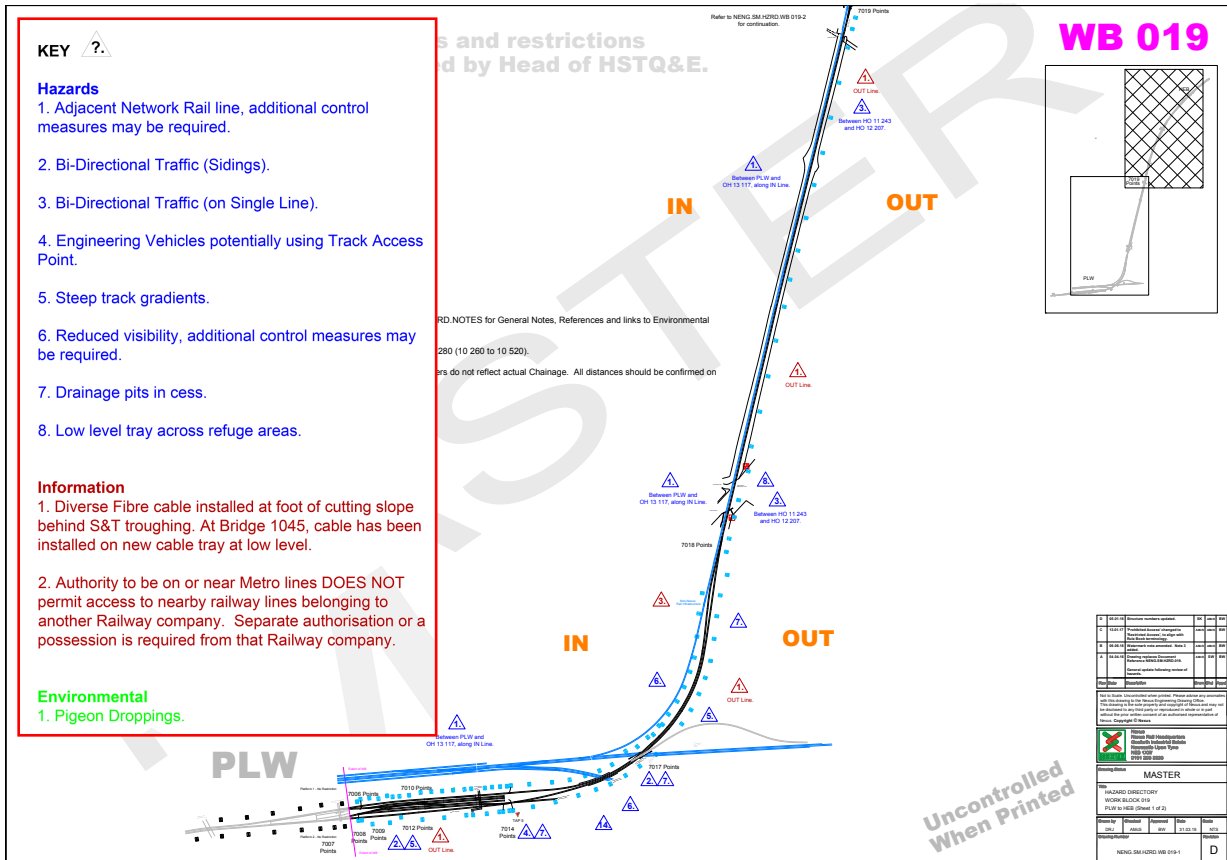
Figure 7: The section of the hazard directory which covers Pelaw North Junction

- 53 Site-specific hazards for Pelaw North Junction which are listed in the hazard directory include:
  - ‘Steep track gradients’; and
  - ‘Reduced visibility; additional control measures may be required’.

- 54 The hazard directory is an on-line document and therefore access to the Nexus Rail computer system is necessary in order to view its contents. Mobile staff, such as the two track workers involved in the near miss at Pelaw North Junction, are not provided with any means to directly access the contents of the hazard directory.

- 55 In order to overcome the lack of direct access afforded to mobile staff, the NIM is required<sup>12</sup> to provide site-specific information from the hazard directory to the WSC. In the case of the near miss at Pelaw North Junction, the NIM did not provide this information, due to an oversight. However the WSC, who required this information to compile an effective safe system of work, did not correct the oversight by requesting the information from the NIM.

Nexus Rail should provide its mobile staff, including fault finding teams, with remote access to the hazard directory to enable them to set up safe systems of work and alert them to sighting hazards.
