## Safety Investigation Report

RAF BLSA LUGE ACCIDENT - NSI

29 January 2018

<b>Report Title:</b>	RAF BLSA LUGE ACCIDENT - NSI
<b>Reference:</b>	DAIB/18/003
<b>Issue:</b>	1
<b>Date:</b>	July 18
<b>Authors:</b>	Lt Cdr [REDACTED] (Eng) and WO1 [REDACTED] (Eng)
<b>Reviewed by:</b>	Wg Cdr [REDACTED]
<b>Approved by:</b>	Gp Capt [REDACTED]

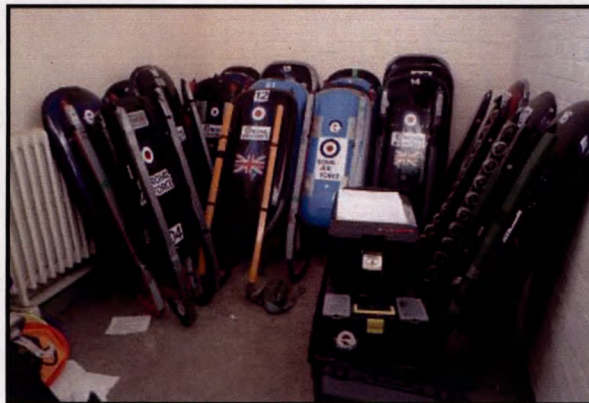
Figure 10: BLSA Luge Equipment Storage Facility Room 2, RAF Halton

The luge equipment used by the RAF BLSA Luge Team was stored at RAF Halton within an allocated storage facility. The luge sled store was seen to have sleds propped up against radiators which may degrade the fibreglass pods (Figure 10).

**Safety Recommendation – The RAF BLSA RP should establish procedures to ensure the internal management of RAF BLSA Luge equipment including the servicing of sleds, sizing of athletes to sleds and equipment usage records are appropriately maintained and assured by the RAF BLSA SM. The storage of RAF BLSA Luge equipment should also be revised in line with the OEM instructions.**

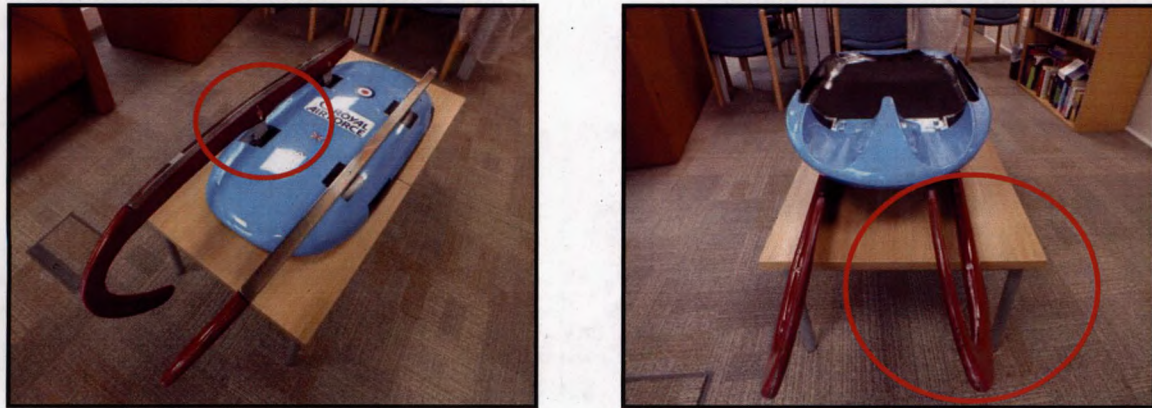
Figure 12: IP's Luge Sled, BLSA Serial Number 1 damage

The IP's sled sustained damage to the LH Bow and LH bridge during the accident (Figure 12); there is no evidence that there was any unserviceability with the IP's sled prior to the accident. The IP's sled had functioned as expected during her initial ice-run at Igls and there is no evidence to suggest that the IP reported any defects prior to her 2nd ice-run.

The Left Hand (LH) runner was cracked at the forward bridge location; this cracking was consistent with the application of a tensile load to the outboard surface of the runner. Damage was also observed on the top surface of the runner, forward of the forward bridge, covering an area approximately 10 x 7 mm. At this location part of the gel coat was missing and cracks in the gel coat propagated outwards. The loss of the gel coat material is indicative of a compression load at the center of the damage location. The cracking surrounding the loss of material indicated that a bend had occurred in the structure about this location. This damage is consistent with that produced should the forward part of the runner flex inboard and slightly upwards, pivoting about the forward edge of the forward bridge.

The damage to the LH runner of the IP's sled occurred as the result of the forward part of the runner bending inboard and slightly upwards about the forward bridge. There was no evidence of a pre-existing failure mechanism and therefore the damage is considered to be as a result of the accident.

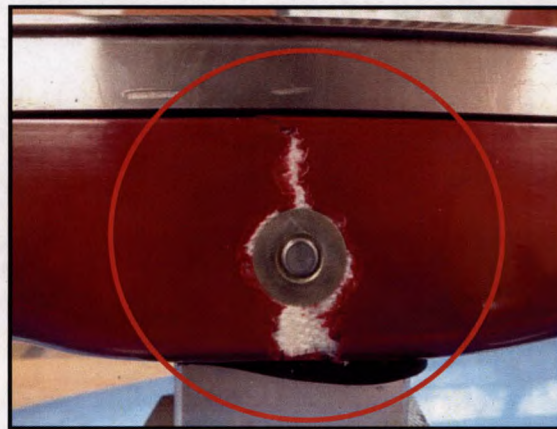
Figure 13: Front LH Internal Bridge Attachment Bolt Damage Figure 11

The luge sled has suffered a number of impacts; it is not possible to determine more than general directions of force which caused the damage to the internal surface of the composite runner (Figure 13)

Gel coat material had been lost on the inboard surface of the LH runner at the forward bridge approximately 10 mm wide below the attachment bolt and 20 mm wide above the attachment bolt. Material had also been lost surrounding this attachment bolt particularly in the forward upper and lower back quadrants around the bolt, producing an asymmetrical damage pattern. The damage observed on the inboard surface of the left-hand runner was consistent with the compression loading associated with the forward runner structure bending inboard and lengthwise about the attachment bolt to the forward bridge. The asymmetrical damage about the attachment bolt indicated that the bend also contained an upwards force component.

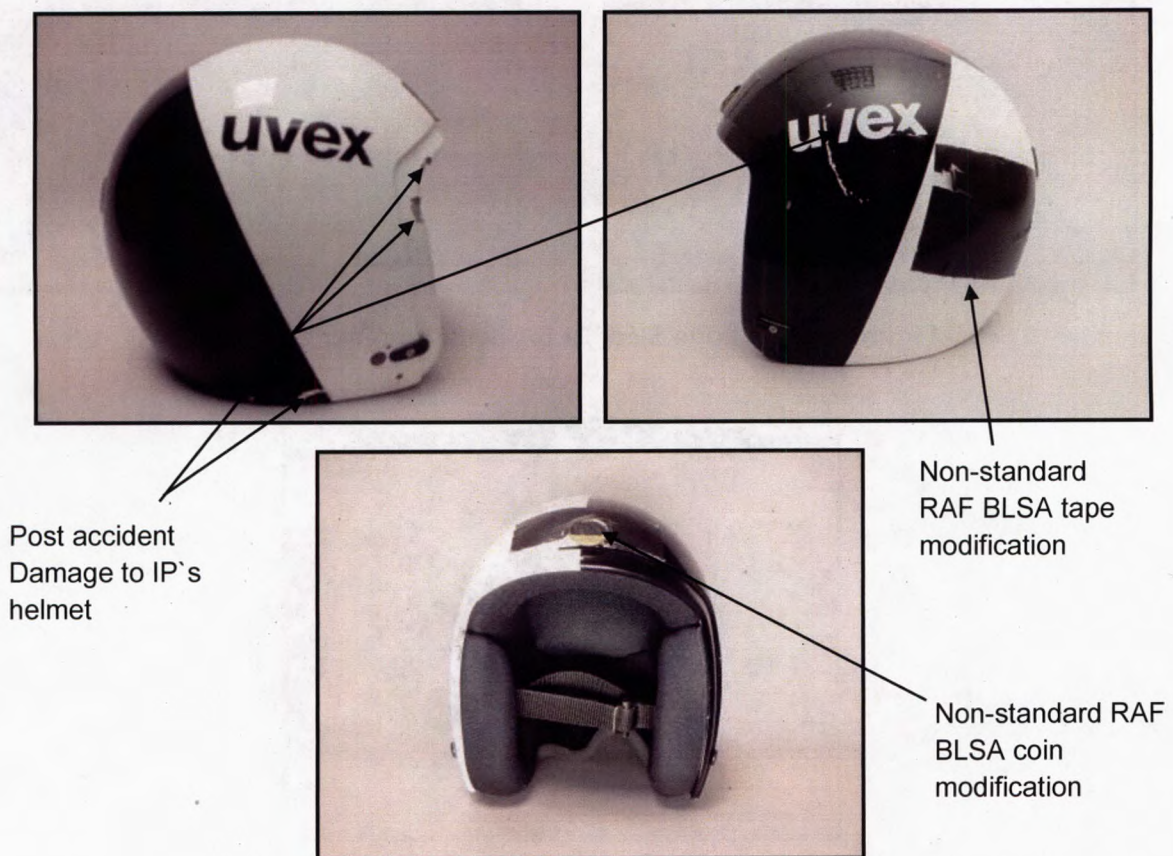
Figure 14: IP's Helmet (Standard - FIL 2010 050)

Figure 14 illustrates a number of impact marks on the IP's helmet<sup>51</sup>, the largest concentration of which is seen in the vicinity of the RHS of the helmet. Tape has been added (Figure 14) by RAF BLSA Coaches to various areas of the helmet. The Luge TM stated<sup>52</sup> this is used as a sacrificial layer in order to prolong helmet life. The IP's helmet also incorporated a modification using a 50 cent Euro coin taped to the front centre (Figure 14). Coach 3 stated<sup>53</sup> that this modification was incorporated by the RAF BLSA and was improvised to prevent the visor from misting up and was normal practice within the RAF BLSA<sup>54</sup>.

**Safety Recommendation – The RAF BLSA RP should introduce a lifing policy for luge helmets and additionally introduce an assured method of identification for all issued PPE used by RAF BLSA athletes.**

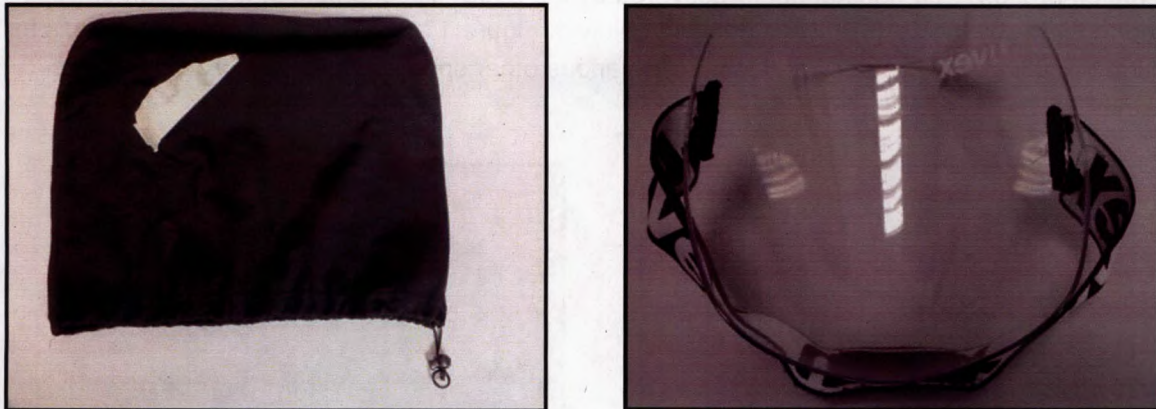
Figure 15: IP's Helmet Bag and Visor

<sup>55</sup> 1710 NAS identified that the IP's visor was not compatible with the helmet issued to the IP. Evidence reference DAIB/18/003/2058.

design purpose in relation to the helmet is aerodynamic<sup>56</sup>. The IP was not wearing the helmet visor when the accident occurred as directed by Coach 1; Coach 1 stated<sup>57</sup> in interview that this is normal practice for RAF BLSA novice luge athletes.

**Safety Recommendation – The RAF BLSA RP should review all RAF BLSA Risk Assessments in order to ensure all hazards associated with novice luge activities have been identified and mitigated including the removal of visors.**

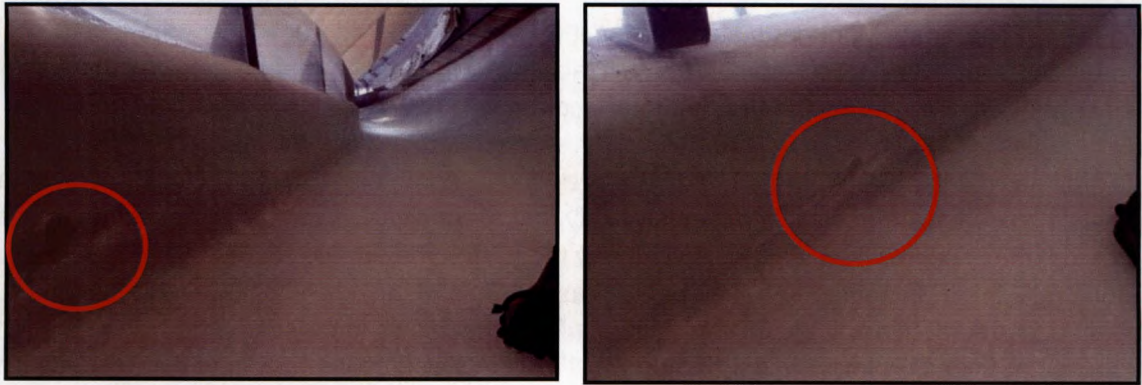
Figure 18 - Ice wall damage at the exit of Turn 10

The witness mark in Figure 18 represents evidence of a significant high energy impact against the LHS ice-wall at Igls on the exit of Turn 10. Due to the time elapsed<sup>79</sup> between the IP's accident and the visit by the NSI team this impact mark could not be confirmed as being directly attributed to the accident on 29 Jan 18. Whilst the position of the witness mark on the ice wall is consistent with the IP's trajectory established from CCTV footage, and is corroborated by Coach 2 as being in the area of the IP's collision, it is not possible to be certain that this is the damage caused by the IP at Impact Point 6. It is however highly probable<sup>80</sup> that the IP had a high energy impact with the LHS of the ice wall on the exit of Turn 10 very close and consistent with the impact mark detailed at Figure 18 and Figure 19.

Based on the witness statement from Coach 2, the impact damage to the ice wall on the exit of Turn 10 (Figure 18) and the CCTV footage it is extremely likely that the IP lost momentum and fell from a height of approximately 4.5m and experienced a high energy impact and a significant deceleration event with the LHS ice wall on the exit of Turn 10 just out of CCTV Line of Sight (LoS). This is corroborated by Coach 2's account of the accident phase and further supported by the CCTV footage of the IP departing her sled as she comes back into view on the exit of Turn 10

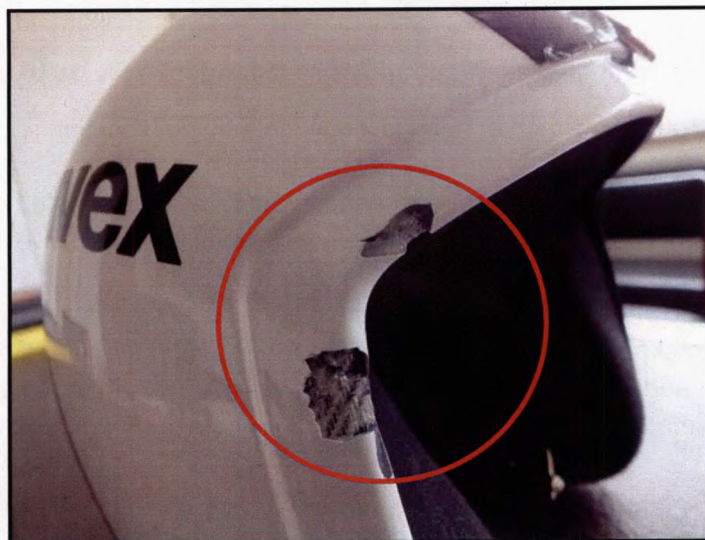
**Figure 21: IP's Helmet Damage RHS Upper**

Numerous scratches were present on the external shell of the helmet consistent with polishing actions. The lining of the helmet was noted to have debonded from the internal surface of the external shell; it was not possible to determine when this debonding occurred. Damage was observed in two locations within the recessed area surrounding the face opening (Figure 21). Gel coat was missing in these areas exposing the underlying glass fibre composite material; cracking in the gel coat was observed originating from areas of this damage consistent with that of impact damage. This area of the helmet would normally be covered by a visor during a luge run, this impact damage was imparted whilst the visor was not fitted.

The LHS of the helmet was observed to be cracked in the external shell material. This was within an area of the helmet specified for testing within BS EN 13484. Gel coat material had been lost at the crack exposing the underlying glass fibre material. This damage is consistent with impact damage.

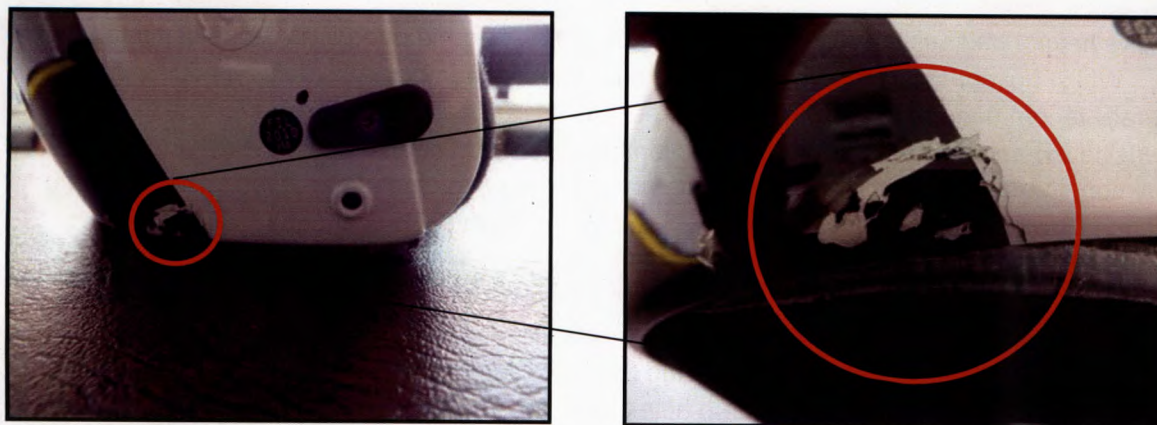
**Figure 22: IP's Helmet Damage RHS lower**

Two further areas of damage were also observed on the lower RHS of the helmet (Figure 22). The smaller area of damage is consistent with a chip, impact damage, the larger area towards the front of the helmet was also noted to have gel coat missing which exposed the cracking in the underlying composite shell structure. At higher magnification, a blue product was observed embedded within the damage. This blue product was consistent in colour to that of the gel coat of the IP's luge sled pod section. It is considered that this larger area of damage at the base of the IP's helmet was produced by an impact event between the sled pod and the helmet during the accident sequence.
