Report on the investigation of
unintentional release of carbon dioxide

Eddystone

in the Red Sea on 8 June 2016

in Southampton Water on 17 July 2017

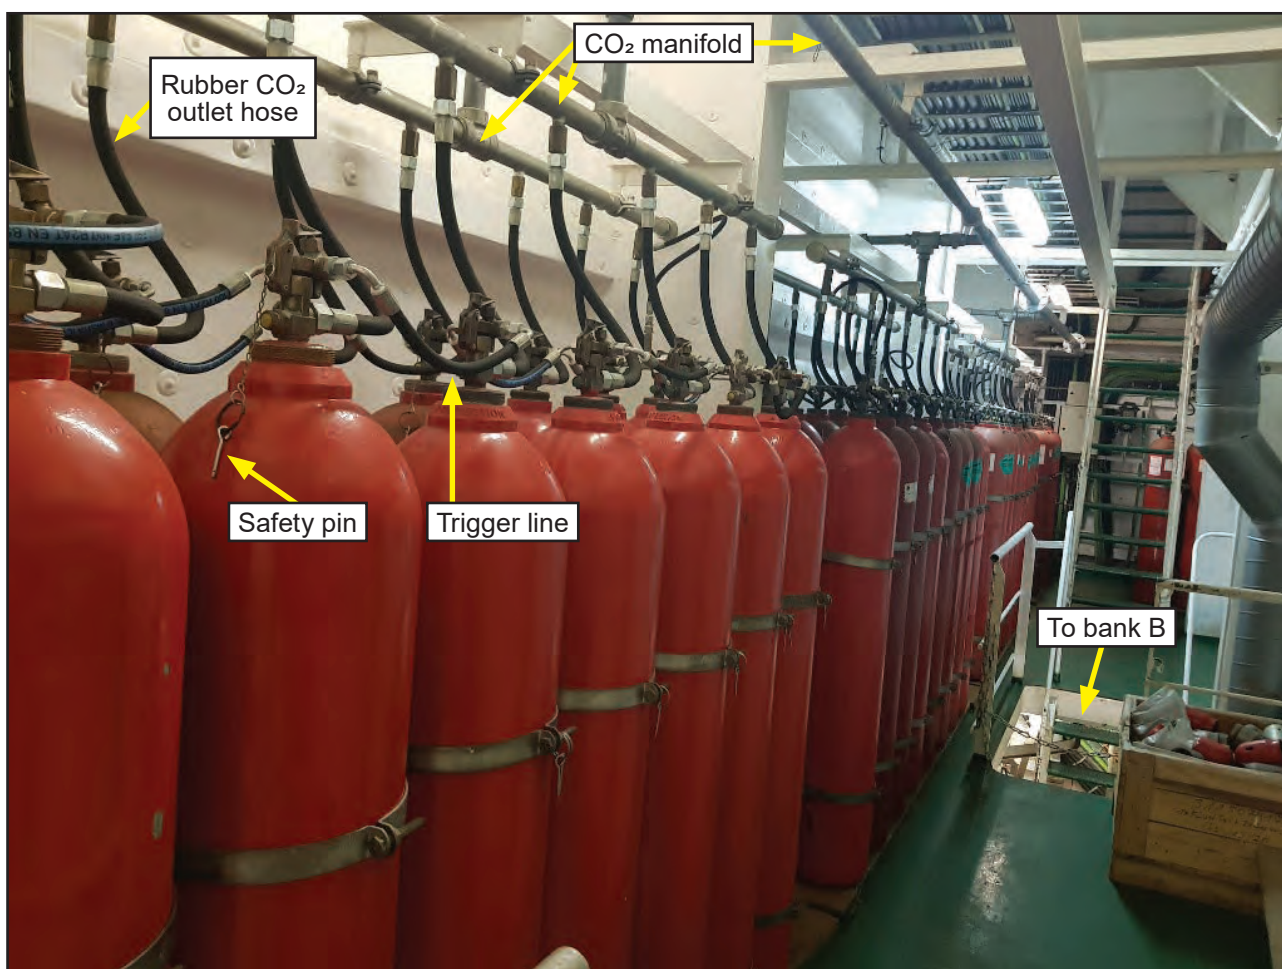
Figure 2: *Eddystone*'s CO₂ room: bank A

The chief engineer and chief officer donned breathing apparatus and entered the upper level of the CO₂ room, which contained the 65 CO₂ cylinders that comprised bank A⁴ of the vessel's fixed fire-extinguishing system (**Figure 2**). A white cloud was seen forming at the far corner of the compartment and all the cylinder valves (**Figure 3**) were in the open position. They then went down to the lower level, where the reserve set of 65 CO₂ cylinders comprising bank B (**Figure 4**) were located. All of bank B's cylinder valves were in the closed position.

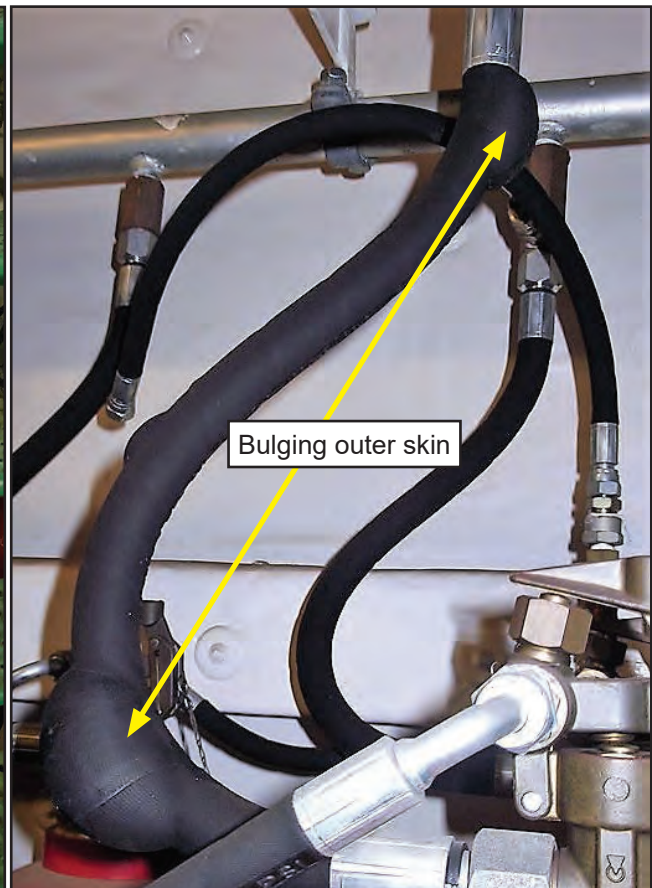
Figure 5: Bulging in outer skin of rubber hoses

To prevent the release of CO₂ from bank B, the chief engineer disconnected the pilot activation lines to both banks of cylinders and left bank B in the manual activation mode, allowing it to be activated from within the CO₂ room if required. CO₂ gas from bank A continued to leak from a few failed cylinder outlet rubber hoses over the next 4 days, during which time most of the rubber hoses in bank A developed bulges in their outer skin (**Figure 5**).

When *Eddystone* reached Marchwood, RESMAR Limited (RESMAR), the company contracted by the managers of *Eddystone* to carry out the annual inspection and maintenance of the CO₂ fire-extinguishing systems on the vessels in their fleet, attended the vessel with its subcontractor, Barber Brothers Limited (Barber). All the cylinders from bank A were transported to Barber's facility in Birmingham, refilled and returned to the vessel. Between 28 July and 2 August RESMAR replaced eight check valves and one non-return valve that had been identified to be leaking, and renewed all the rubber hoses in both banks.

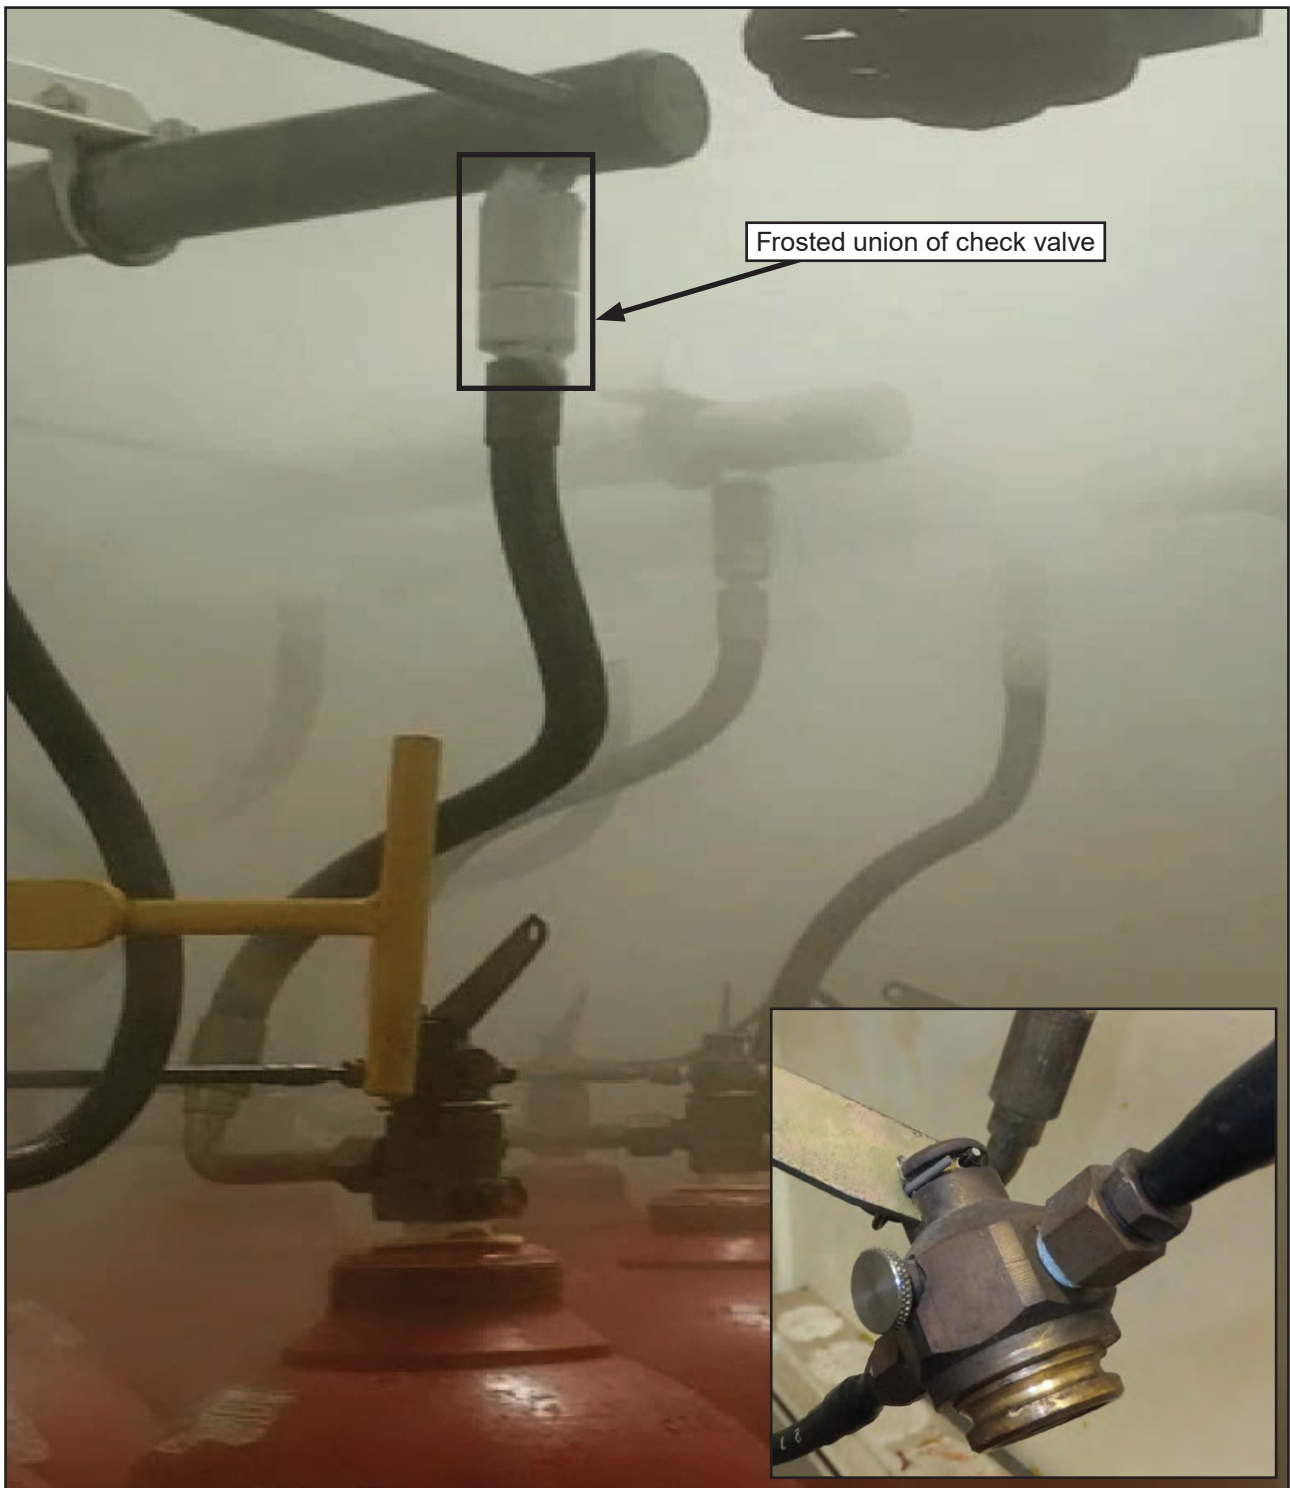
A GFT technician arrived on board at 0630 and, having donned breathing apparatus, went inside the CO₂ room to investigate. He could hear several of the cylinder valves rattling due to the back pressure in the outlet manifold, and CO₂ still leaking into the room from some of the cylinder outlet hose to manifold connections (**Figure 8**). To prevent further discharge of gas, the technician removed all the cylinder valve actuation heads (**Figure 8 inset**).

Figure 8: Dense white cloud in CO₂ room (inset: cylinder valve actuation head)

Ocean Safety emptied and pressure tested all the CO₂ cylinders, examining and refurbishing the cylinder valves as required. It was during the process of refilling the cylinders that the MCA asked the vessel's owners to replace all the cylinder valves as the valve that had caused the leakage could not be identified. Ocean Safety then ordered 26 new cylinder valves from DAB Fire Engineering Ltd (DAB) in York. The filled cylinders were emptied and refilled with the new valves fitted, and the vessel returned to normal service on 21 July after the system had been reinstated.

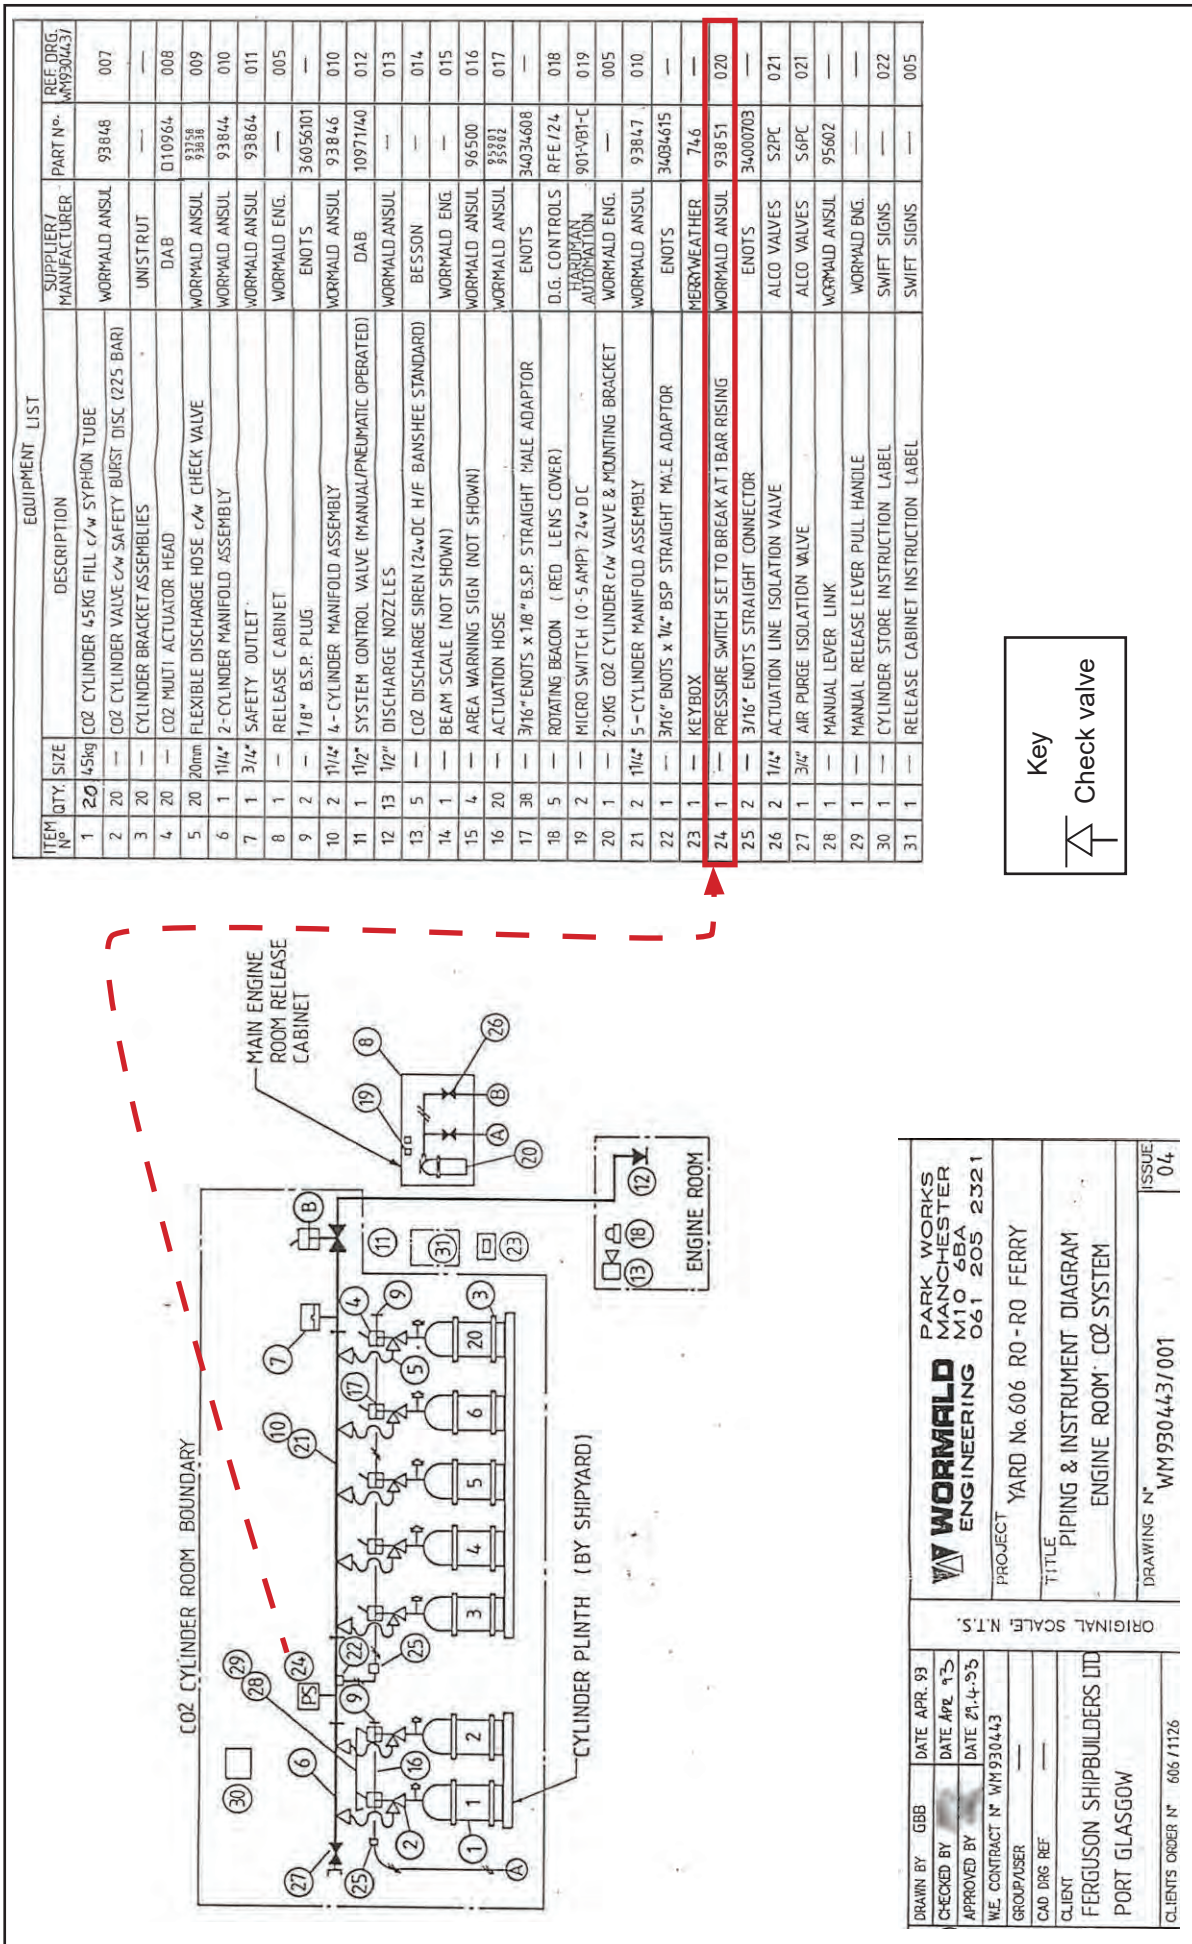
Figure 9: Red Eagle system drawing showing pressure switch

The manifold was fitted with a widely available Danfoss KPS 33 pressure switch, designed to trigger the CO₂ release alarm in the event of minor leaks from the cylinder valves as well as act as a CO₂ discharge alarm. This pressure switch had a stated range of 0 to 3.5 bar and was to be set to break at 1 bar rising (**Figure 9**).

- The switch was set to open at 0 bar rising
- Upon application of pressure up to 4 bar, the switch did not operate
- The lower diaphragm appeared to be contorted
- The upper plate that the mechanism attached to was bent upwards.

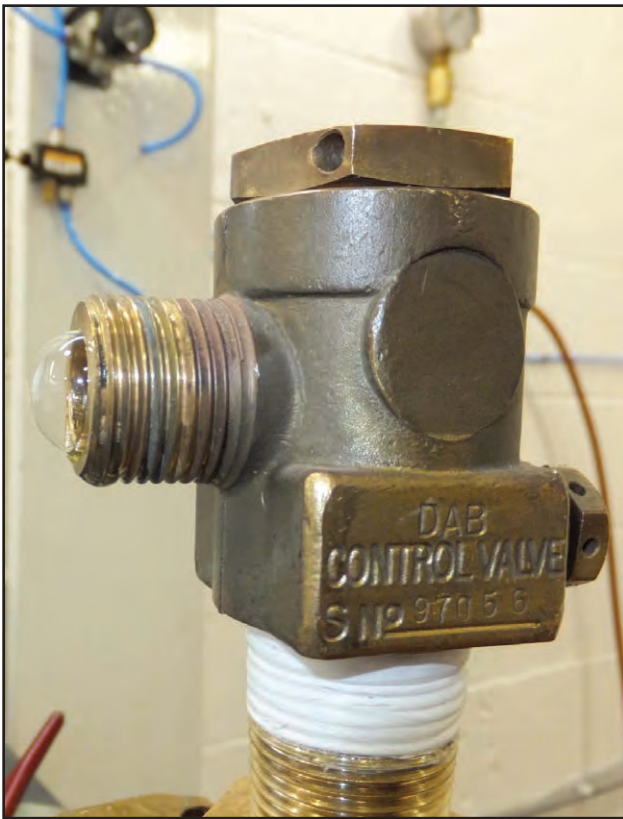
The leakage from valve 97056 was very small. The bubble formed in the soap solution during testing took a few seconds to burst (**Figure 12a**). On dismantling this valve, evidence of corrosion was apparent (**Figure 12b**) and the DAB report of the tests (**Annex A**) stated:

Figure 12a: Leaking DAB valve 97056

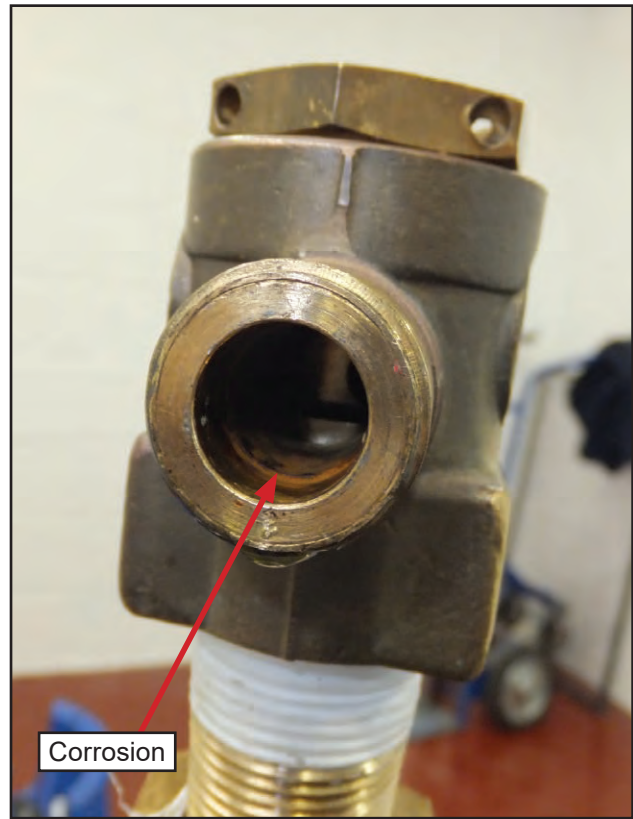
When valve 97056 was disassembled, it was noted that the outlet side of the valve was heavily discoloured internally and rust had formed in the outlet. As the valve is manufactured from brass and stainless steel it was surmised that the rust had come from the discharge hose fitting which are normally manufactured from zinc plated steel. [sic]

Figure 12b: Evidence of corrosion

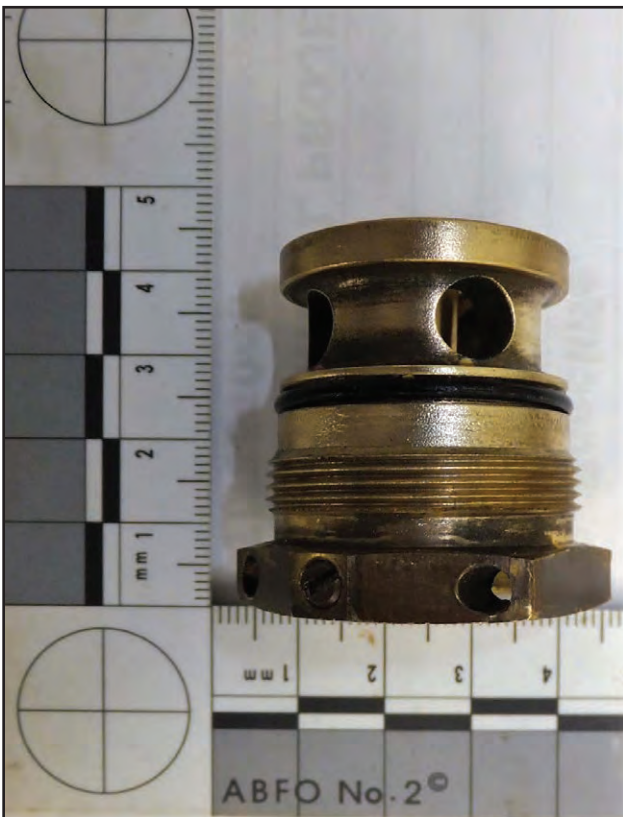
The report also noted that *the bonnet assembly showed signs of pitting associated with being cleaned with a wire wheel, or similar. The valve had obviously been disassembled previously during its service life* (**Figure 12c**).

Figure 12c: Evidence of cleaning with wire wheel

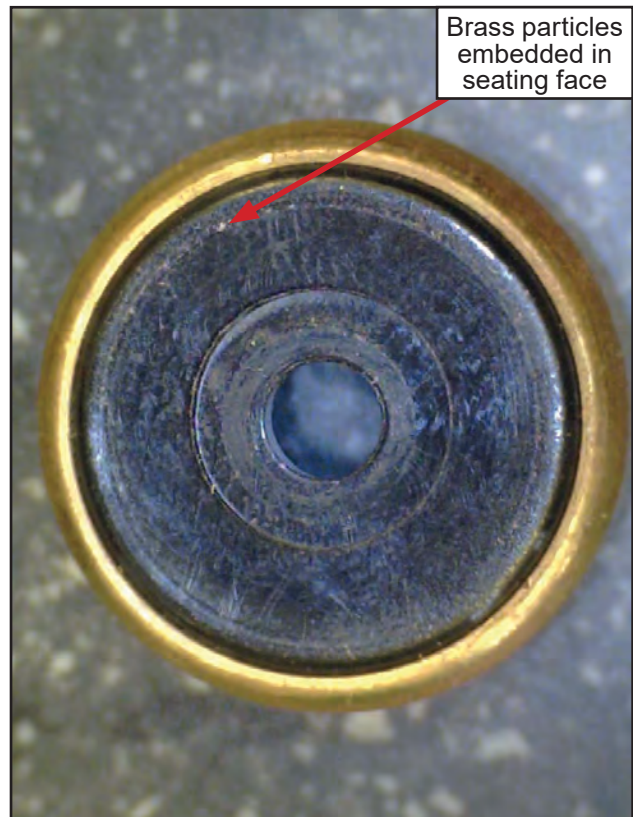
With regard to the source of the leak, the seating area of the valve seat was found to have small particles, subsequently identified as brass, embedded in it (**Figure 12d**). The DAB report stated:

From experience, this brass swarf was the most likely cause of the leak. The leak however, was so slight that it would have taken many months if not longer for the leak to build up pressure inside the manifold and discharge the system.

Figure 12d: Brass particles embedded in seating face
