## **Air Quality and Dust Monitoring Monthly Report – July 2018**

**Three Rivers District Council**

A report prepared by Osborne on behalf of HS2 Ltd.

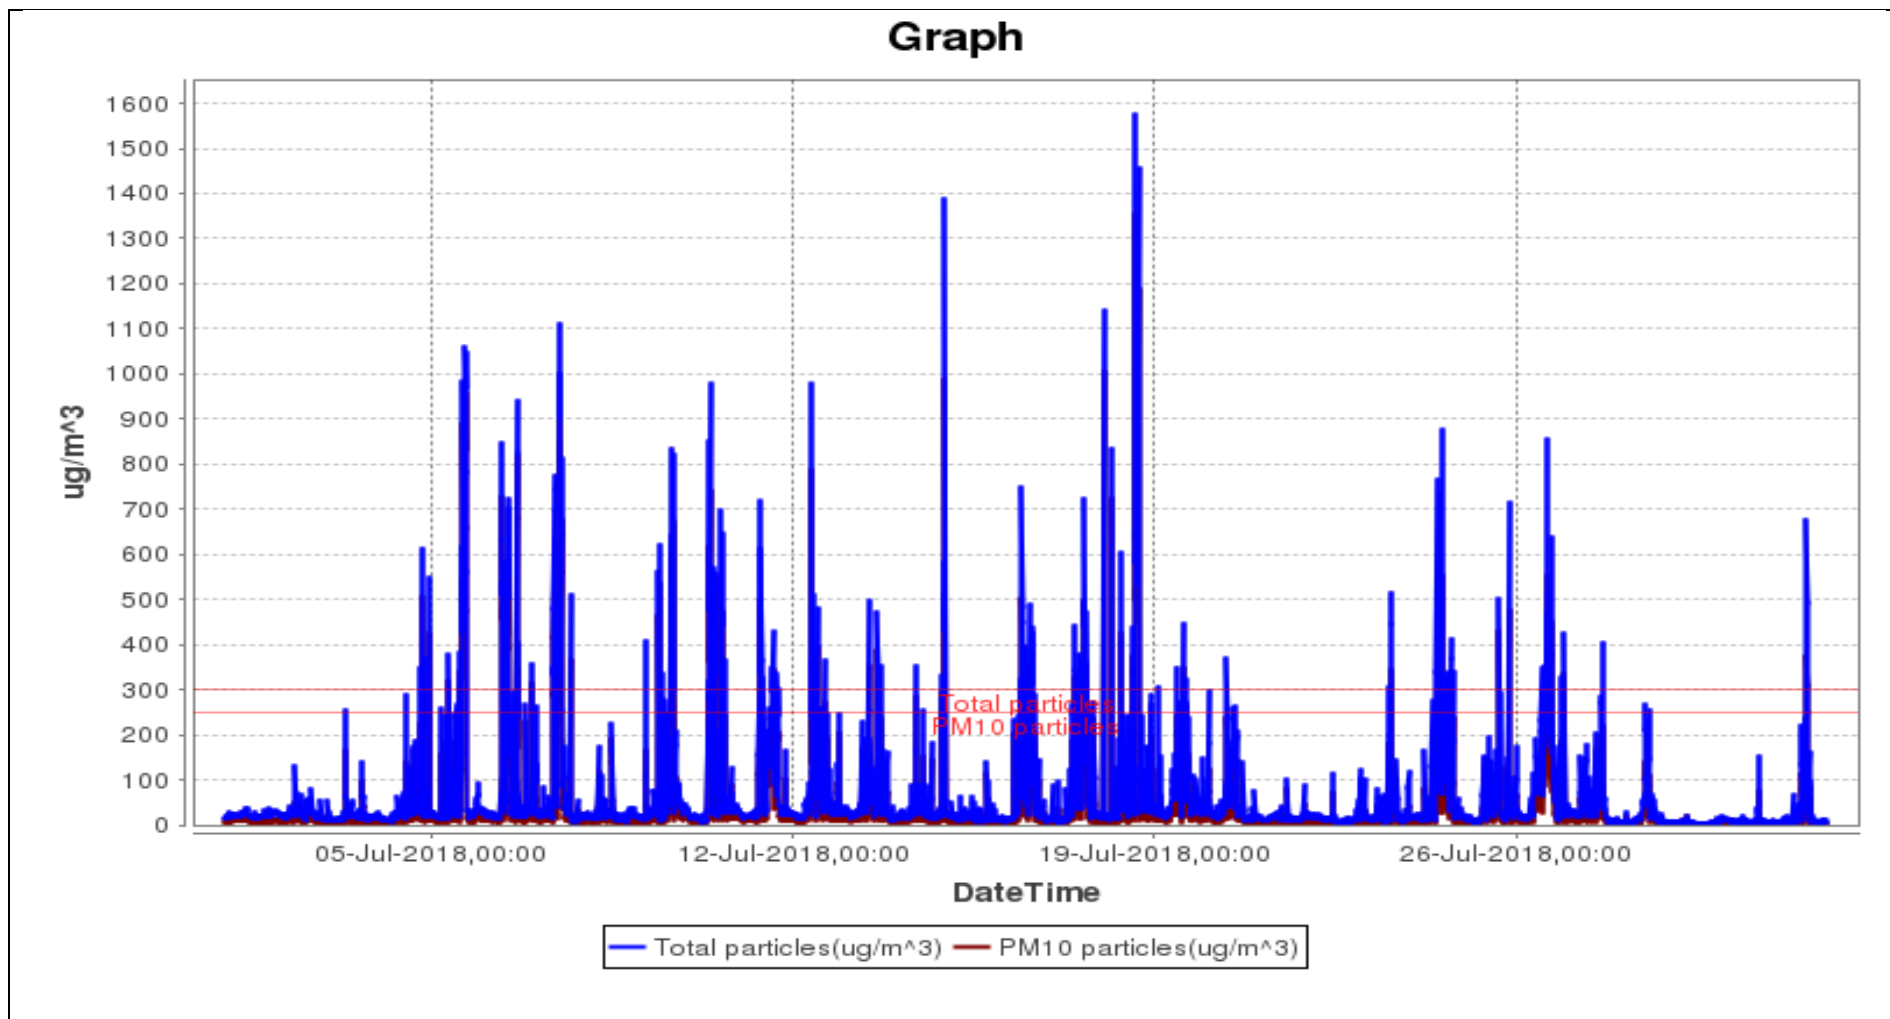
Figure 3: Construction dust 15-minute mean indicative PM<sub>10</sub> concentration for dust monitors

- 1.1.7 One hundred and twenty-seven (127) exceedances of the dust trigger level were recorded during the July 2018 monitoring period, as detailed in Appendix B, Table 2. Osborne works in Chalfont Lane re-commenced on 19<sup>th</sup> July (following the transfer of land south of Chalfont Lane from Affinity Water to Highways England). Exceedances prior to this date were attributed to prolonged dry weather periods coupled with Kier's construction activities and vehicle movements along the access haul route through this field.

- 1.1.8 There are also several exceedances relating to windy conditions which resulted in the generation of dust plumes/ swirls through the vastly open field south of Chalfont Lane, blowing directly across the monitor. Kier, working on behalf of Affinity Water, and Osborne are automatically notified of each exceedance to conduct further investigations and implement mitigation measures where the cause is associated to construction works. Osborne are unable to confirm what, if any, mitigation measures were implemented by Kier for their works where the monitor was triggered. Osborne mitigation measures throughout the July period are detailed within the context of this report.

- 1.1.9 From July 19<sup>th</sup> onward, Osborne have been undertaking bulk earthworks from Sunnyhill Road down to Denham Way (within the vicinity of the designated medium-risk receptors where the dust monitor has been positioned). Osborne have employed a tractor and bowser to spray water along the length of Chalfont Lane (specifically, the access route to/ from this works area and targeting the stockpile locations) and address the work areas themselves. The mitigation measures executed by Osborne have successfully mitigated dust trigger exceedances associated with Osborne works. On occasions where the water spraying measures dried out in the hot temperatures faster than anticipated and resulted in a monitor alert, Osborne responded with additional dampening measures to address the dust generation.

- 1.1.10 At the end of July 2018, Osborne began to provide supportive dust suppressant measures to address Kier work zones in an attempt to reduce construction related dust generation along the haul road. The notable decline in trigger alerts can be attributed to the completion and de-mobilization of the Kier contractor from site coupled with increased and targeted water spraying efforts.
