Tram overspeeding on a curve, Sheffield, 19 July 2018

Important Safety Messages

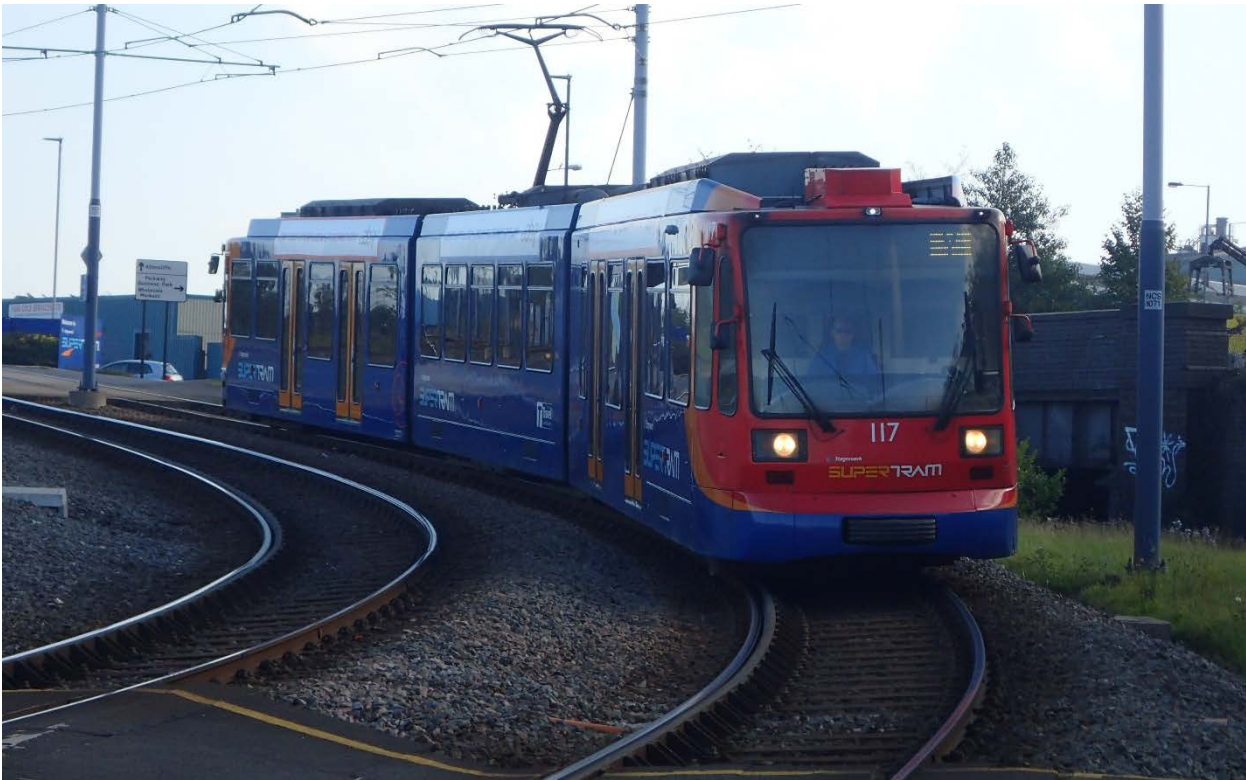
Tram 117, the tram involved in the incident. Photograph not taken at Middlewood.

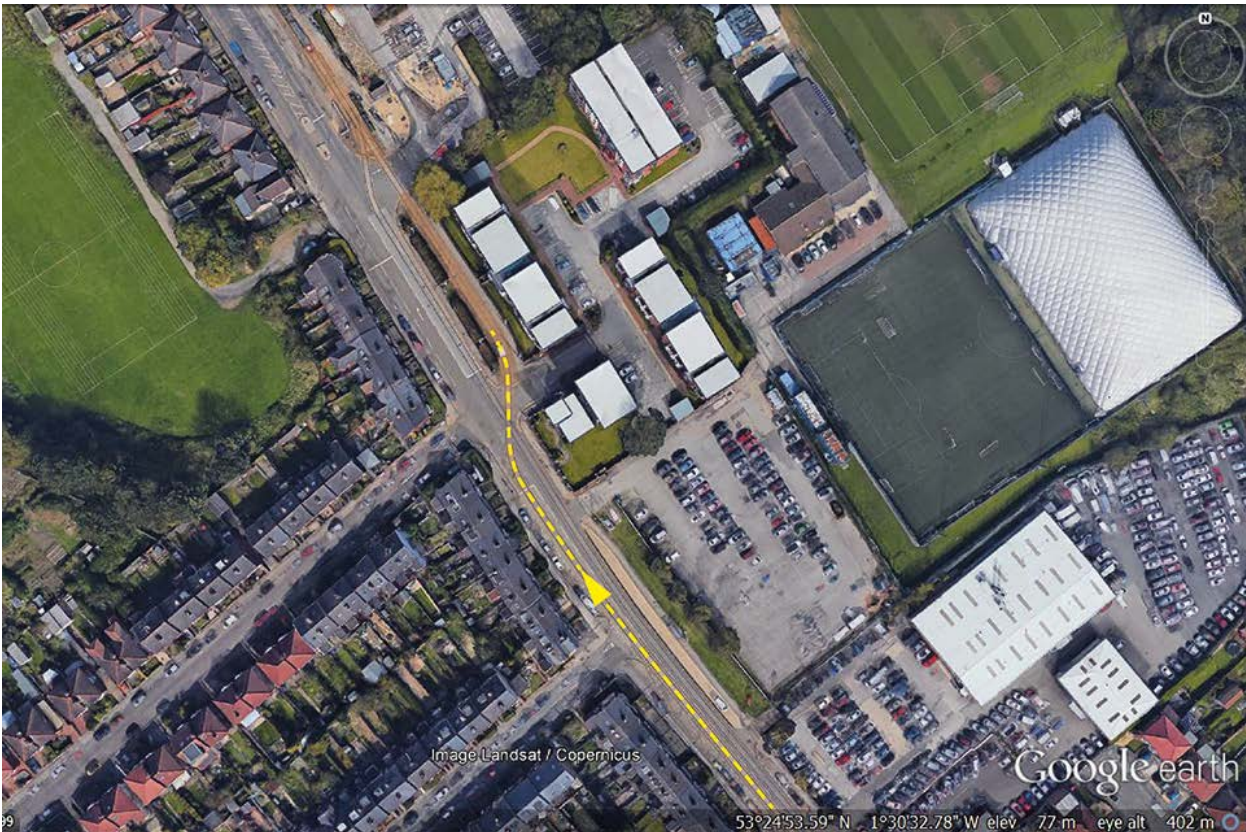
The track layout immediately before the Middlewood terminus includes a reverse curve. This allows trams travelling outbound, away from Sheffield city centre, to cross Middlewood Road and enter a holding area, clear from other road traffic. Due to the tight radius of these curves, a permanent speed restriction of 10 mph (16 km/h) applies at this location.

Middlewood terminus, showing the reverse curve and the direction of travel of tram 117

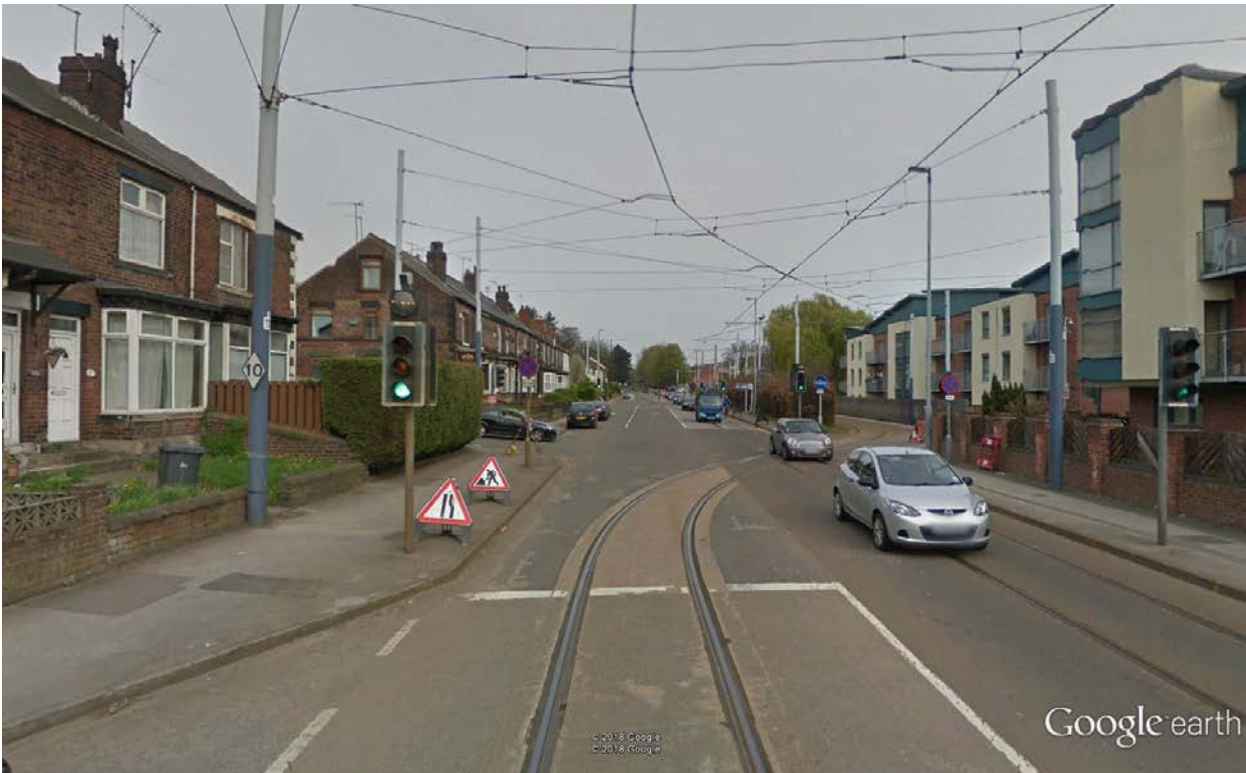
The incident occurred because the tram driver lost awareness of where the tram was in relation to the curve. Consequently, he did not progressively reduce the tram speed down to the 10 mph (16 km/h) speed limit at the start of the curve on approach to Middlewood terminus. Drivers are reliant on their trained knowledge of the tram system to be aware of their location, and hence the appropriate speed. A sign to remind drivers of the reduced speed limit is provided at the start of the curve, but there were no advance markers relating to the reduction in permissible speed preceding this.

Approaching Middlewood terminus, viewed in the direction of travel of the tram. The 10 mph speed restriction sign can be seen on the blue pole to the left.

Since the incident, Stagecoach Supertram reports that it has implemented a 'step down' speed restriction of 20 mph (32 km/h) approximately 100 metres before the start of the curve at Middlewood, and advised its drivers accordingly. It has also identified another on-street curve with similar characteristics to the incident location and introduced a step down speed restriction there.

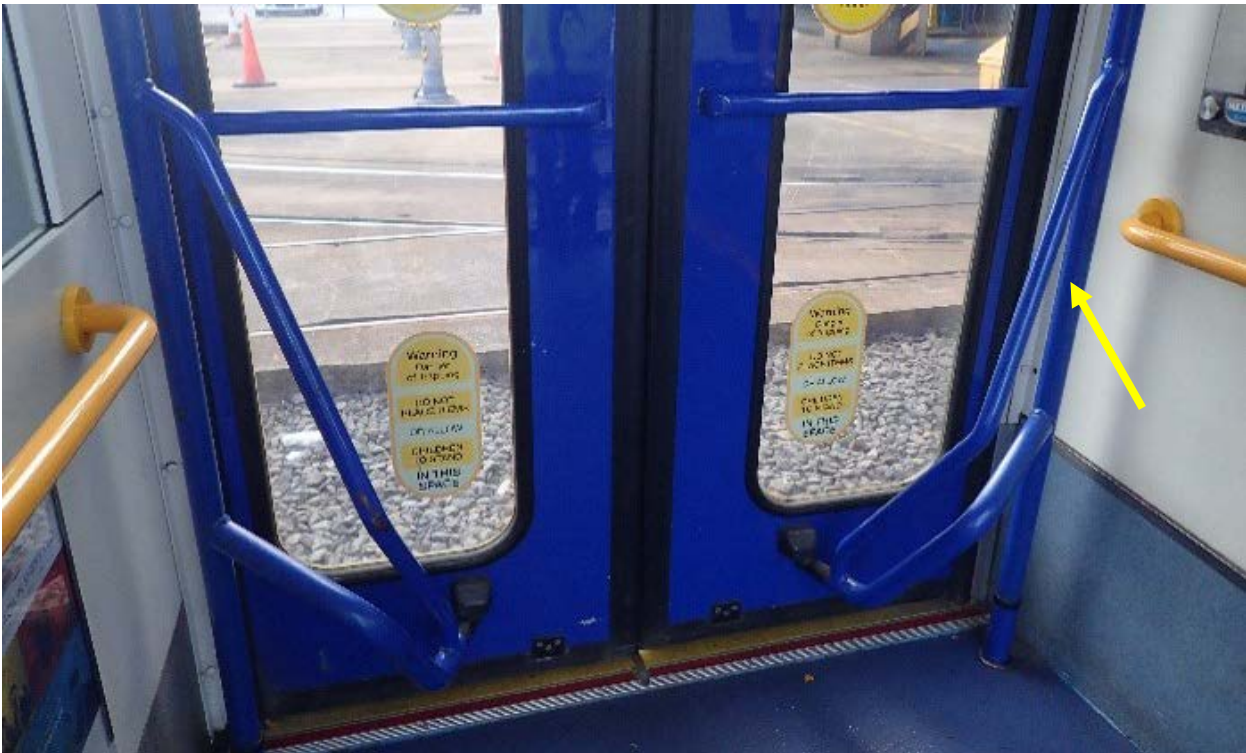
The doors fitted to this type of tram are of the 'swing plug' type. Each tram has four doorways on each side, and there are two door leaves at each doorway. Opening and closing the door leaves is effected by a vertical rotating shaft connected to each door leaf. An air-powered actuator is connected to the top of each vertical shaft by a ball joint. Actuation of the air cylinder causes rotation of the shaft and the door to open or close. Mechanisms within the door system lock the door when closed, and also detect when the door is correctly closed and locked.

The doors on a Sheffield tram. The rotating vertical shaft is arrowed yellow

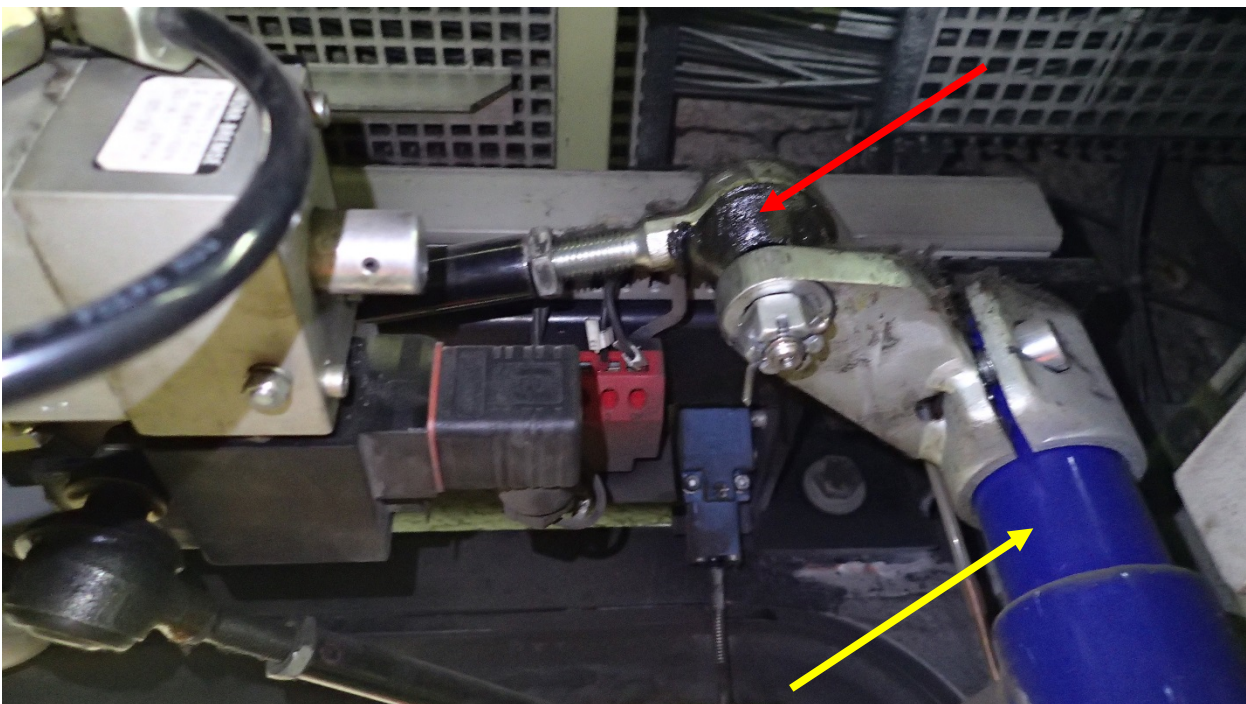
When the passenger was thrown against the door, the connection between the ball joint and the vertical shaft fractured. The arrangement of the door mechanism is such that failure of this ball joint disconnected the vertical rotating shaft and its corresponding door leaf from the locking mechanism. The door leaf then became free to open.

Part of the door operating mechanism. The rotating vertical shaft is arrowed yellow. The ball joint which failed is arrowed red.

Stagecoach Supertram have commenced a programme to check the condition of all the ball joints fitted to these doors. Work is also underway to develop an alternative design. It is believed that the Sheffield Supertrams are the only UK tram to use this design of door system.
