Rail Accident Report

**Extensive track damage between Ferryside and Llangennech, Carmarthenshire
30 October 2017**

Report 17/2018
v2 February 2023

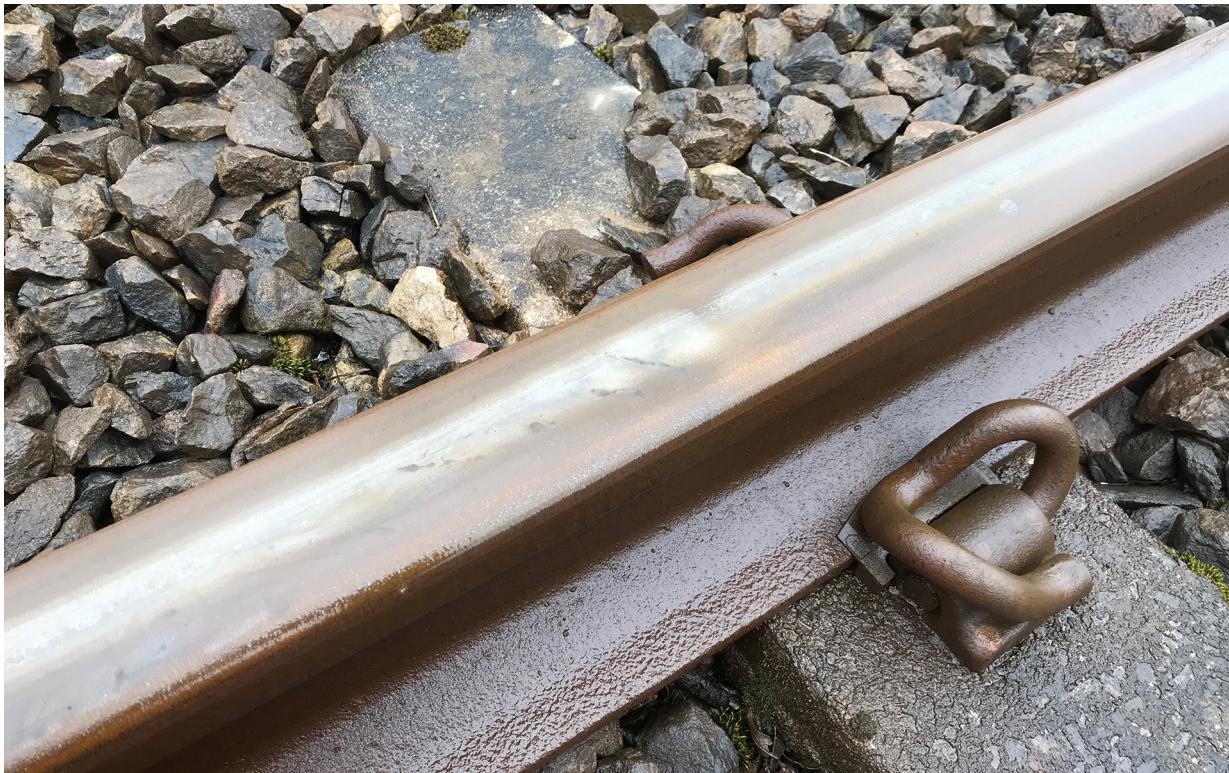
- 33 At 06:32 hrs, the train passed through a 20 mph (32 km/h) permanent speed restriction, starting 40.5 miles (65.2 km) from Robeston, shortly after passing Carmarthen Junction. After the accident track maintenance staff found the first signs of damage on the rail head at 41.6 miles (67.0 km) (figure 4). This damage continued along the route of the train and was consistent with impacts from the wheel flats that were subsequently discovered on the wheels of wagon GERS89009.

Figure 4: Rail head damage (six foot rail) 43.2 miles (69.5 km) from Robeston, still visible in April 2018

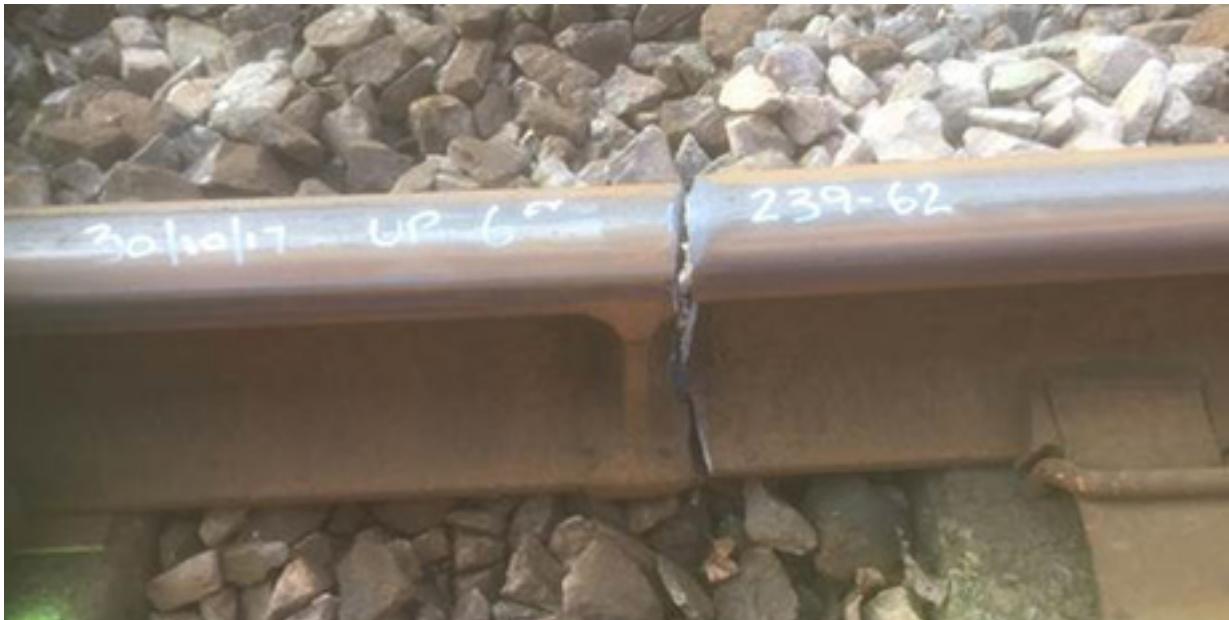
- 34 The first broken rail occurred at 44.9 miles (72.2 km), adjacent to a welded rail joint (figure 5). There are no track circuits at this location, so the fault was not apparent to the signaller. Train 6B13 passed this location at 06:40 hrs.

Figure 5: Broken weld 44.9 miles (72.2 km) from Robeston (courtesy Network Rail)

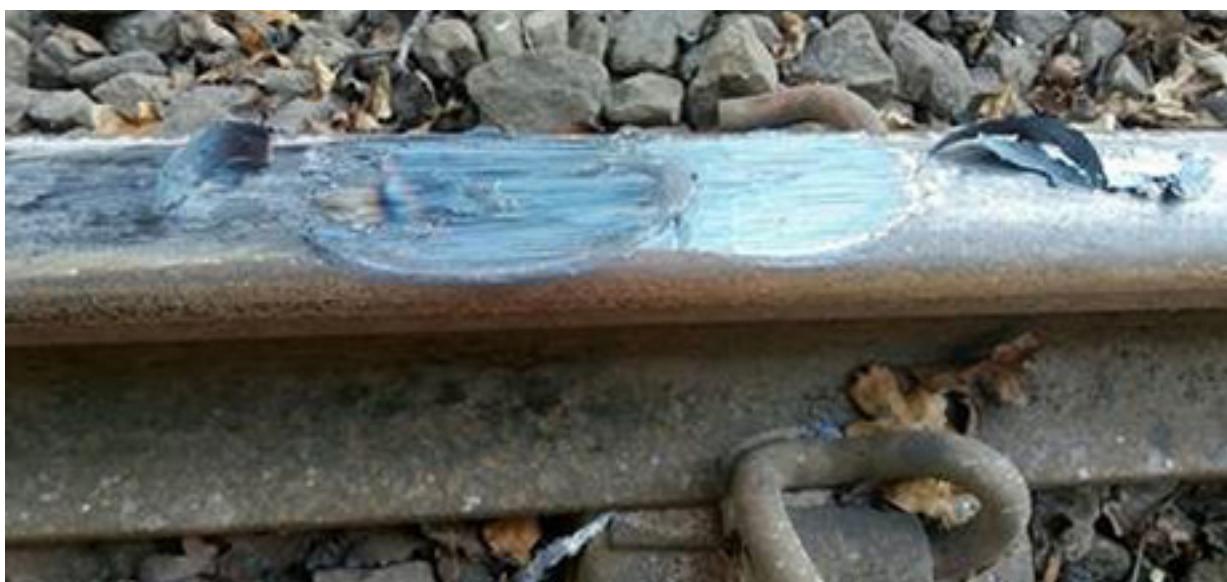
Figure 7: Damage to the rail head 67.2 miles (108.1 km) from Robeston (courtesy Network Rail)

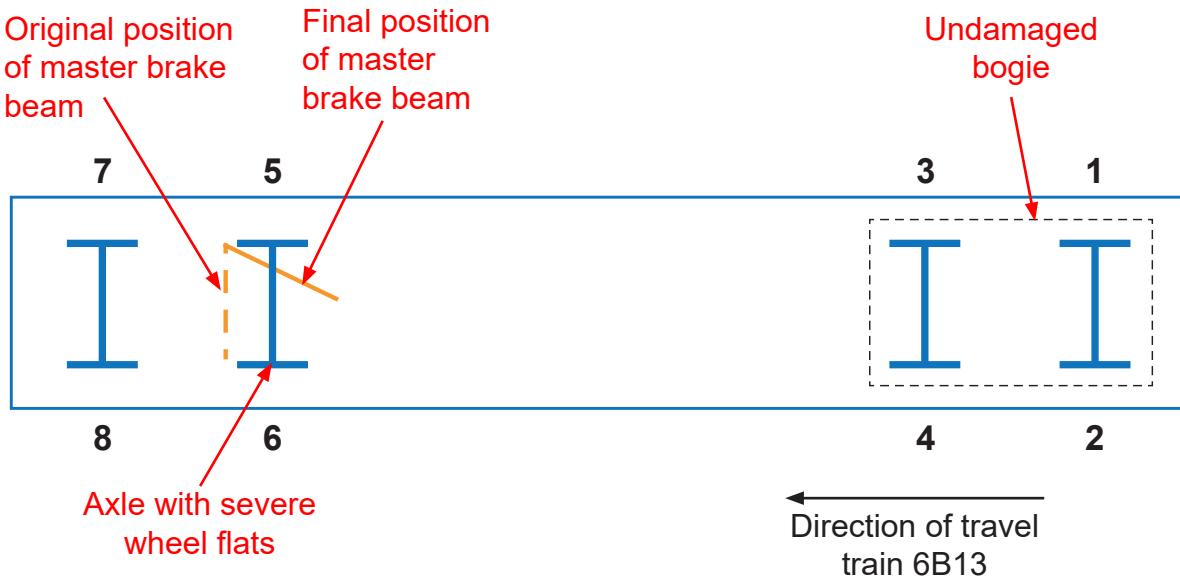
- 45 The driver of the train contacted the signaller at 08:21 hrs to advise him that the brake frame (actually the master brake beam, see paragraph 52) under the leading wagon had collapsed and was dragging under the train (figure 8).

Figure 8: Schematic of wagon GERS89009 showing wheel numbering in black, and the final position of the master brake beam

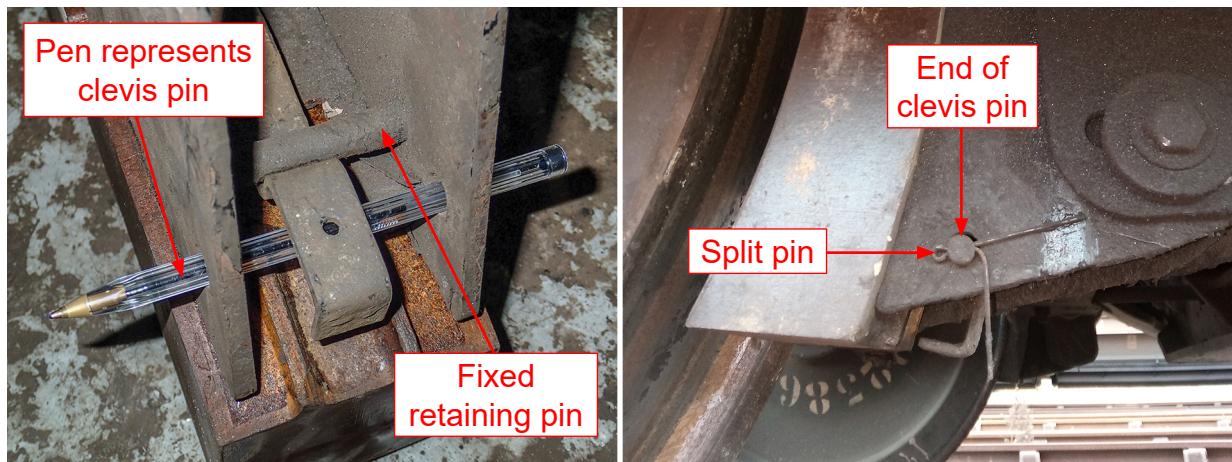
Figure 13: Arrangement of brake block, block holder, key and clevis pin; the right-hand image shows wheel position 1 on the trailing bogie of wagon GERS89009 after the accident (courtesy DB Cargo)

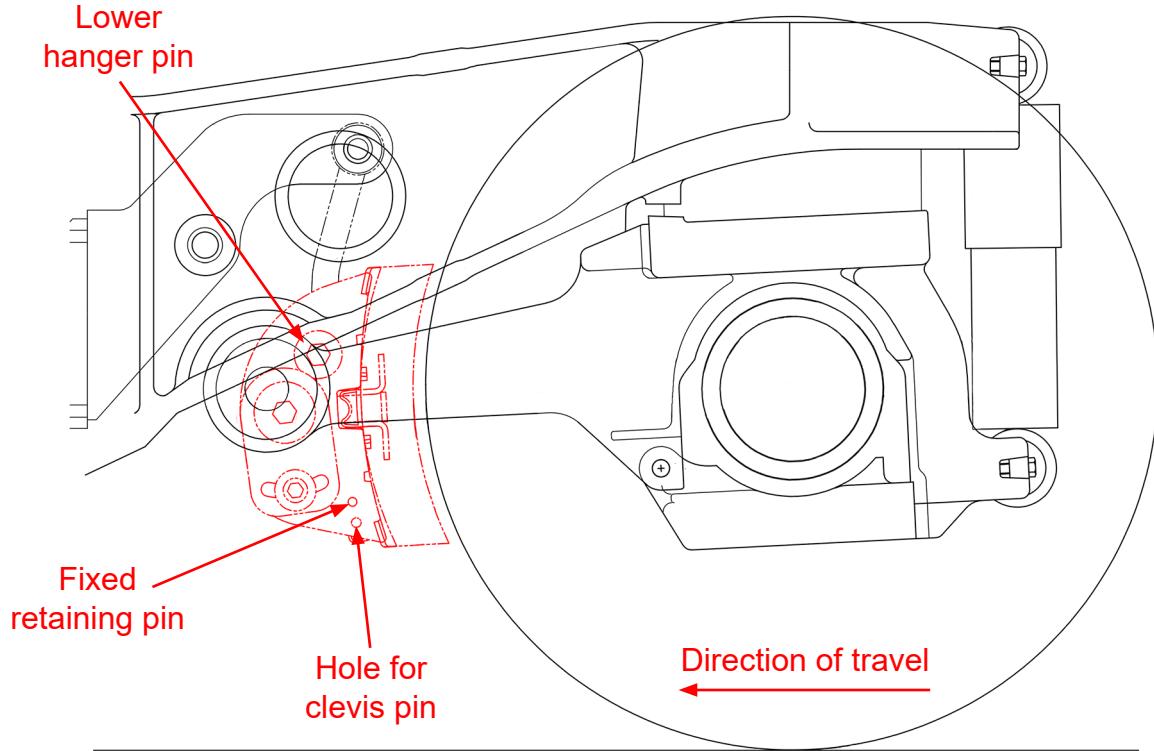
- 61 The lower hanger pin at wheel position 6 had sheared (paragraph D10, appendix D), allowing the end of the master brake beam to break free. The associated block holder was pulled apart and the head of the hanger pin, together with part of the brake block holder, has not been found.

Figure 15: View of bogie at wheel position 6 (block holder and brake block shown in red) (based on a drawing supplied by Wabtec Faiveley)

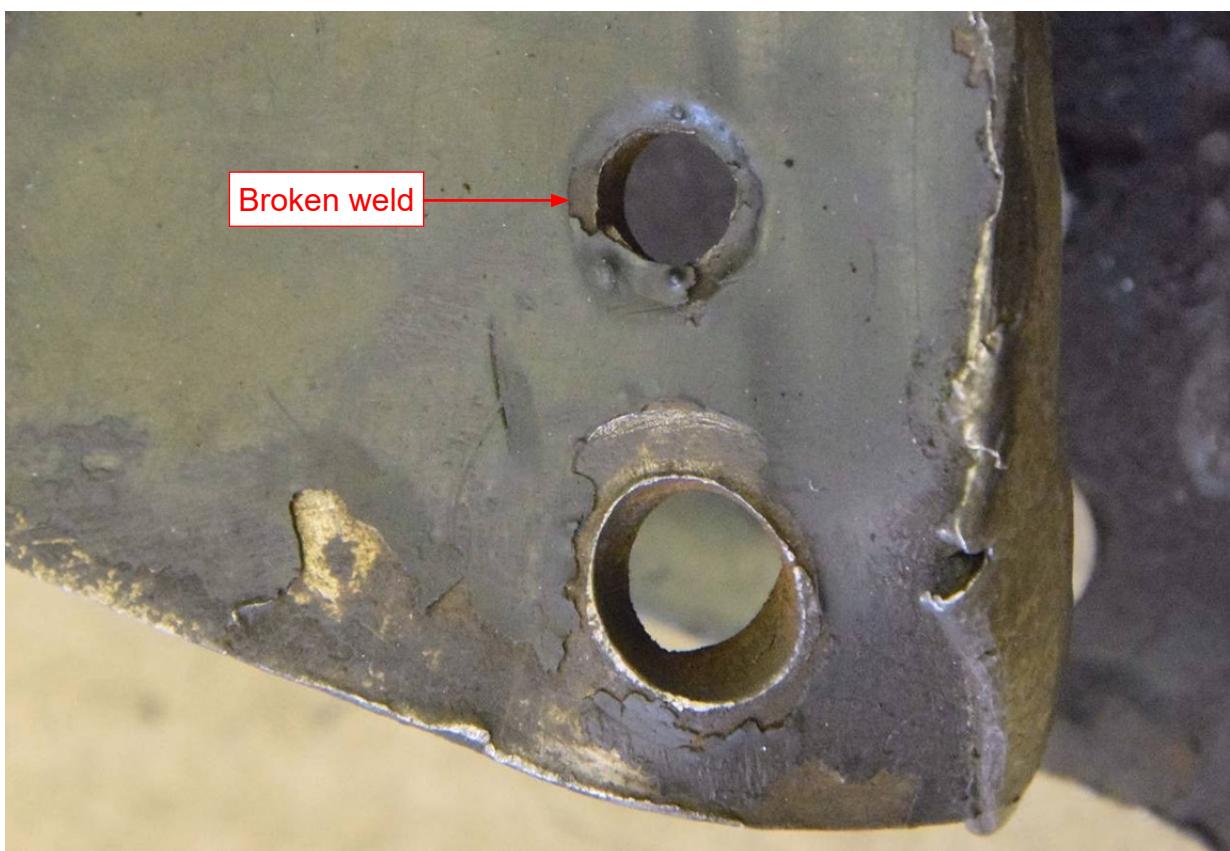
- 80 The fixed retaining pins that form part of the mechanism for attaching the brake blocks were missing from the block holders on the second wheelset of bogie 2741 (paragraph D9, appendix D). If one or both of these pins had fallen out, the associated key could also fall out and the brake block would no longer be restrained.
- 81 While the block holder from wheel position 6 (figure 8) was destroyed, accounting for the loss of that retaining pin, the block holder from wheel position 5 remained intact. The welds that secured the pin in position had failed (compare figure 16 with figure 14).

Figure 16: Inside corner of block holder from wheel position 5 (courtesy Serco Rail Technical Services)

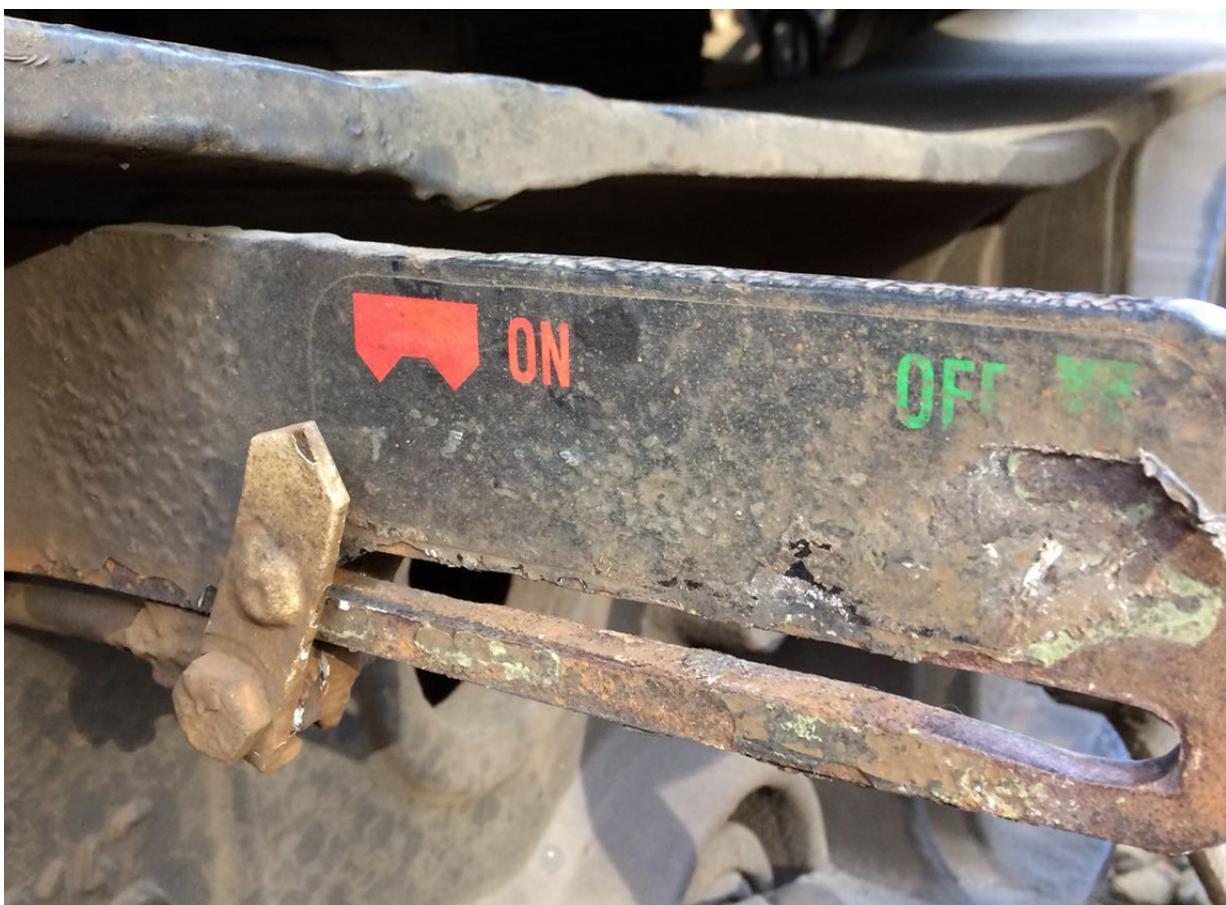
- 84 Wagon handbrakes that have been left on have been causal factors in previous accidents (eg the freight train derailment at Hatherley on 18 October 2005, [RAIB report 08/2006](#)), which is one reason for roll-by examinations such as that carried out as train 6B13 left Robeston (paragraph 32). Wagons are provided with tell-tale indicators showing the status of the handbrake.

Figure 17: Handbrake indicator on wagon GERS89009 after the accident (courtesy Network Rail)

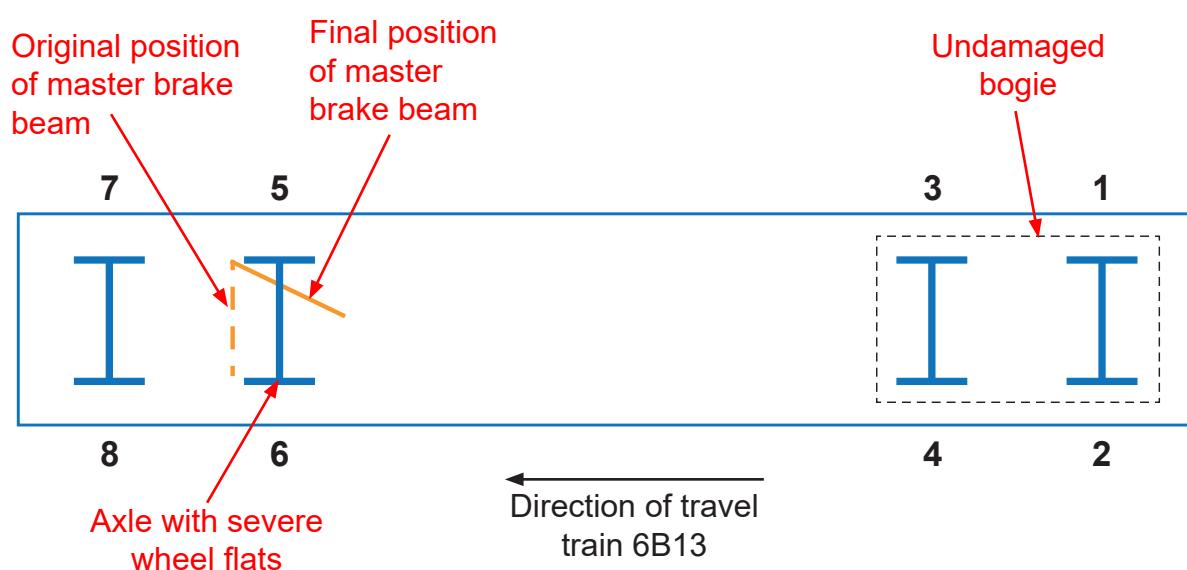
- D1 After train 6B13 was moved to Margam (paragraph 46), wagon GERS89009 was detached and held for examination. The diesel fuel was drained from the wagon on 8 January 2018, allowing the wagon to be lifted and the damaged leading bogie, no. 2741, to be swapped on 25 January. The bogie was then taken to Axiom Rail (Wabtec Faiveley) at Stoke on Trent, where it was examined by representatives of Touax Rail, DB Cargo, Wabtec Faiveley, Serco, ORR and RAIB on 13 February.
- D2 Examination of the bogie revealed that the lower left-hand hanger pin had sheared on the master brake beam, allowing the end of the brake beam to break free. The right-hand hanger was still intact, although twisted, and had pulled the partially detached beam along the four foot (figure D1).

Figure D1: Schematic of wagon GERS89009 showing wheel numbering and the final position of the master brake beam

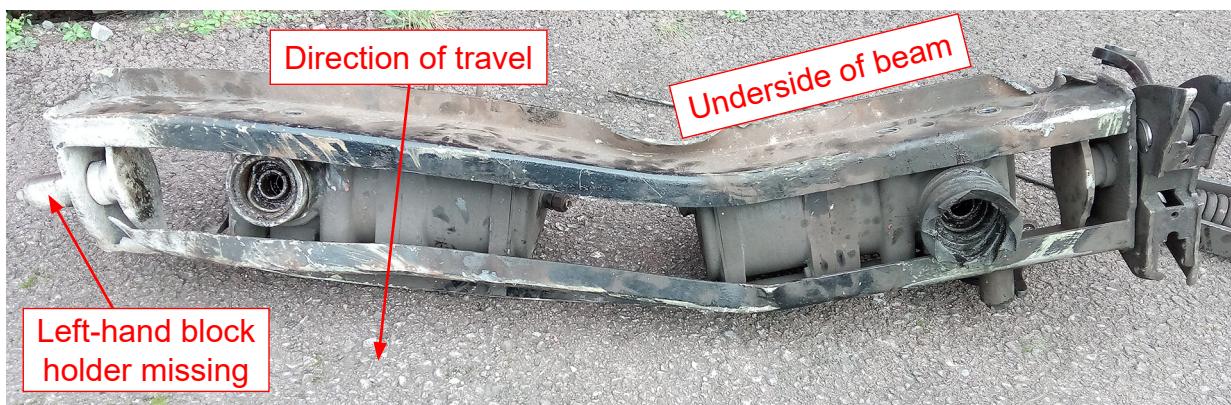
- D3 The master brake beam had bent around the middle (figure D2). The bending was consistent with the beam having come into contact with the trailing axle of the bogie while bouncing along at speed under the wagon. The left-hand block holder (wheel position 6) was missing from the end of the beam; part of it (the outer face) was later found 62.1 miles (100.0 km) from Robeston.

Figure D2: Master brake beam from bogie 2741 (courtesy DB Cargo)

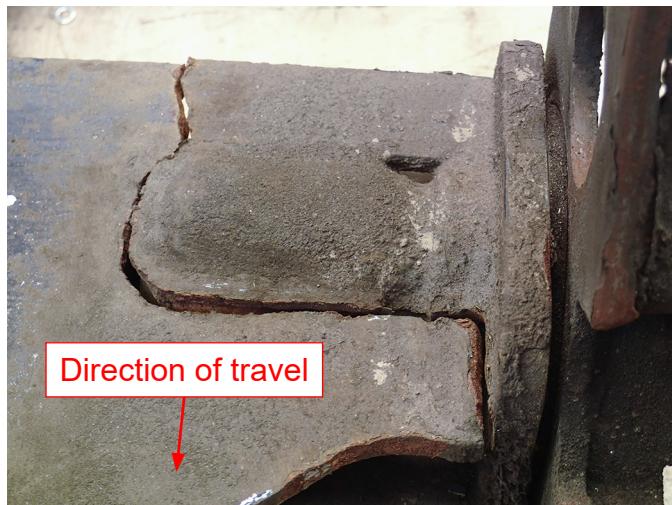
- D4 The welded joint at the left-hand end of the slave brake beam was found to be cracked adjacent to the block holder (figure D3).

Figure D3: Cracking of slave brake beam at wheel position 8

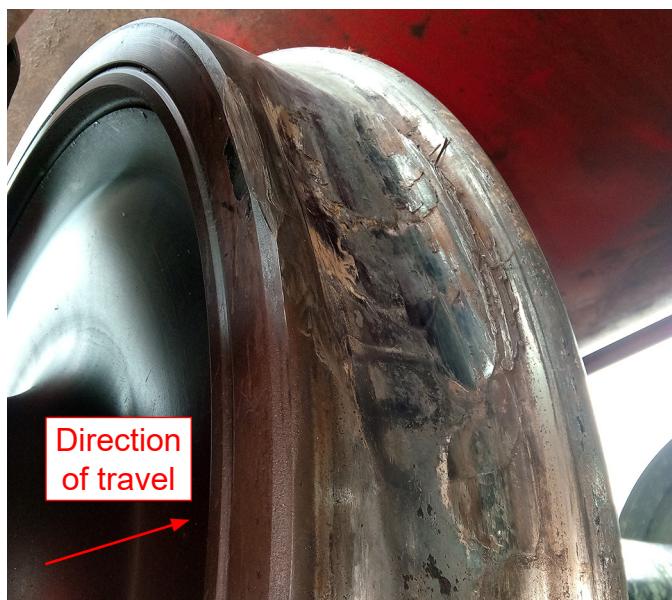
- D5 The second wheelset (wheel positions 5 and 6) of bogie 2741 had wheel flats approximately 250 mm long and 10 mm deep (figure D4). The size of the flats is consistent with the wheels having slid an estimated 5 to 10 miles (8 to 16 km) while the wagon was fully laden with a 25 tonne axle load. The marks on the rail head (paragraph 33) and the broken rails over the following 22 miles (36 km) indicate that the second wheelset had started turning again approximately 42 miles (67 km) from Robeston.

Figure D4: Flat on wheel at position 5 (courtesy DB Cargo)

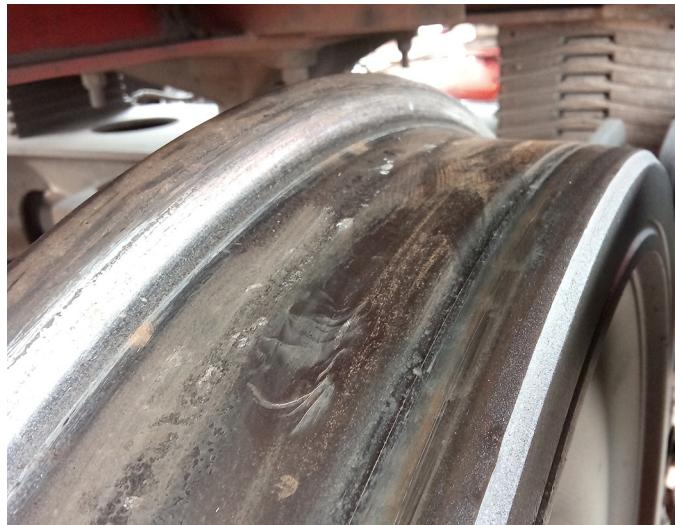
- D6 DB Cargo examined the wheelsets from bogie 2741 after the accident. In addition to the severe flats on the wheels at positions 5 and 6, there was also a small flat spot on the wheel at position 8 (figure D5). This was probably pre-existing and unrelated to the accident (paragraph 89).

Figure D5: Flat on wheel at position 8 (courtesy DB Cargo)

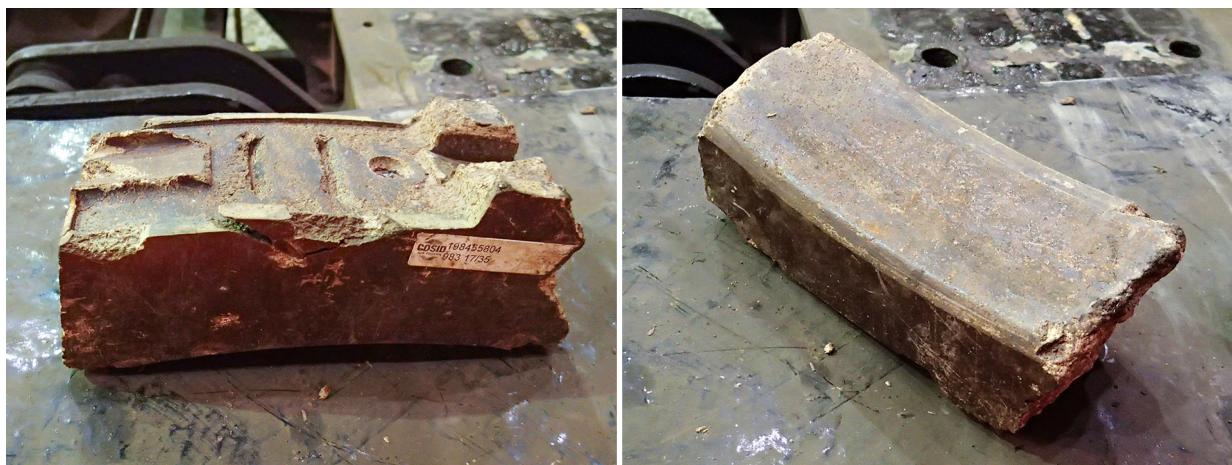
- D7 The brake blocks were missing from all four wheels on bogie 2741, together with the keys and clevis pins (paragraphs 54 and 55). Part of a brake block was found 43.6 miles (70.2 km) from Robeston; this was 2.0 miles (3.2 km) after the start of damage to the rail head (paragraph 33). This was only lightly worn, indicating that it had recently been fitted to a vehicle (figure D6); the label records that it had been manufactured in the week commencing 28 August 2017. It is the same type of block as that fitted to wagon GERS89009 on 27 October 2017, which is not used on any passenger vehicles that operate in the Carmarthen area. No other brake blocks have been found that might have come from bogie 2741.

Figure D6: Brake block fragment found 4 miles (7 km) east of Carmarthen

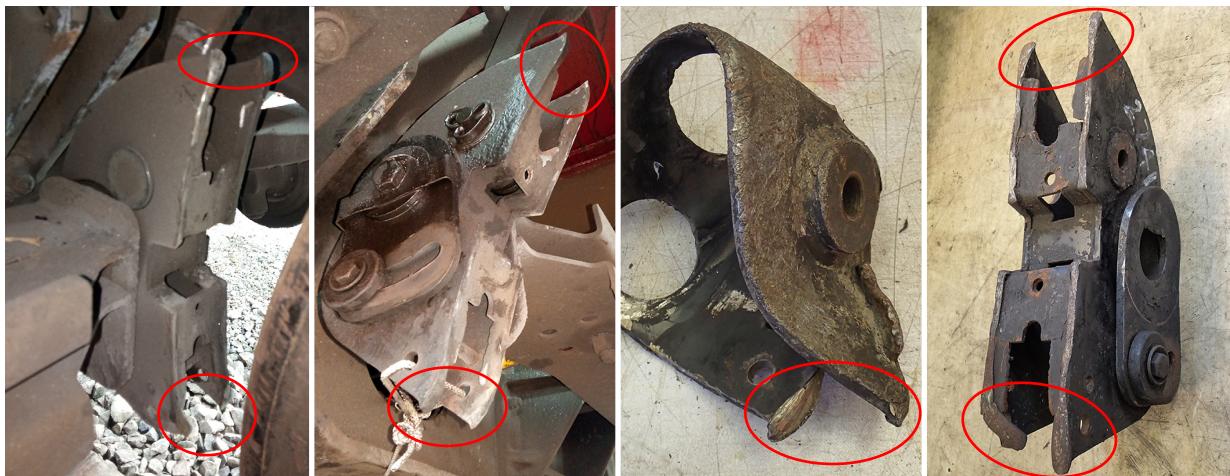
- D8 The corners of all block holders from both wheelsets were worn (figure D7). This indicates that the block holders had been in contact with the rotating wheels with no brake blocks present. Measurements of the wear made by Serco indicate that the block holders from the master brake beam were more severely worn than those from the slave beam, and the bottom of each block holder was worn more than the top.

Figure D7: Brake block holders from wheel positions 8, 7 (both courtesy DB Cargo), 6 and 5 with worn corners indicated

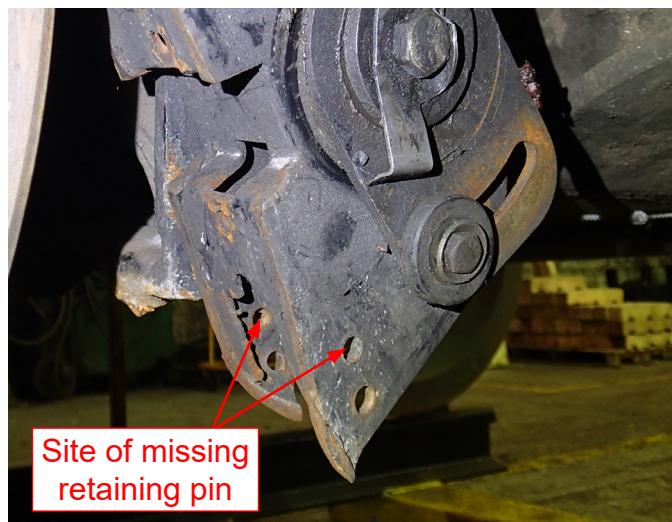
D9 The fixed retaining pins, that together with the clevis pin (figure 13) hold the brake block key in place, were missing from the damaged block holders on the second wheelset. The block holder from wheel position 6 had been torn in two, probably causing failure of the welded joints at the ends of the retaining pin. However, the retaining pin was also missing from the block holder at wheel position 5 (figure D8), which remained intact although distorted.

Figure D8: Brake block holder from wheel position 5

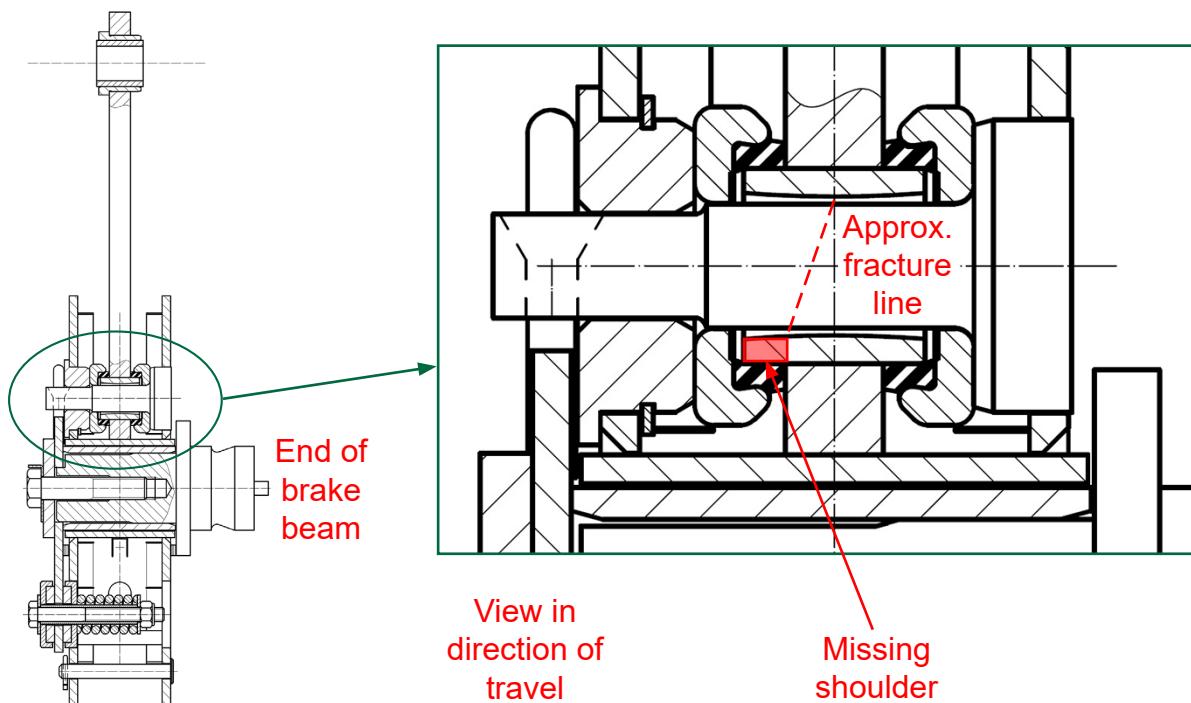
D10 The lower left-hand hanger pin (at wheel position 6) had sheared, and the corresponding shoulder of the hanger bush was damaged (figure D9). Only the outer half of the block holder has been found on the track, together with the tail of the hanger pin; the rest of the block holder and the head of the pin are missing.

Figure D9: Section through brake hanger from wheel position 6; inset showing lower hanger pin (courtesy Wabtec Faiveley)

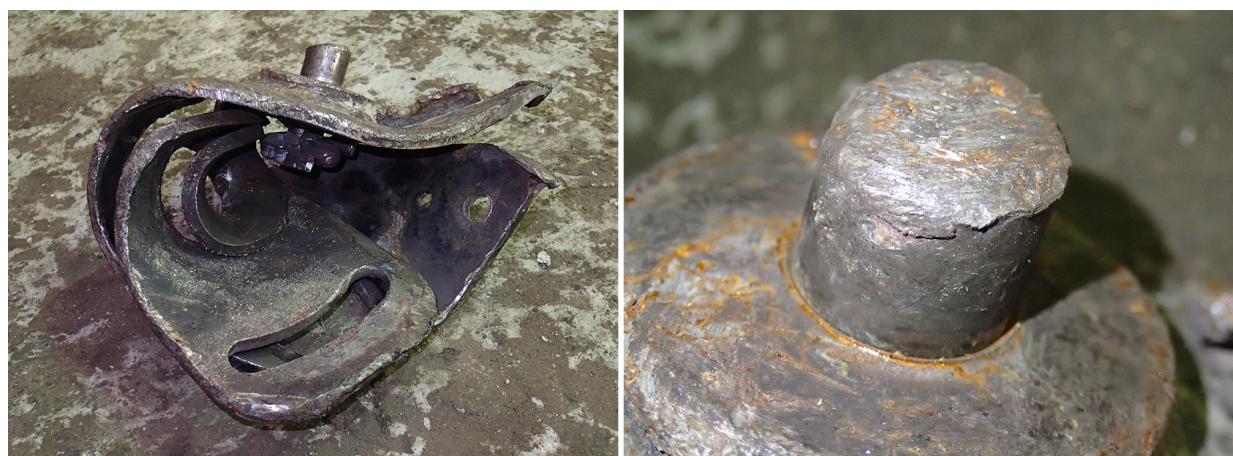
D11 Serco Rail Technical Services carried out a metallographic examination of the remains of the hanger pin. Serco concluded that, although the fracture surface of the pin was too badly damaged to determine the cause of the failure, the angled fracture (figure D10) indicated it had been overloaded in bending and shear. Conversely, failure due to fatigue would probably have resulted in a perpendicular fracture.

Figure D10: Remains of block holder from wheel position 6 and close up of fractured hanger pin

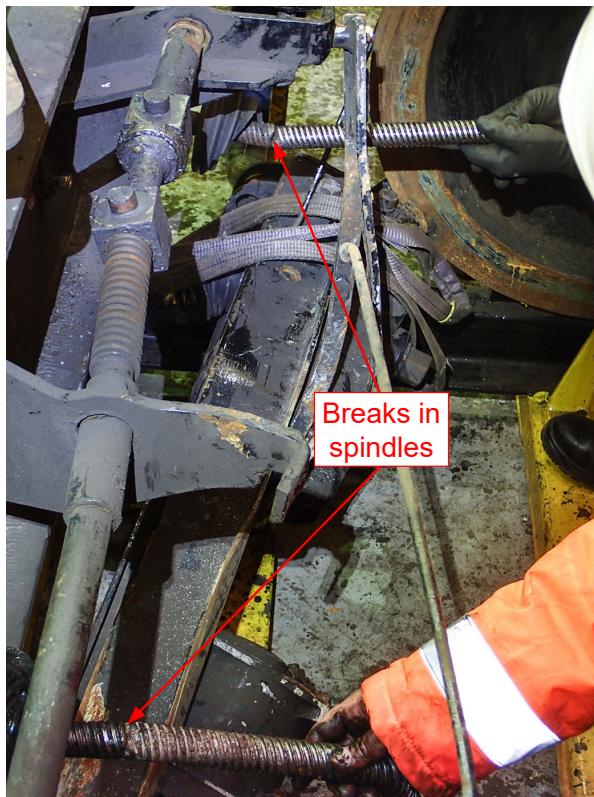
Figure D11: Reconstruction of bogie 2741; the visible part of the spindles would normally be hidden within the actuators mounted on the master brake beam (the detached brake beam is visible underneath)

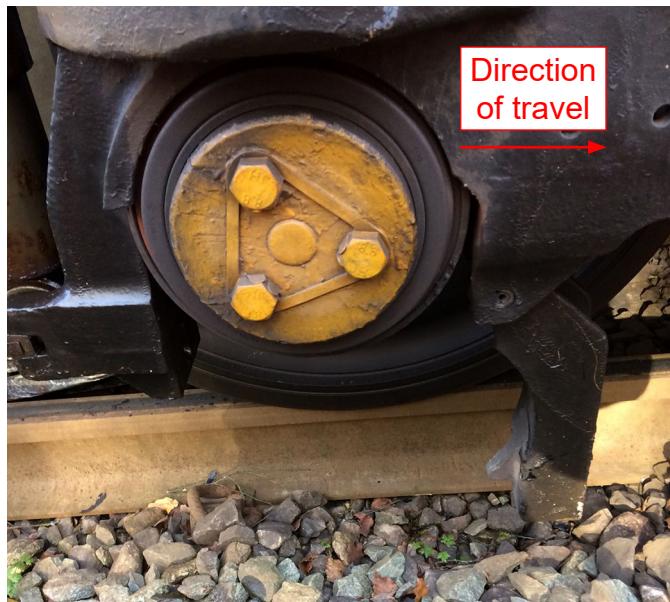
D14 The retaining bolt for the wheelset lift bracket at wheel position 5 was missing (figure D12). The bolt probably failed due to the dynamic loading caused by the wheel flats on this wheelset. The missing bolt has not been associated with any possible causal mechanism for the brake system failure on the wagon.

Figure D12: Wheelset lift bracket at wheel position 5 hanging down after the accident (courtesy Network Rail)

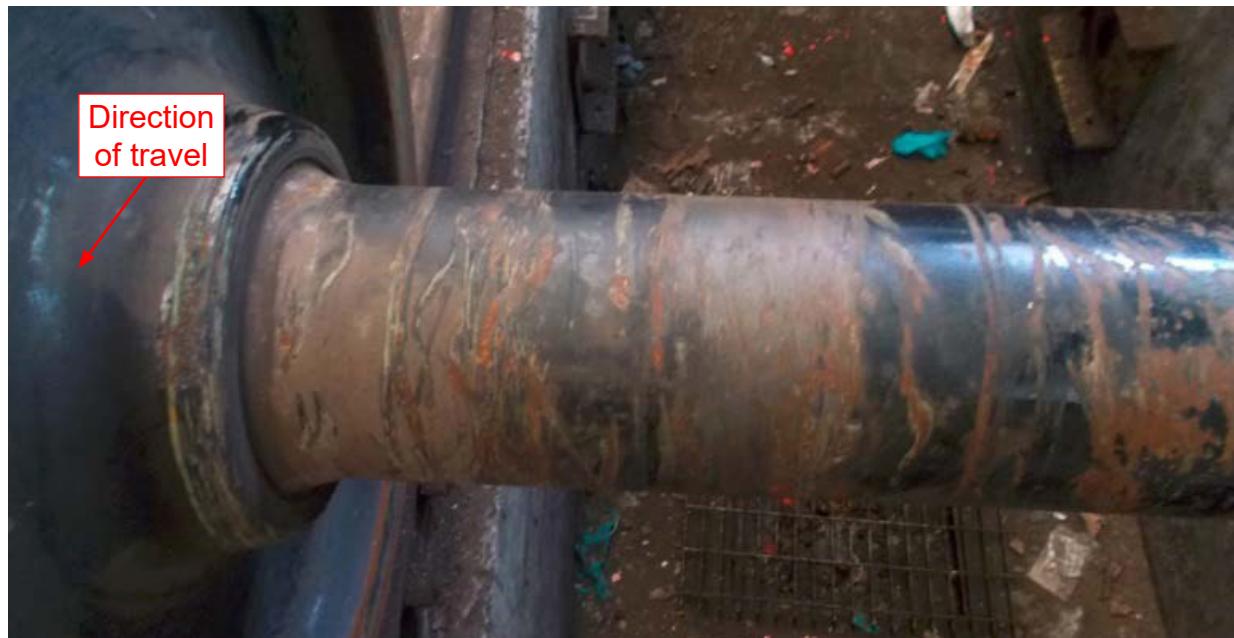
Figure D13: Evidence of rubbing contact adjacent to wheel position 5 (courtesy DB Cargo)

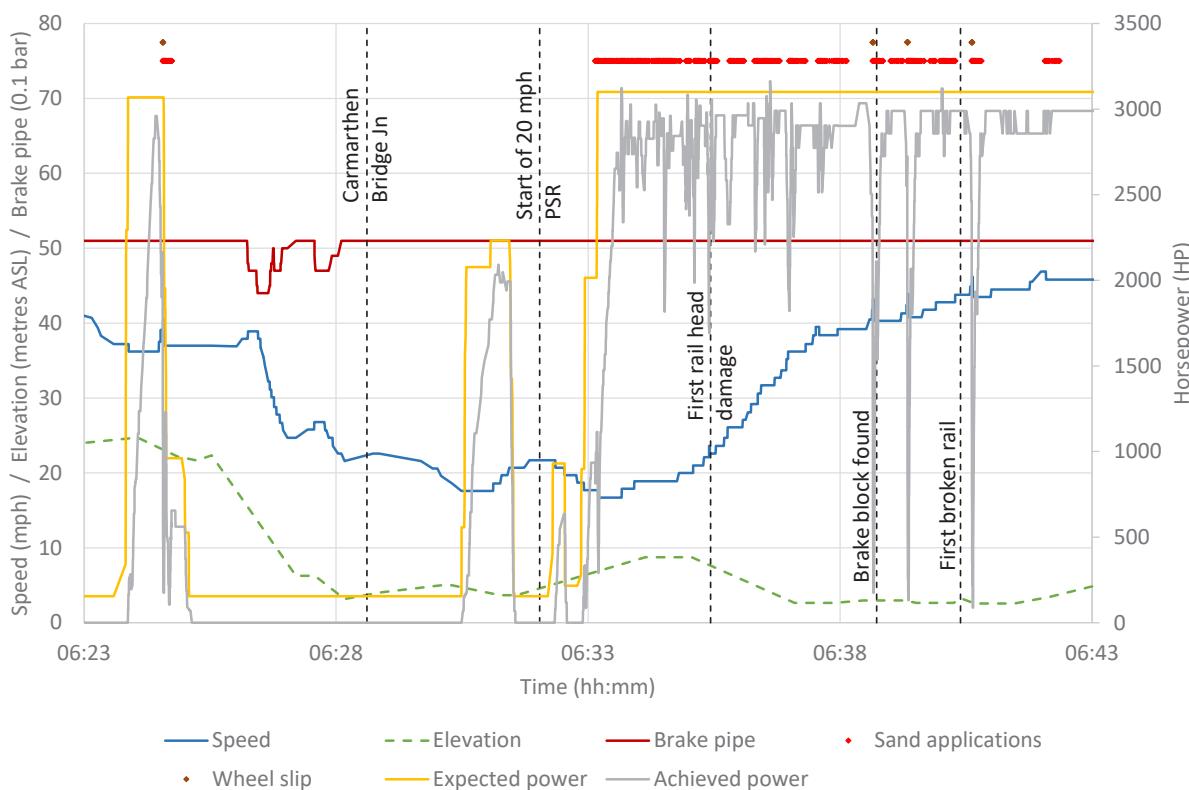
- H17 Calculations of the adhesion encountered by the locomotive while applying power through the section between Whitland and Carmarthen indicate that it was generally in the low to medium range (between 0.05 and 0.10, table H1). At the approach to the start of the railhead damage, it was in the medium range (between 0.10 and 0.15). However, at some of the locations for which wheel slip was recorded by the OTDR (figures H1 and H2), RAIB has calculated that the adhesion levels fell to less than 0.01 (very low).

Figure H2: OTDR analysis for locomotive 60001 (06:23 to 06:43 hrs on 30 October 2017).
