# Near miss with track workers at Dundee, 10 July 2018

## Summary of the incident

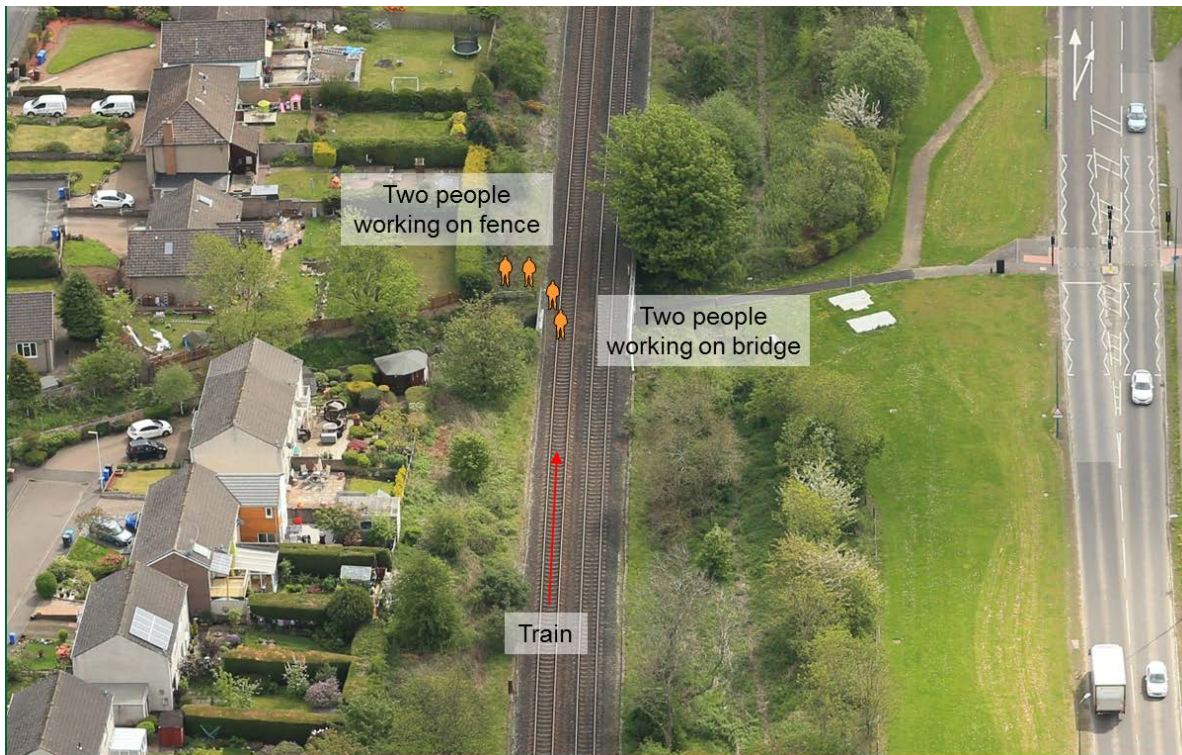
At around 00:30 hrs on Tuesday 10 July 2018, four track workers were involved in a near miss with a train about two miles west of Dundee. The track workers were working on a bridge over a footpath when the train, travelling at 72 mph (115 km/h), approached them. Two of the track workers were on the bridge at the time (the other two were working on a fence just off the railway line); one of these climbed through the bridge handrail to get clear of the train, while the other pulled himself towards the handrail, with very little space available between him and the train.

Aerial view of the location showing the bridge, the direction of the train, and the approximate locations of the four track workers at the time of the incident (adapted from an image provided by Network Rail)

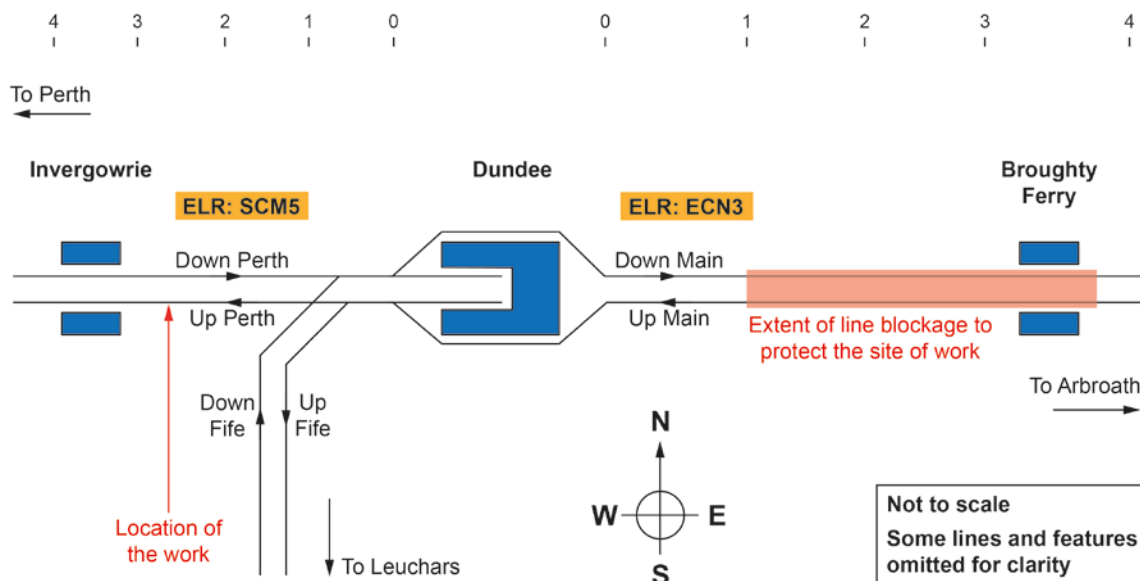
The incident occurred due to a number of people not realising that the location of the work, and the location where protection of the work from moving trains had been planned, were different. Lines had been blocked to allow the work to be carried out, but this blockage was actually about two miles east, rather than west, of Dundee station. Crucially, railway mileages increase both to the east and west of Dundee, from zero datum points either side of Dundee station. Therefore, the mileage at the site of the work appeared to be consistent with that for the blockage; however, these mileages referred to different sections of line. This confusion arose at several points in the planning process.

**Map showing the location of the bridge, the location of the line blockage, and the mileage values either side of Dundee**
