## ACCIDENT

<b>Aircraft Type and Registration:</b>	DHC-8-402 Dash 8, G-JECX
<b>No &amp; Type of Engines:</b>	2 Pratt & Whitney Canada PW150A turboprop engines
<b>Year of Manufacture:</b>	2007 (Serial no: 4155)
<b>Date &amp; Time (UTC):</b>	17 April 2018 at 1205 hrs
<b>Location:</b>	Newquay Airport, Cornwall
<b>Type of Flight:</b>	Commercial Air Transport (Passenger)
<b>Persons on Board:</b>	Crew - 4                      Passengers - 55
<b>Injuries:</b>	Crew - 1 (Minor)          Passengers - None
<b>Nature of Damage:</b>	Damage to several skin panels, frames and stringers and the aft pressure bulkhead
<b>Commander's Licence:</b>	Airline Transport Pilot's Licence
<b>Commander's Age:</b>	46 years
<b>Commander's Flying Experience:</b>	7,200 hours (of which 1,065 were on type) Last 90 days - 70 hours Last 28 days - 26 hours
<b>Information Source:</b>	Aircraft Accident Report Form submitted by the pilot and further enquires by the AAIB

## Synopsis

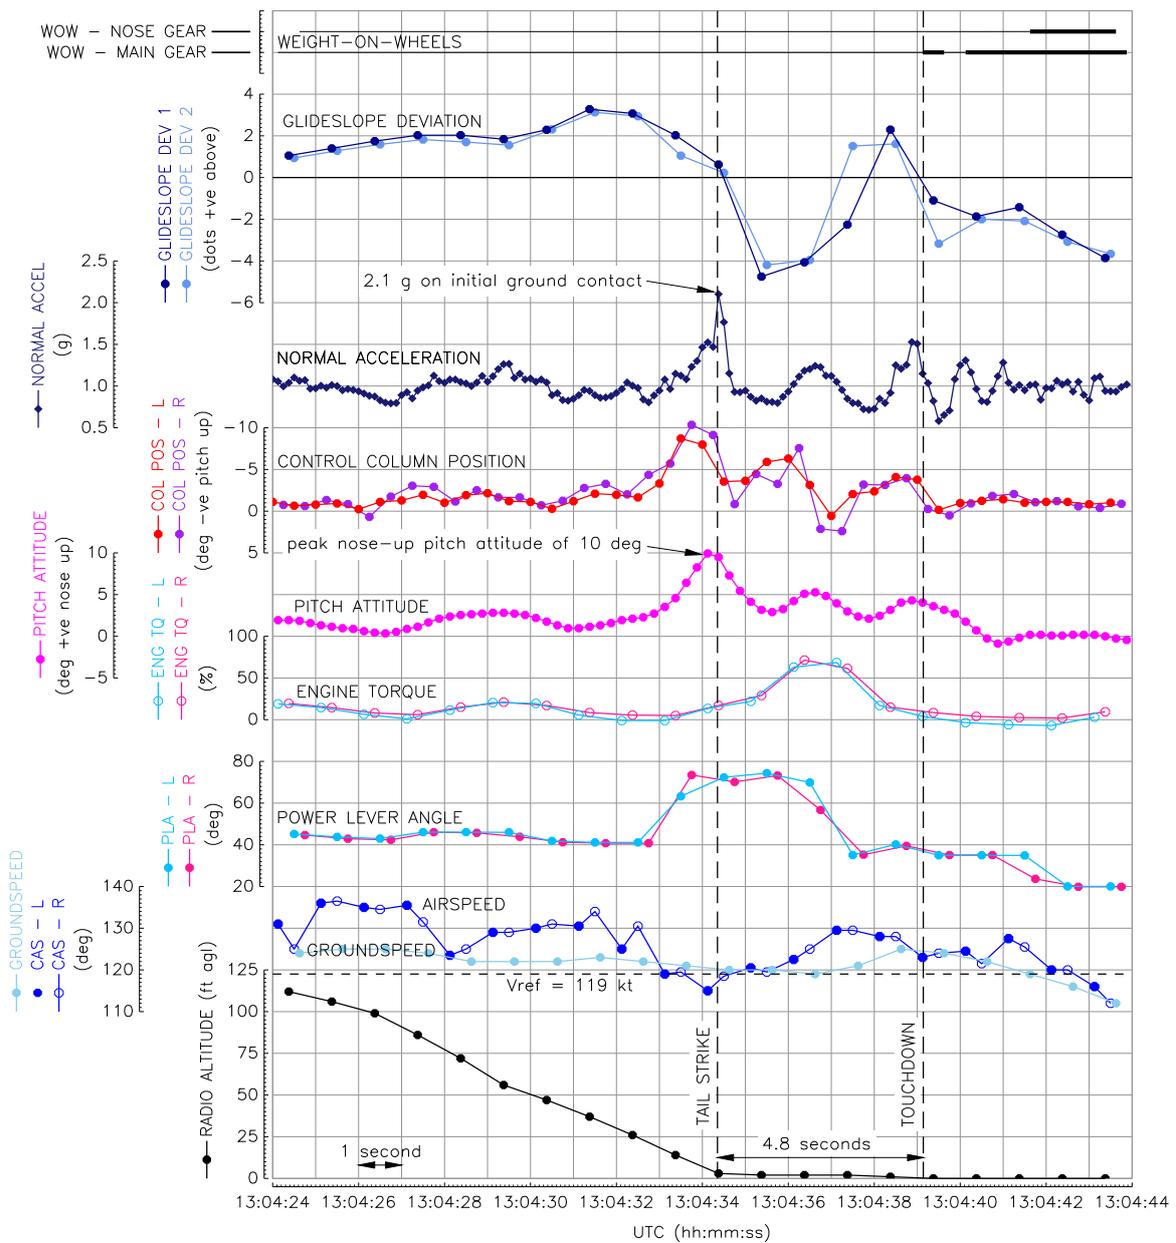
**Figure 1**  
Selected information from FDR

At approximately 100 ft, engine torque reduced corresponding to an increase in airspeed. Torque increased at approximately 80 ft as the airspeed started to reduce. Torque reduced at approximately 40 ft to idle and the airspeed reduced further. The data suggests that this corresponded with a reduction in headwind, although the sample rate is too low to determine this exactly. At approximately 20 ft power increased markedly and pitch attitude increased.

The aircraft tail touched the runway at 2.1g with the aircraft at a pitch attitude of 10° nose up. The main wheels touched down 4.8 seconds after the tail touched.

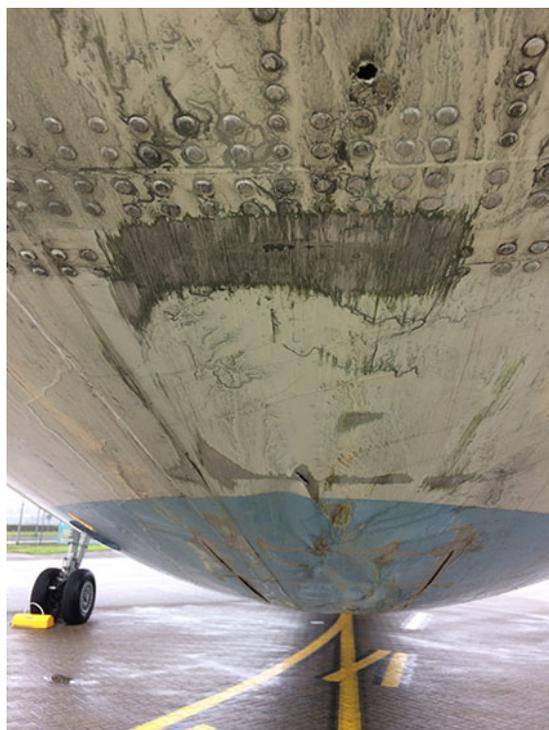
**Figure 2**  
Damage to aft fuselage

The aircraft was examined by the manufacturer. Damage was found to several skin panels, frames, stringers and aft pressure bulkhead.

The tailstrike occurred because the pilot flying reacted instinctively to the high sink rate by increasing pitch attitude and power, rather than increasing power only. The aircraft manufacturer recommends that operators provide annual recurrent training in pitch awareness for flight crew to establish the correct response to high sink rate near the ground.
