**ACCIDENT**

<b>Aircraft Type and Registration:</b>	Hapi Cygnet SF-2A, G-BRZD	
<b>No &amp; Type of Engines:</b>	1 Volkswagen 2078 piston engine	
<b>Year of Manufacture:</b>	1995 (Serial no: PFA 182-11443)	
<b>Date &amp; Time (UTC):</b>	1 August 2018 at 1400 hrs	
<b>Location:</b>	Nayland Airfield, Essex	
<b>Type of Flight:</b>	Private	
<b>Persons on Board:</b>	Crew - 1	Passengers - None
<b>Injuries:</b>	Crew - None	Passengers - N/A
<b>Nature of Damage:</b>	Substantial damage to wings, landing gear, fuselage and tailplane	
<b>Commander's Licence:</b>	Light Aircraft Pilot's Licence	
<b>Commander's Age:</b>	66 years	
<b>Commander's Flying Experience:</b>	Approximately 600 hours Last 90 days - 22 hours Last 28 days - 4 hours	
<b>Information Source:</b>	Aircraft Accident Report Form submitted by the pilot

**Synopsis**

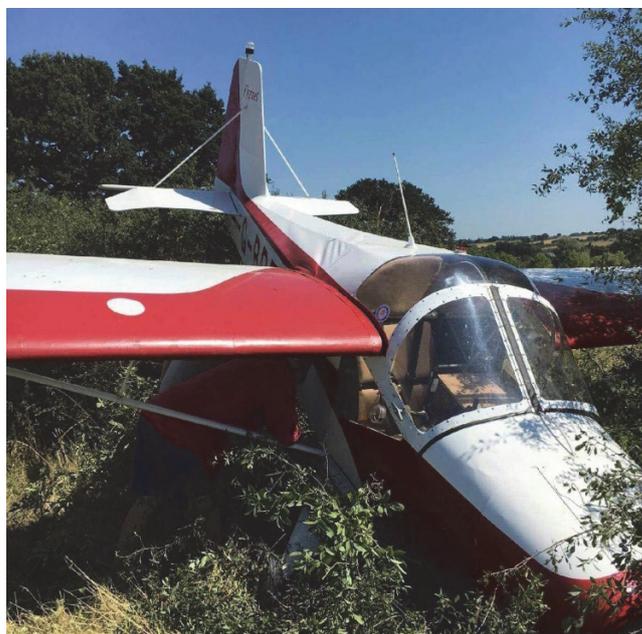
**Figure 1**

On short final, at approximately 140 ft above the ground, as the throttle was advanced the engine abruptly stopped. The pilot attempted to restart the engine by engaging the electric starter and the engine ran for a few seconds before stopping again as the throttle was advanced. By this time the aircraft had descended below the level of the trees on the approach and the pilot determined that he could not clear them, nor land in the available area before the trees. He turned right approximately 20°, flew beneath a set of power lines and aimed for a low hedge to cushion the impact. The aircraft came to rest in the hedge, Figure 1. The pilot, who was wearing a four-point harness, sustained a minor leg injury in the accident but was able to vacate the aircraft using the cockpit door. The aircraft sustained substantial damage to the wings, landing gear, fuselage and tailplane.

Accident site
