ACCIDENT

Aircraft Type and Registration:	Rotorway Executive 90, G-BZES	
No & Type of Engines:	1 Rotorway RI 162 piston engine	
Year of Manufacture:	1994 (Serial no: 6191)	
Date & Time (UTC):	1 July 2018 at 1430 hrs	
Location:	Fenland Airfield, Lincolnshire	
Type of Flight:	Private	
Persons on Board:	Crew - 1	Passengers - None
Injuries:	Crew - None	Passengers - N/A
Nature of Damage:	Extensive	
Commander's Licence:	Private Pilot's Licence	
Commander's Age:	36 years	
Commander's Flying Experience:	71 hours (of which 18 were on type) Last 90 days - 11 hours Last 28 days - 0 hours	
Information Source:	Aircraft Accident Report Form submitted by the pilot and subsequent enquiries by the AAIB

Synopsis

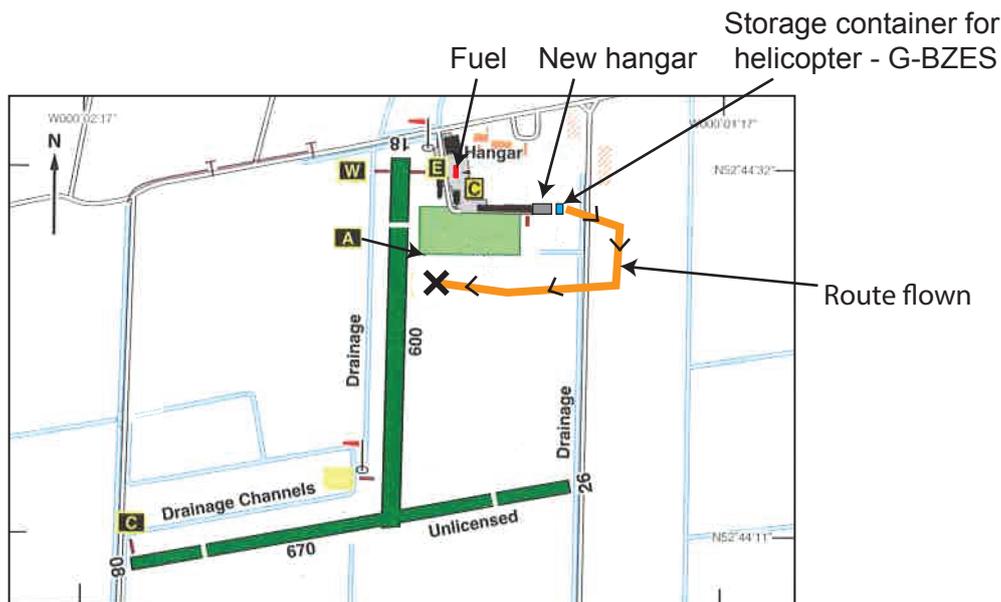
Figure 1

Diagram of accident flight path, as provided by the pilot, superimposed on amended plate from Pooleys Flight Guide

The pilot stated that he wished to refuel the helicopter which was stored at the eastern end of the hangars, within the roped-off area. The refuelling facility was to the north-west of the hangar complex (Figure 1). He arranged with an airfield steward to keep bystanders well away whilst he was starting up and preparing to lift.

In order to access the refuelling facility, the pilot found it necessary to fly to Holding Point 'A', to the west-south-west of the point of departure. He planned to remain there in the hover whilst he established movement information from the Air-Ground radio and confirmed that it was acceptable to fly over the northern end of Runway 18/36, not in use that day, but where aircraft were parked.

The wind was reported as being easterly, at 12 kt. The pilot lifted off and departed in an approximately easterly direction, before turning onto a southerly heading, remaining just outside the airfield boundary. He then turned onto an approximately westerly heading towards Holding Point 'A'. Thus, he was initially travelling into-wind, before turning crosswind and then proceeding downwind. In subsequent discussion, he stated that he did not go to a great height.
