ACCIDENT

Aircraft Type and Registration:	Mainair Blade, G-CCZW	
No & Type of Engines:	1 Rotax 582-2V piston engine	
Year of Manufacture:	2004 (Serial no: 1368-0904-7-W1163)	
Date & Time (UTC):	20 May 2018 at 1900 hrs	
Location:	Headon Airstrip, near Gamston, Nottinghamshire	
Type of Flight:	Private	
Persons on Board:	Crew - 1	Passengers - 1
Injuries:	Crew - None	Passengers - None
Nature of Damage:	Minor damage to the left wing and to the pod/ trike unit	
Commander's Licence:	National Private Pilot's Licence	
Commander's Age:	51 years	
Commander's Flying Experience:	71 hours (of which 71 were on type) Last 90 days - 4 hours Last 28 days - 4 hours	
Information Source:	Aircraft Accident Report Form submitted by the pilot and Airstrip details provided by the Airstrip owner

Synopsis

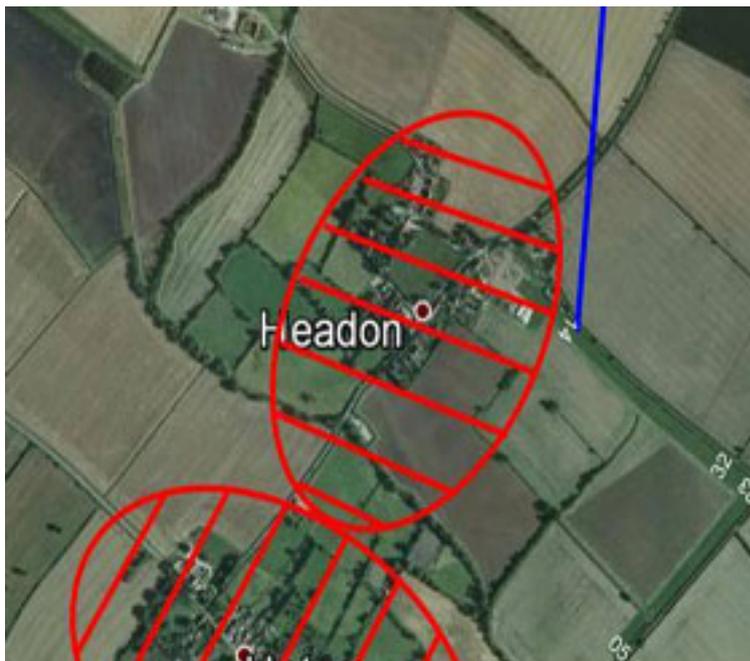
Figure 1

In view of the local noise sensitive areas, the airstrip owner’s website recommended an offset approach to Runway 14, and highlighted the presence of trees along the northern boundary. A diagram on the website had superimposed numerals, which indicated a displaced threshold for use following a 40° offset approach (Figure 1), but a video on the website showed the approach which a microlight pilot should aim for. This suggested flying a track of 170°, so offset 30° left of the centreline, until just prior to crossing the boundary hedge, where aircraft should start turning left (towards 140°). The video showed an aircraft which touched down slightly beyond the midpoint of the runway.

Part of the website diagram, with areas to avoid shown in red and with a blue line representing the suggested offset approach towards the superimposed '14' numerals. The numerals painted on the ground are in reality not as large and are nearer the northwestern end of the runway.

The airstrip owner states that since this accident occurred, the trees on the northern boundary have been removed and the recommended approach has been modified to reduce the offset angle to 20° or less. The website is to be amended accordingly and a new video added in due course.
