Report on the investigation of heavy contact  
with the quay and two shore cranes  
by the UK registered container ship  
***CMA CGM Centaurus***  
at Jebel Ali, United Arab Emirates

4 May 2017

SERIOUS MARINE CASUALTY

REPORT NO 17/2018

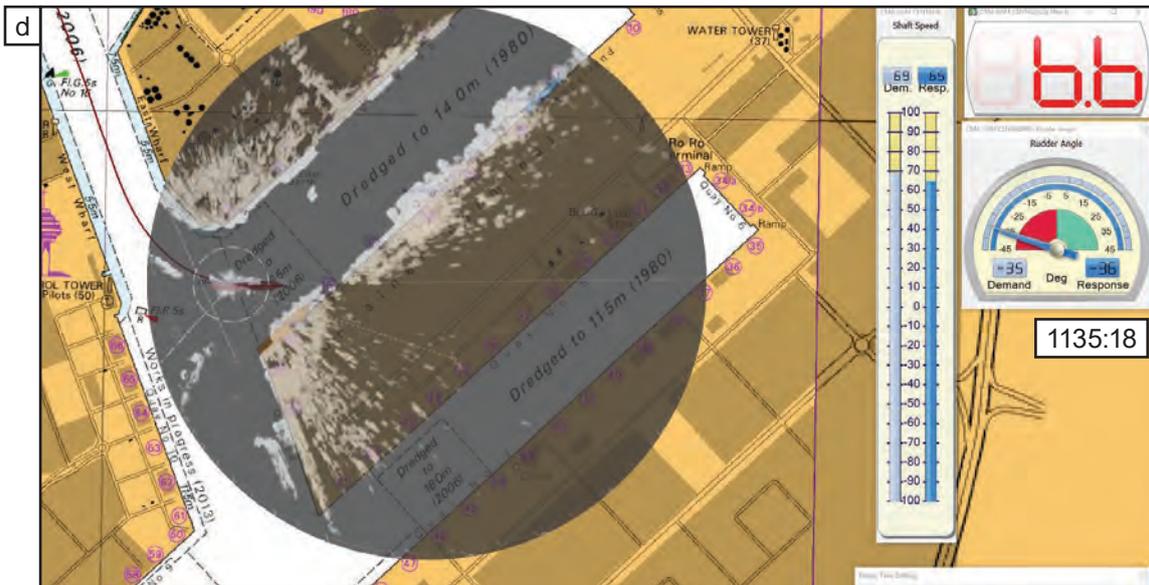
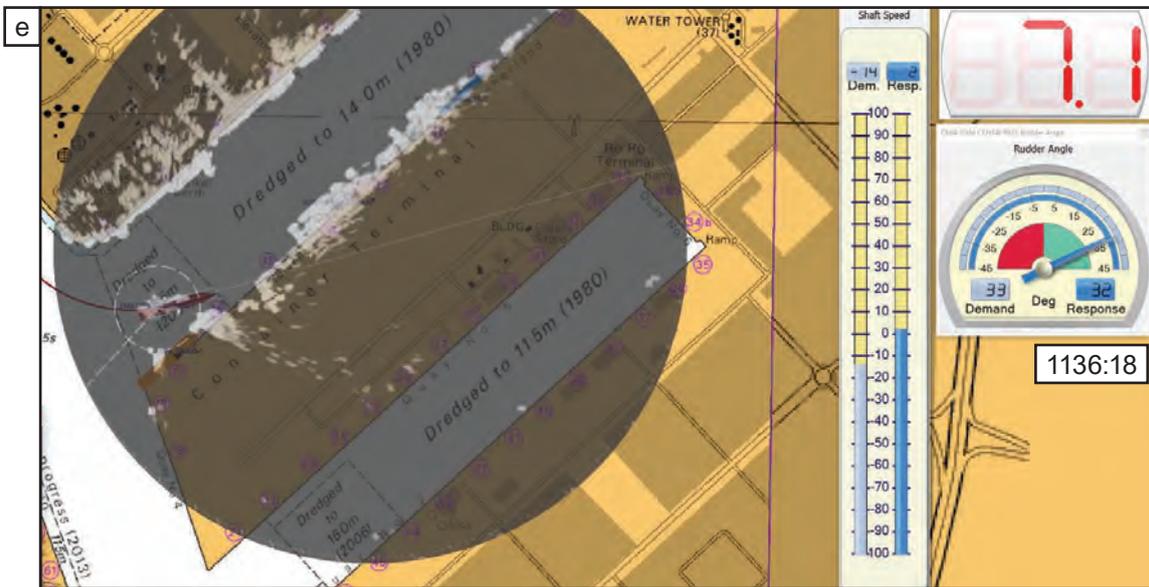
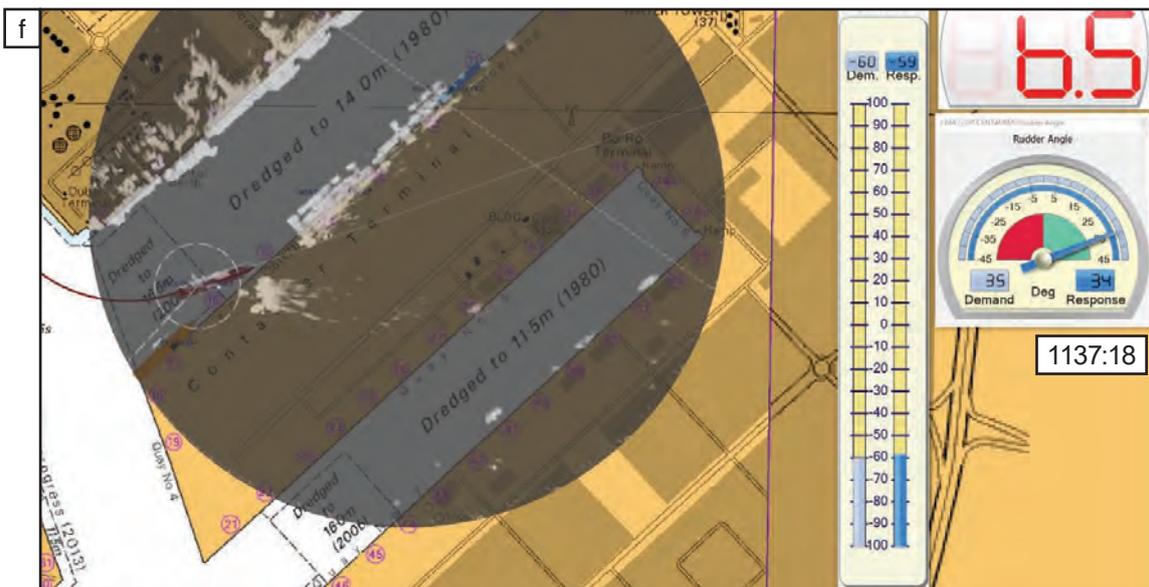
Figure 5d-5f: Series of MADAS screenshots

The pilot then ordered 'stop engines', and then in quick succession 'slow astern', 'half astern' and 'full astern'. The pilot ordered 'amidships' and, 30 seconds later, 'hard to starboard', resulting in *CMA CGM Centaurus's* stern clearing *NYK Crane*.

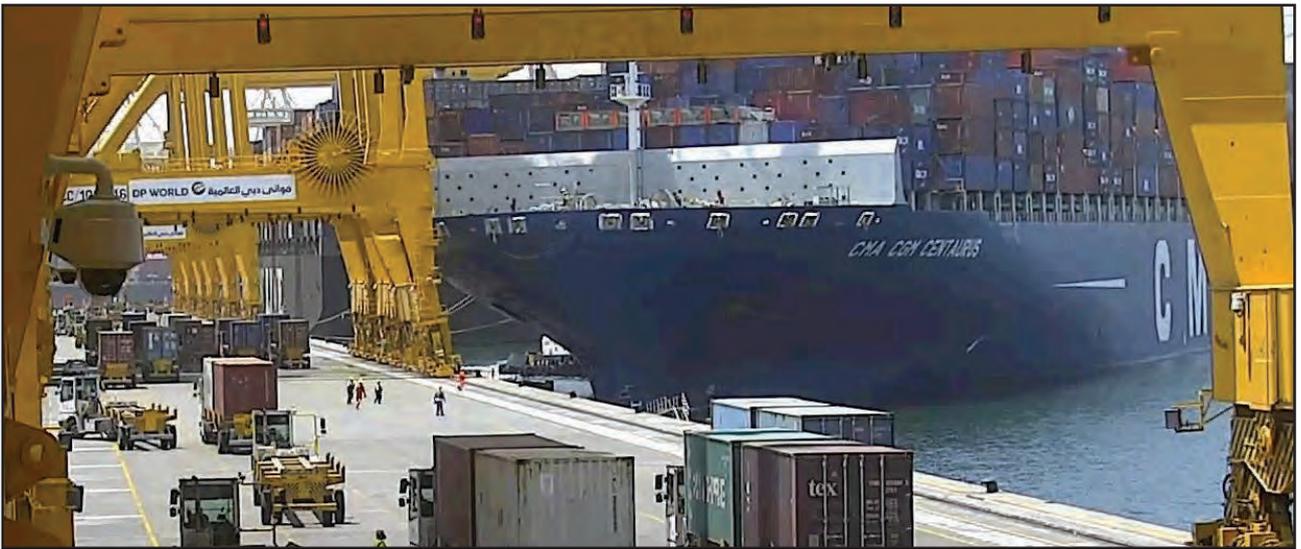
A spacer pontoon and 10 quay fenders sustained damage, one mooring bollard was displaced, and several port vehicles were damaged.

Figure 6: CMA CGM Centaurus making contact with the quay

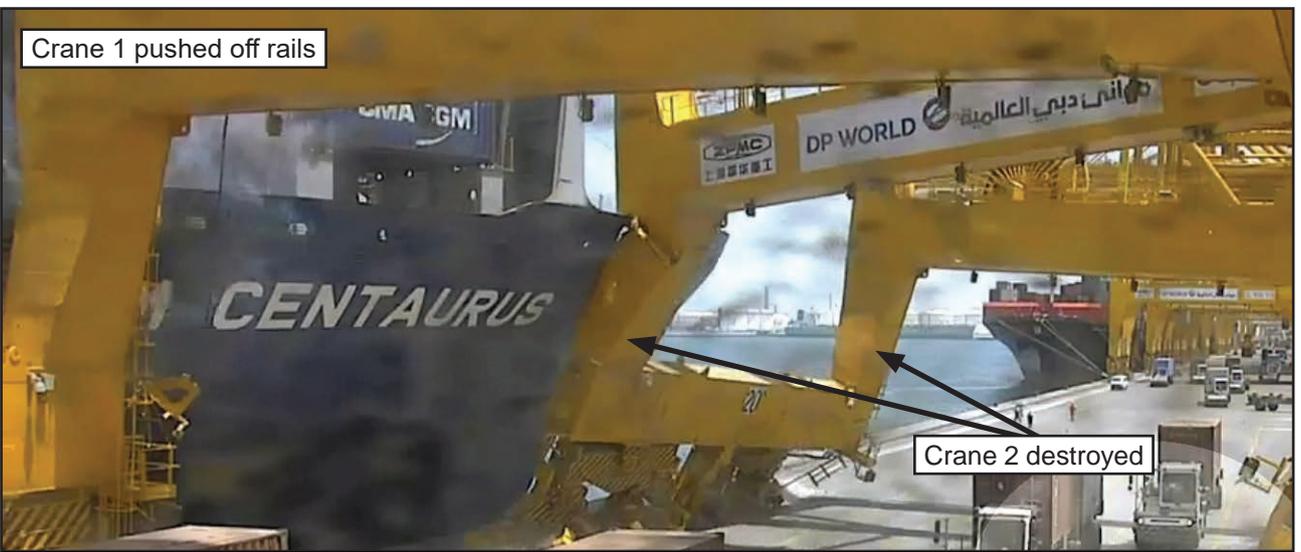
Two shore cranes were structurally damaged. One crane was removed from its tracks by the impact. The second crane collapsed completely, narrowly missing an occupied office building (**Figure 9**), which was structurally damaged as a result of the accident.

Figure 7: CMA CGM Centaurus making contact with two shore cranes

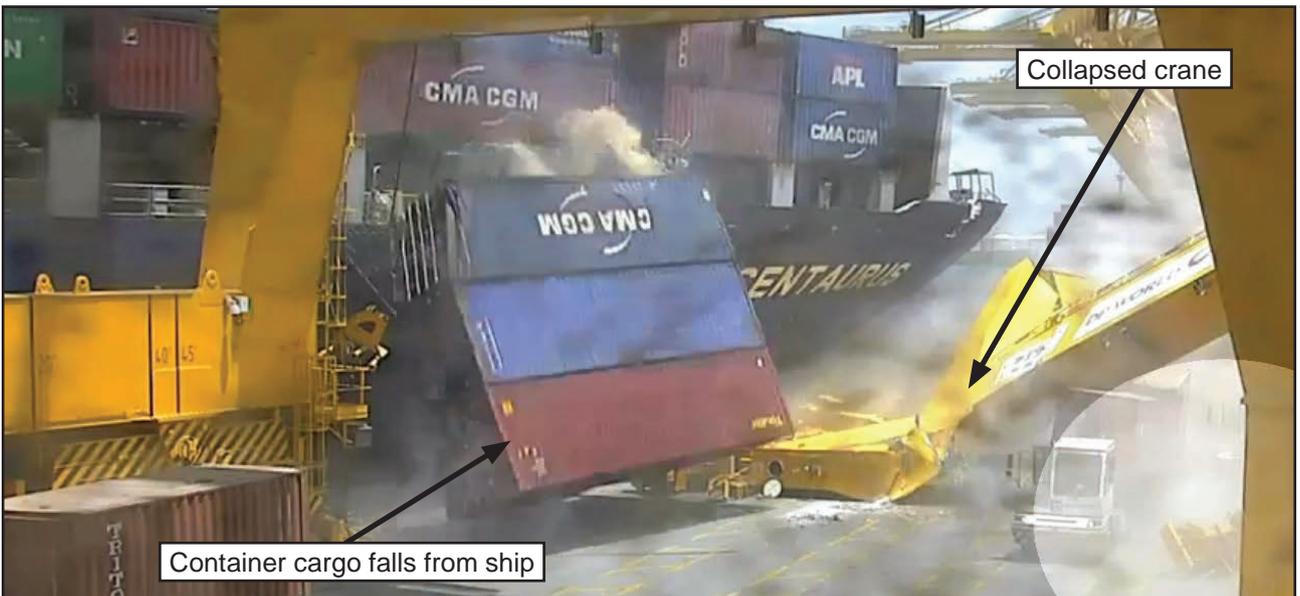
Figure 8: Containers falling from ship onto the quay

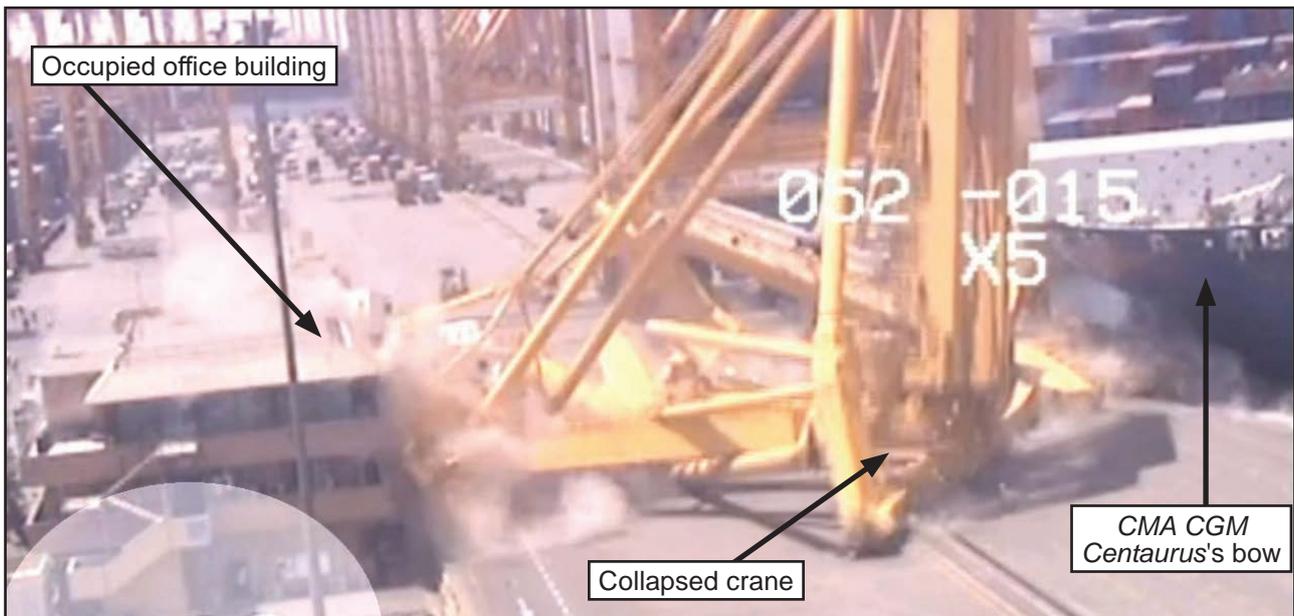
**Figure 9:** Crane collapsing in close proximity to an occupied office building
