# Rail Accident Investigation: Interim Report

**Loss of speed restrictions on the Cambrian line  
20 October 2017**

Report IR1/2018  
October 2018

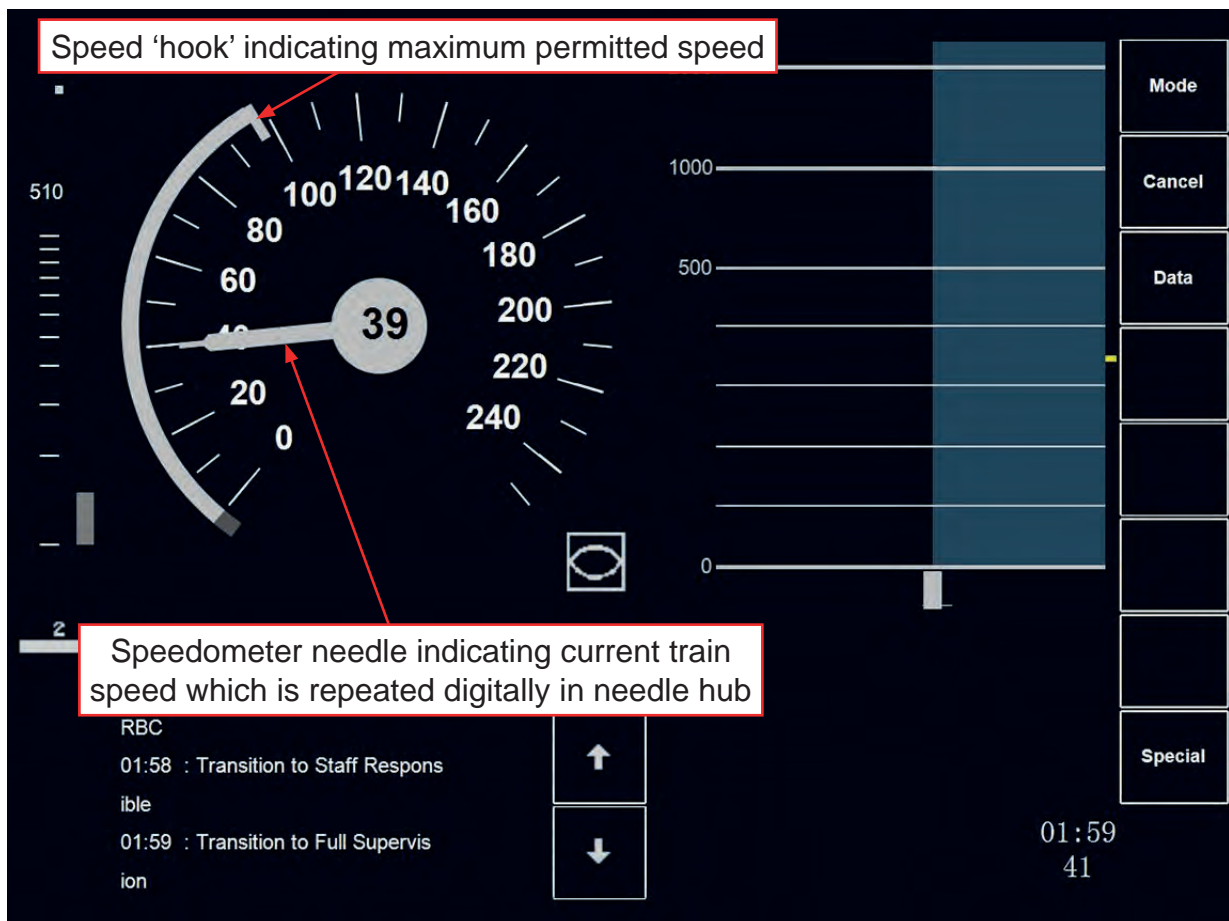
Figure 3: DMI screen showing speedometer with maximum speed supervision and actual speed

- 21 The DMI provides the driver with the current train speed and the maximum permissible speed, including any temporary speed restrictions, on a simulated analogue speedometer (figure 3). The standard analogue speedometer is retained for degraded operation and operation on non-ERTMS equipped infrastructure.
- 22 The ERTMS signalling implemented on the Cambrian lines, although new to Network Rail infrastructure, was based on a system already in operation elsewhere in Europe. Implementation in the UK was reliant on the product validations already achieved in Europe with the differences unique to the Cambrian lines being subject to the UK railway approval procedures.

- 33 Arriva Trains Wales downloaded the journey data from the trains which travelled between Dovey Junction and Pwllheli on the morning following the rollover. This data indicated that no temporary speed restrictions were being transmitted to trains, and so none were shown on train DMIs, from the start of service until after the fault was discovered and corrected.

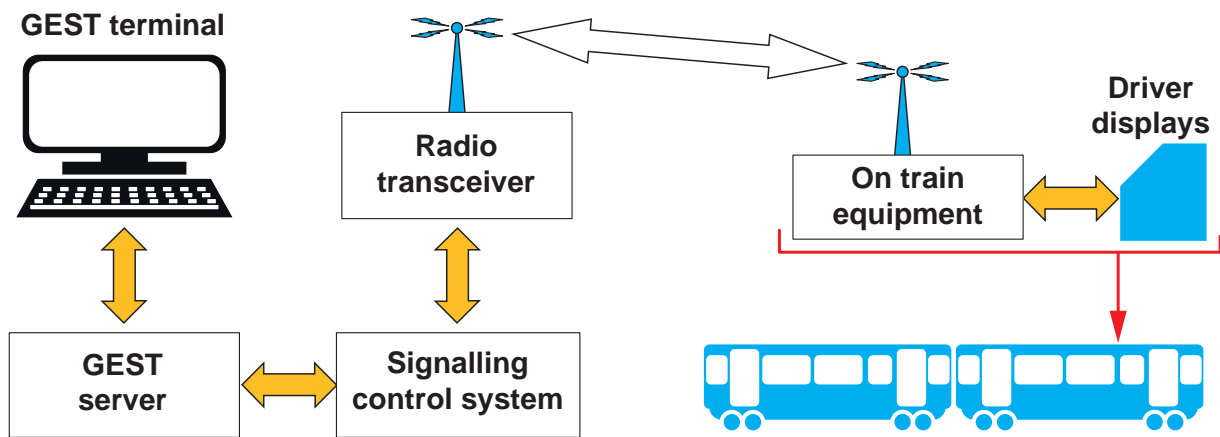
Figure 4: Simplified arrangement of GEST and signalling control system interface

- 25 To apply a temporary speed restriction on the Cambrian ERTMS system, the signallers use a computer system called the 'poste de GEstion des Signalisations Temporaires' (GEST) terminal. This terminal acts as an interface between the signalling control system and the signalling staff (figure 4). The GEST terminal is also used by the signalling staff to perform other tasks associated with the operation of the ERTMS signalling system, such as those required to return the signalling system to service after a rollover.

- 30 Following the initial rollover shortly after 23:00 hrs on 19 October 2017, the automated process to upload temporary speed restrictions from the database in the GEST system failed. Such failures should have been revealed to the signallers by the signalling control system and trains should have been prevented from resuming service. However, on this occasion the failure to upload the temporary speed restriction database was not recognised by the signalling system.

- 40 Ansaldo STS has concluded from testing on the replica system that the cause of the failure exists solely within the GEST system and not in other parts of the ERTMS signalling infrastructure. Ansaldo STS engineers have examined the GEST system software programming to identify potential programming errors which were then tested on the laboratory system. The testing has also included manipulating system inputs, its operating environment and the introduction of software bugs mimicking possible hardware failures.

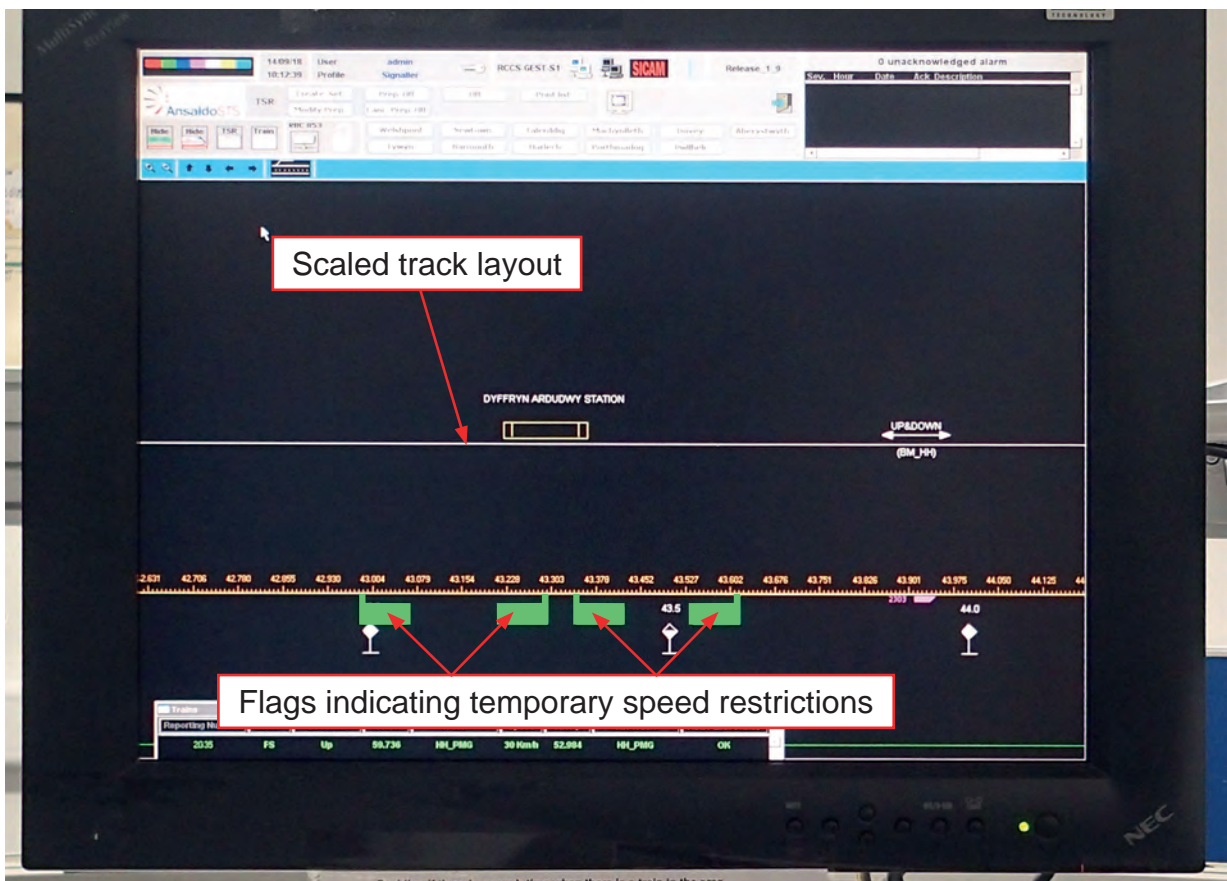
Figure 5: GEST terminal interface screen, here showing a single track with a station and flags at the beginning and end of two temporary speed restrictions

27 As well as real-time application and removal of temporary speed restrictions, it is possible for signallers to set speed restrictions to be applied or removed at a later date and time. To avoid confusion between indicated restrictions, the GEST terminal interface uses a colour coding of the flags (figure 5). The meaning of each status colour is given in table 1.

- 29 The restriction flags are coloured red if a temporary speed restriction has been applied by the signaller, but an error has occurred and so the information is not available to the signalling control system. The signalling control system will not permit trains to operate when implementation errors have been detected and red flags are indicated on the GEST terminal.

- 31 The signallers should have been alerted to the failure to transmit the restrictions by the restriction flags turning red on the GEST terminal interface screen. When asked by the Ansaldo STS engineer the following day, several members of staff at the control centre checked and confirmed that the restriction flags were green on the GEST terminal screen. Although this was several hours after the initial rollover had occurred, there is no evidence that the flags were any colour other than green since the rollover the previous evening.

- 32 The GEST system is an integral part of the overall signalling system and safety related decisions relating to the management and control of trains are made based on the information displayed by the GEST terminal screen. Checks within the safety critical system software should have prevented the incorrect displaying of the green restriction flags on the GEST terminal interface screen.
