Runaway of two coaches at Bitton, Avon Valley Railway, 25 July 2018

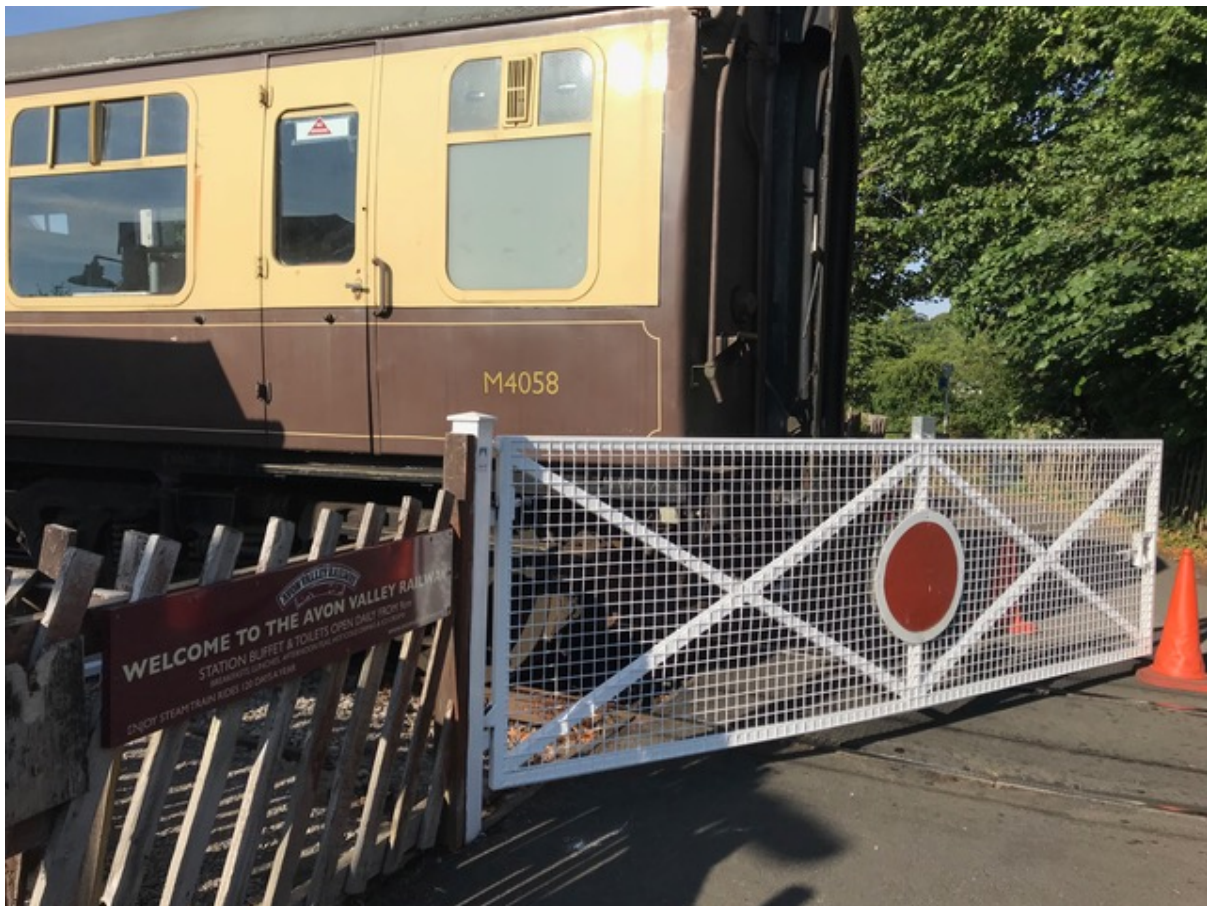
Fortunately the coaches stopped when the flange of the right hand wheel of the leading axle of the first coach became stuck in the converging switch and stock rails of a set of points. At the same time, the leading coach collided with the level crossing gate, bending it and pushing it open over about one third of the width of the crossing.

The stopping position of the leading coach (photograph courtesy of the Avon Valley Railway)

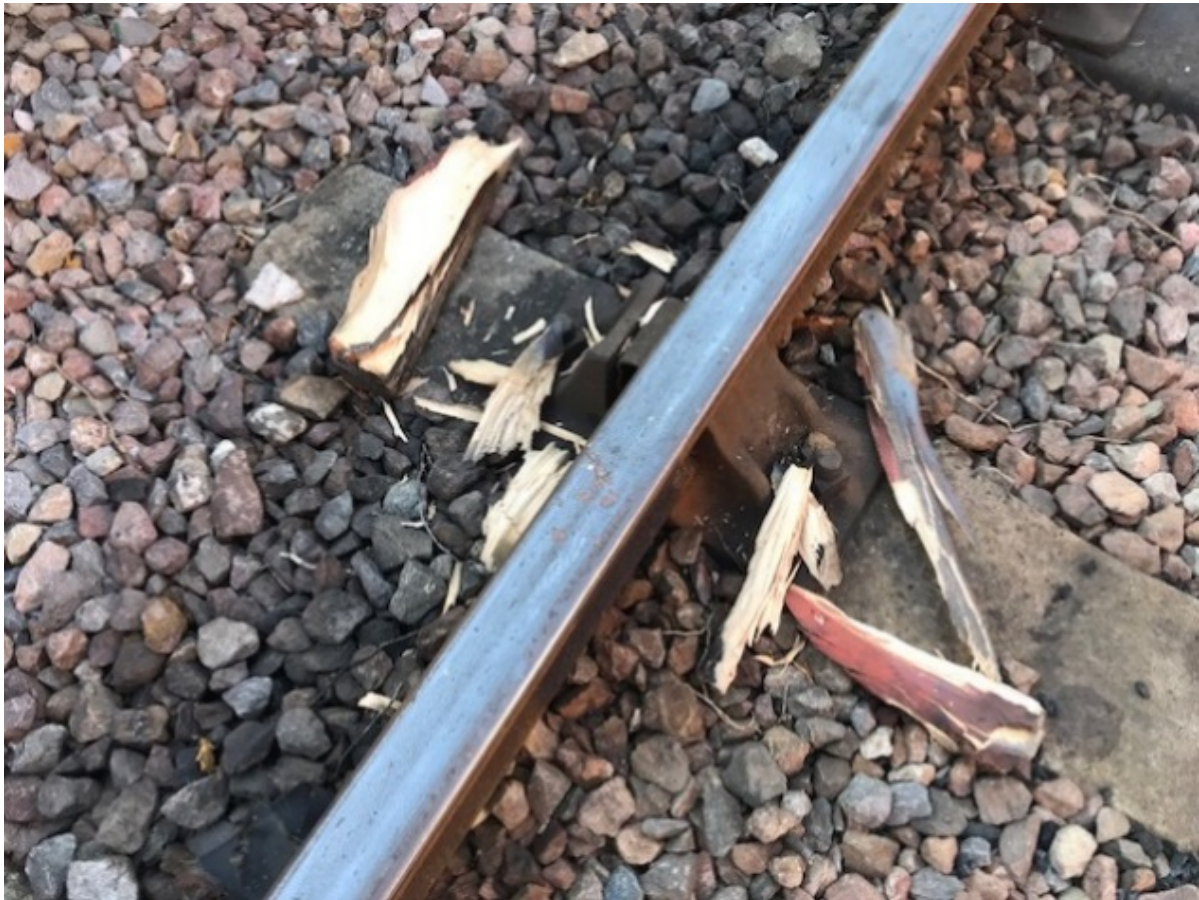
The accident happened because the two coaches were not properly secured after they were uncoupled from the locomotive, which had its parking (hand) brake applied, and the third coach. The coaches, of the British Railways Mark 1 design dating from the 1950s, were equipped with vacuum brakes, but these are only effective once vacuum has been created in the actuating cylinders and reservoirs. The brakes are applied when vacuum in the pipes connecting the vehicles is destroyed, or if the pipes are disconnected. When coaches are stabled, the vacuum in the cylinders and reservoirs will leak away over time, making the brakes on the vehicles ineffective. None of these coaches was fitted with a handbrake.

In order to uncouple, the driver was asked by the shunter to 'ease up' to enable the coupling to be released, without a vacuum having been created in the rear two coaches. The 'easing up' movement compressed the buffers. On being uncoupled, the energy stored in this way gave an impulse to the coaches, which started them moving, and overcame the chocks which were intended to restrain them. Two wooden chocks, which were not the correct profile for the wheels of the coaches, had been placed against two wheels, both on the same axle. Only a visual check had been done to check the chocks were present, rather than a physical check to ensure the chocks were correctly and firmly up against the wheels to prevent any movement. When the coaches began to move, one of the chocks was pushed aside and damaged, and the other was destroyed (see images below).

The remains of the destroyed chock (photograph courtesy of the Avon Valley Railway)

One of the recommendations from the Avon Valley Railway's own investigation into this accident was that prior to dividing rakes, the vacuum should be created and then destroyed to create an automatic brake, removing the reliance on the chocks preventing any unintended movement. This instruction was not previously captured in any Avon Valley Railway documentation.

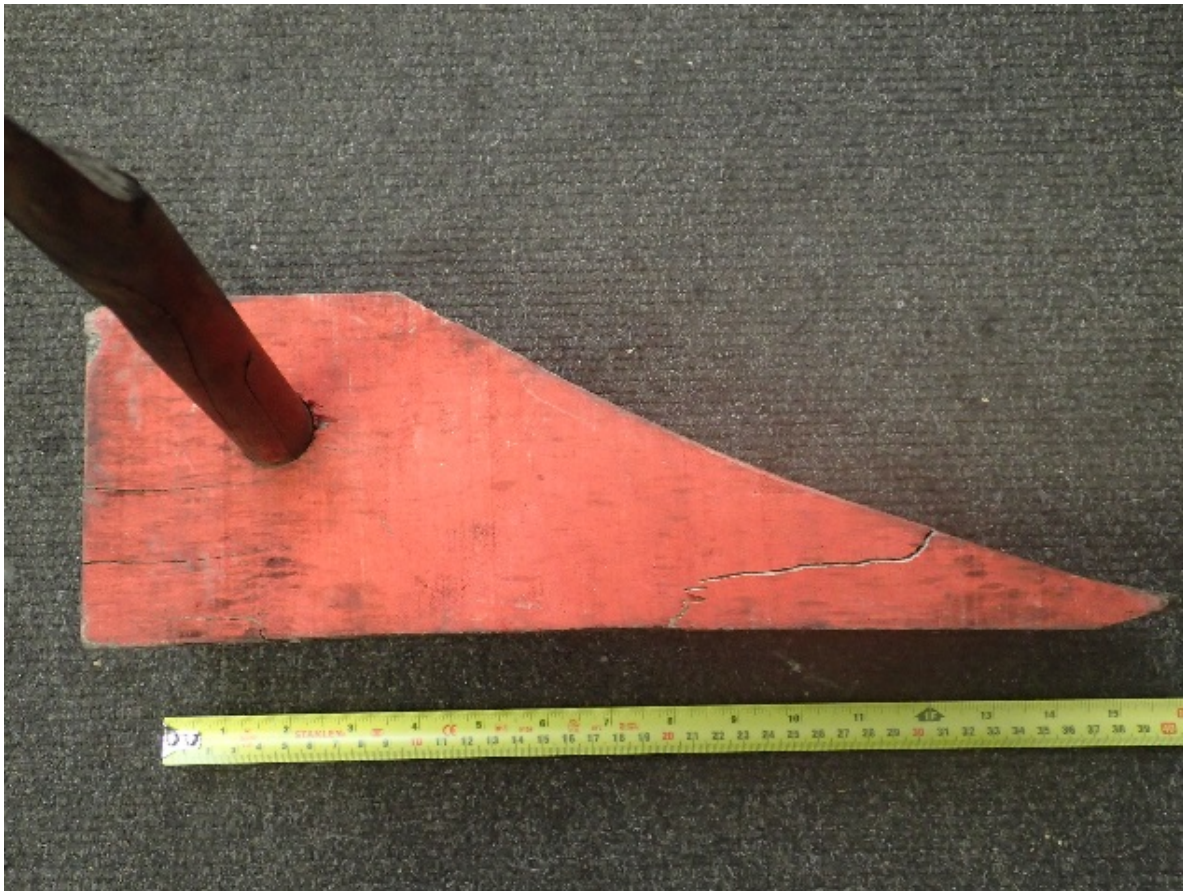
The damaged chock
