Dragging anchor by the general cargo vessel *Celtic Spirit* and subsequent collisions with *Atlantic Explorer* and *Celtic Warrior* River Humber, England on 1 March 2018

SUMMARY

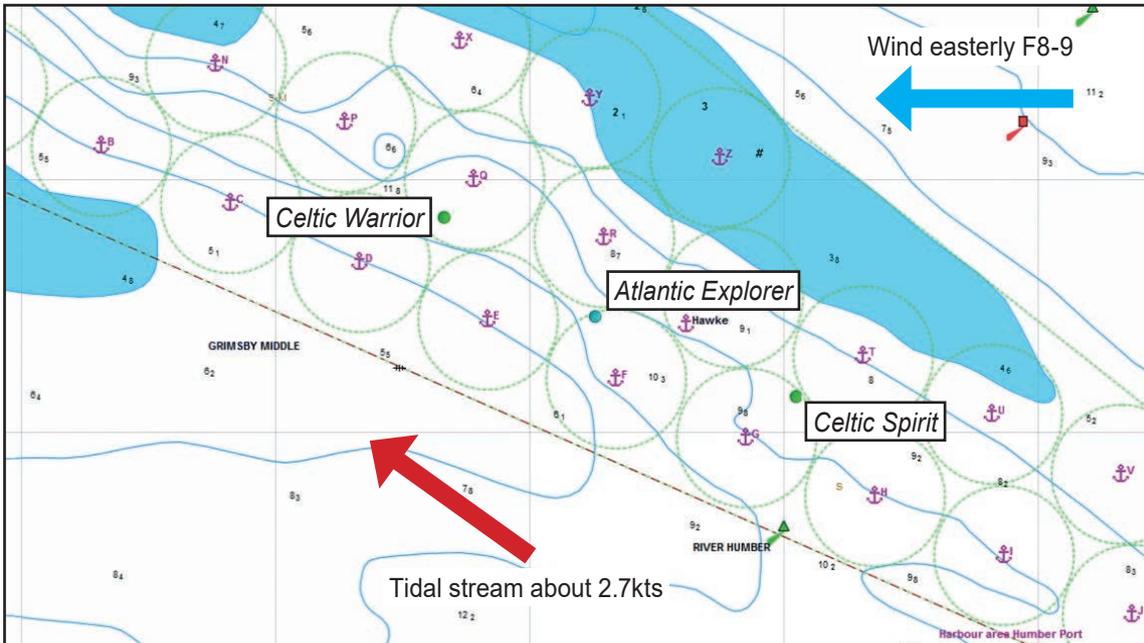
At about 0246, *Celtic Spirit* began to drag anchor in a north-westerly direction (**Figure 2a**). Nine minutes later, in preparation for the watch handover, the vessel's 2/O looked at the radar screen and noticed that the distance to *Atlantic Explorer* had decreased. He plotted the vessel's position on the chart, which verified that the vessel was dragging its anchor, and called the master. He also called the engineer in his cabin and ordered him to start the main engine, and he instructed the duty AB, via hand-held radio, to go forward and check the anchor cable.

Figure 2a: 0246 *Celtic Spirit* starts dragging its anchor

Celtic Spirit started dragging its anchor because insufficient anchor cable had been deployed in the prevailing environmental conditions. It was apparent that the master's use of 5 of *Celtic Spirit's* 7 shackles of cable was based solely on the pilot's advice. It was also evident that the pilot's advice did not adequately take into account the forecast winds and predicted tidal stream.

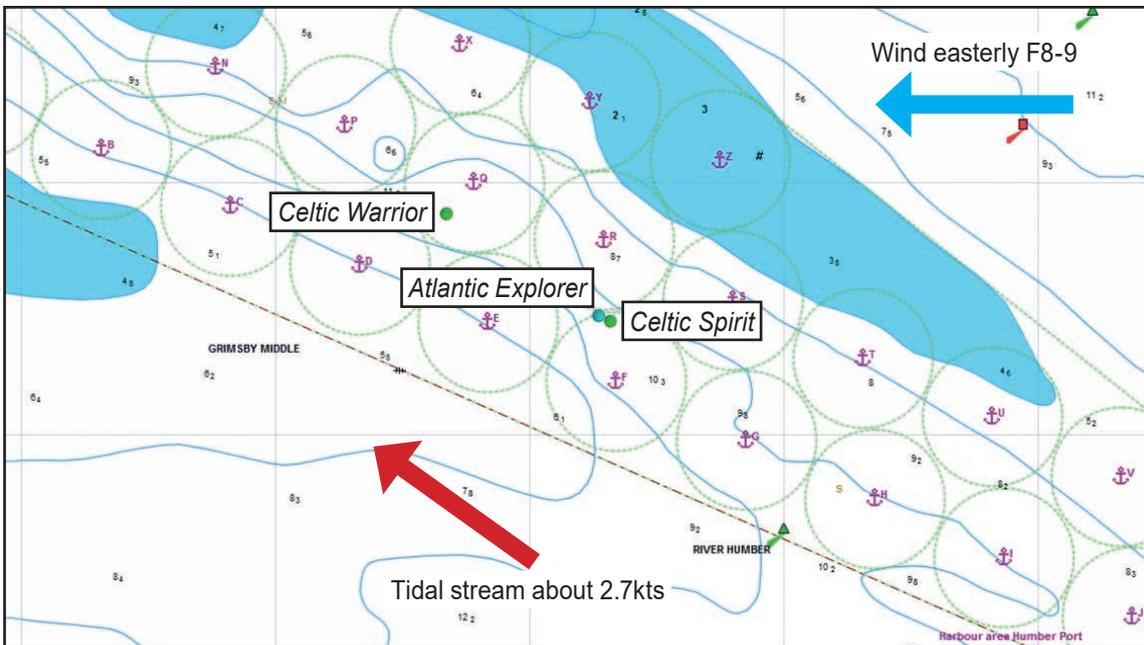
Figure 2b: 0312 *Celtic Spirit* collides with *Atlantic Explorer*

At 0312, *Celtic Spirit's* stern collided with *Atlantic Explorer's* bow (**Figure 2b**). At approximately the same time, *Celtic Spirit's* engineer started the main engine and passed control to the bridge. The master engaged ahead propulsion but was unable to manoeuvre clear because *Celtic Spirit's* stern was fouled on *Atlantic Explorer's* anchor cable. VTS contacted *Atlantic Explorer* to request a damage report, and also mobilised a tug from Immingham.

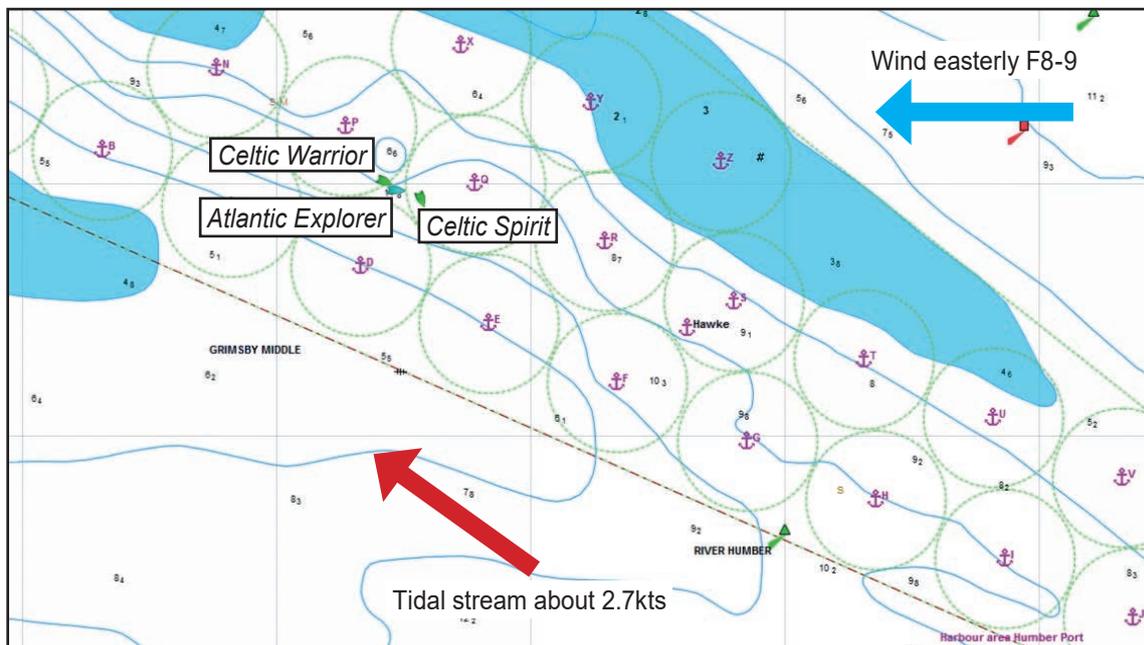
Figure 2c: The vessels drifting north-west after *Celtic Spirit*'s collision with *Celtic Warrior*

Warrior's master, who was on the bridge, immediately engaged astern propulsion but, shortly afterwards, at 0320, *Celtic Spirit's* port quarter collided with *Celtic Warrior's* bow. The impact caused *Celtic Spirit* to become detached from *Atlantic Explorer's* anchor cable and all three vessels began to set to the north-west (**Figure 2c**).

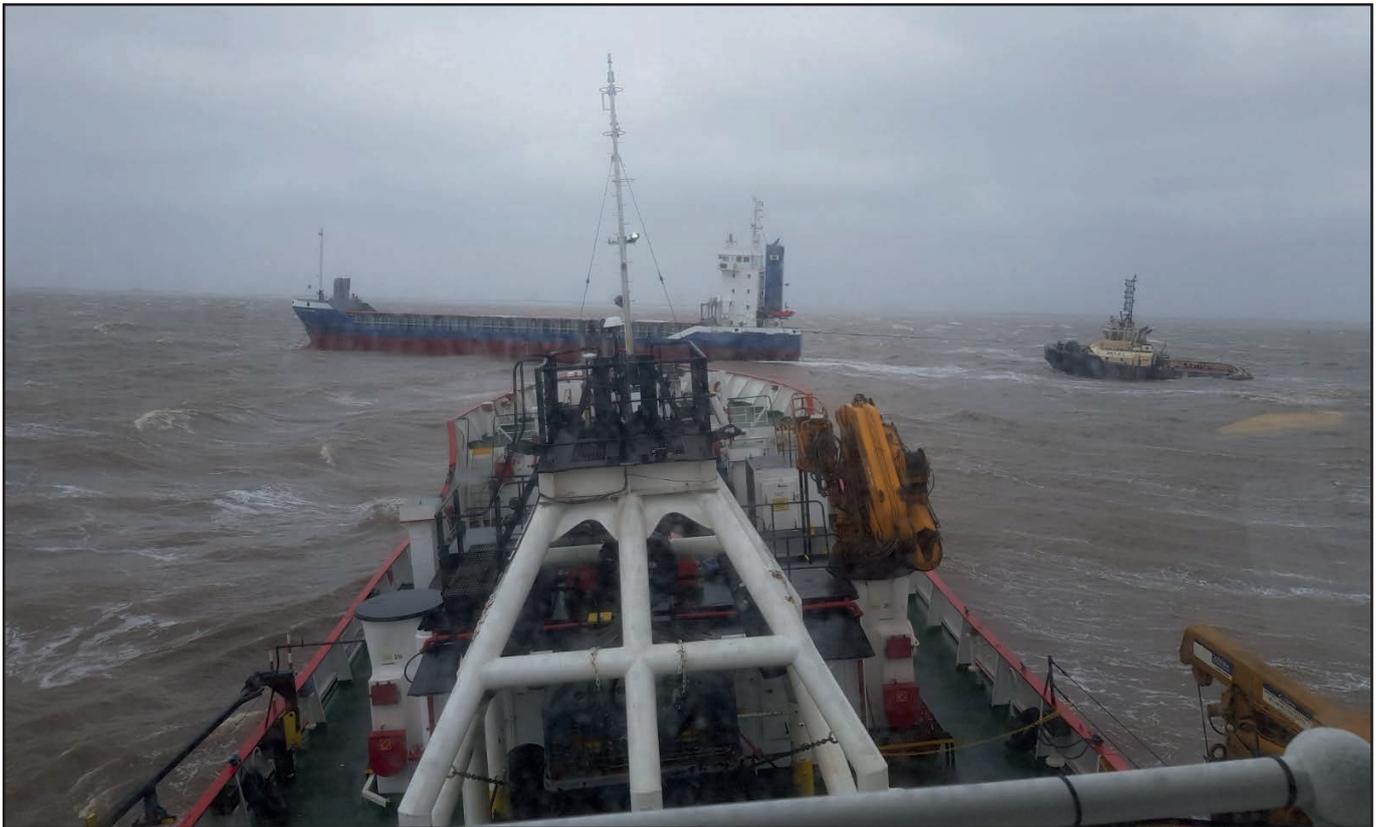
At 0515, the tug *Svitzer Laura* was made fast to *Celtic Spirit's* stern (**Figure 3**) as the cargo vessel's crew continued attempting to weigh anchor. Efforts to weigh anchor continued until 1011, when the windlass failed. This caused the anchor chain to run out and its bitter end to part. With *Svitzer Laura* standing by, *Celtic Spirit* made its way upriver and berthed alongside in Hull.

Figure 3: *Svitzer Laura* made fast to *Celtic Spirit*

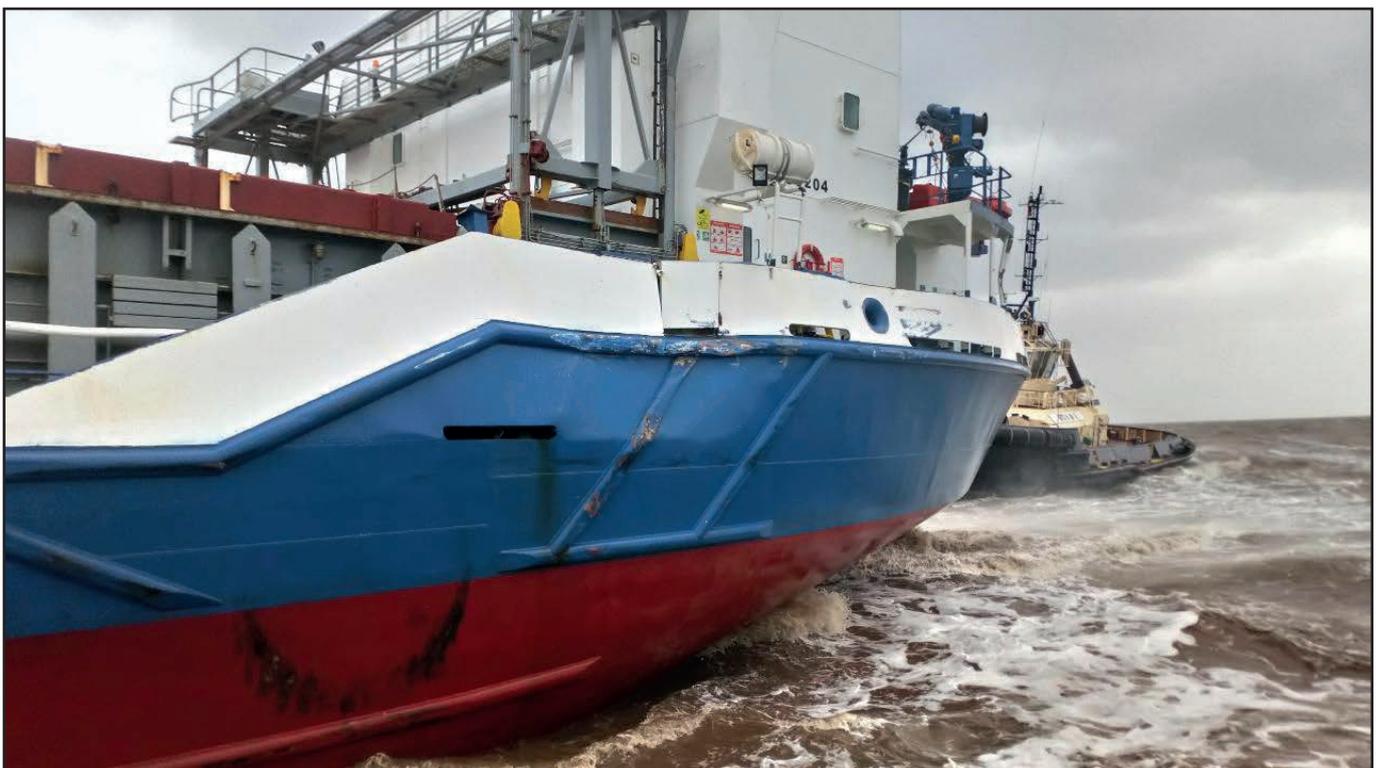
- *Celtic Spirit* suffered structural damage to its weather deck, engine room shell plating and bulwark along its port quarter (**Figure 4**),
- *Atlantic Explorer* suffered damage to its shell plating at its bow and port shoulder, and damage to its anchor equipment,
- *Celtic Warrior* sustained shell plate damage to its bow.

Figure 4: Damage to *Celtic Spirit*'s port side quarter
