# AIRCRAFT ACCIDENT REPORT 2/2018

Report on the serious incident to  
**Boeing 737-86J, C-FWGH**  
Belfast International Airport  
on 21 July 2017

Published 21 November 2018

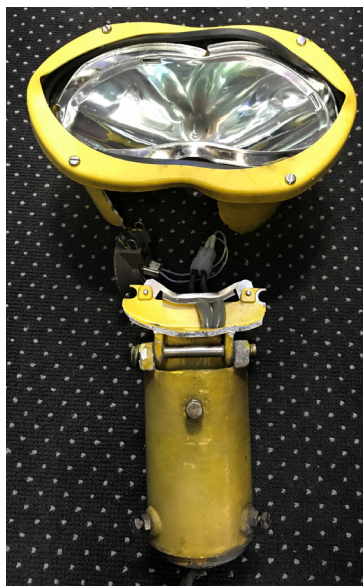
**Figure 2**

One supplementary approach light for Runway 25 at BFS was found damaged (Figure 2). The light was found crushed and lying on the ground having been knocked from its mounting<sup>10</sup>.

Supplementary approach light damage

The runway inspection found one of the Runway 25 supplementary approach lights lying on the ground with substantial damage evident (Figure 2). The damage was reported to the tower and to the duty electrician at 1620 hrs. A discussion between staff in the tower and airport operations concluded that the light had been blown over due to jet blast of the engines. This had happened previously in BFS, although with much larger aircraft and generally at the beginning of the runway behind an aircraft as it began its takeoff roll.

Following a shift change, the new airfield duty manager observed the damage to the light and the rubber deposits on it and suggested that, rather than the light being blown down by jet blast from the aircraft, it had been hit by a tyre. These concerns were reported to the tower by the duty manager. The BFS ATC watch manager then contacted the watch manager at ScACC to request that the ACC try and contact the pilots of C-FWGH. However, the aircraft had long since left ScACC airspace, so the watch manager attempted to contact the operator. The ScACC log showed that, at 1908 hrs, they were told that the aircraft may have hit a light. The watch manager at ScACC contacted the operator in Canada who agreed to contact the crew who had already arrived at their destination.

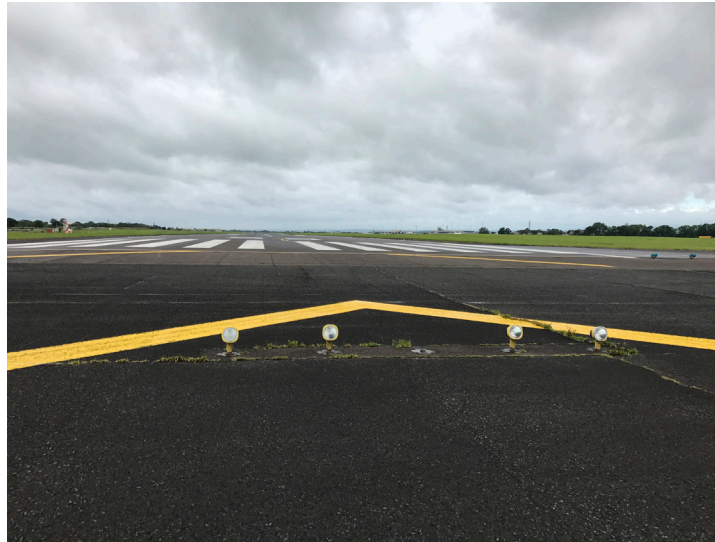
**Figure 6**

Within the stopway were two sets of supplementary approach lights for Runway 25. Each of these sets had thirteen lights set out in three groups across the tarmac. These lights were positioned 36 cm above the stopway surface. The first set of lights was 29 m beyond the end of Runway 07, with the stopway ending 60 m beyond the end of Runway 07. The aircraft struck the centre light within the first set of supplementary approach lights. Figure 5 shows the layout of the lights, together with the dimensions of the stopway and indicates the direction of travel of the aircraft and the light the aircraft struck. Figure 6 shows the view from the stopway with the centre light missing.

The view from the stopway showing the centre light missing

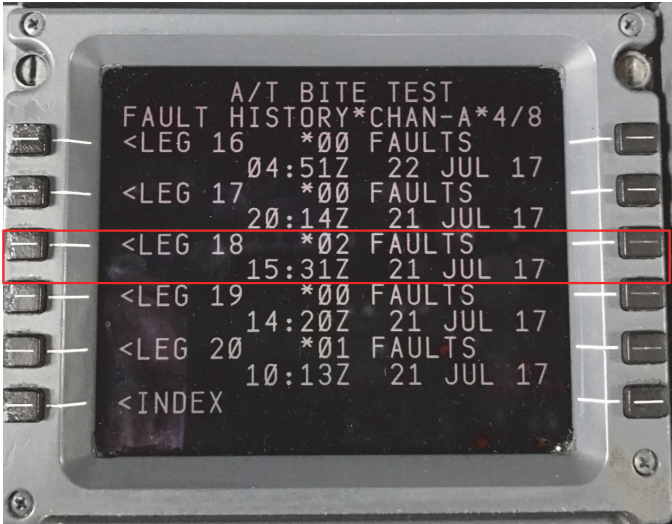
Figure 7

The CDUs support an interface to Built-in Test Equipment (BITE) for various aircraft systems, including the autothrottle system. The AAIB examined the autothrottle BITE data on the CDUs and this showed that two faults<sup>14</sup> had been logged for the incident sector (see the red box in Figure 7).

CDU autothrottle BITE history

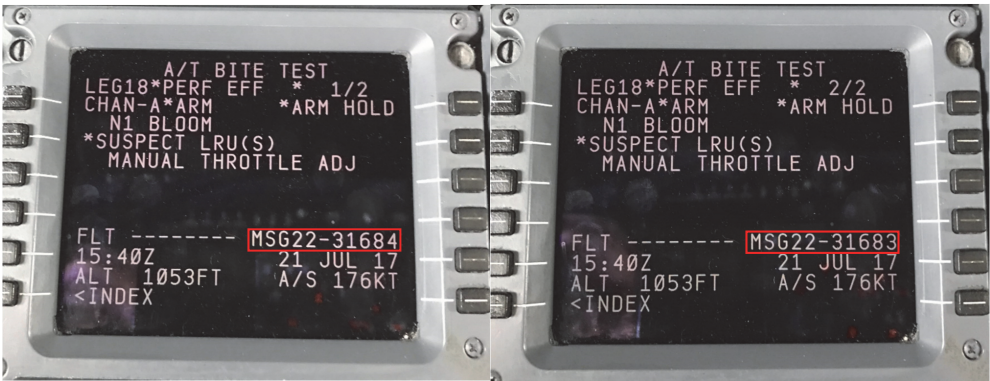
Figure 8

These faults related to the initial climb-out from BFS, and the CDS pages for them are shown in Figure 8. Both messages relate to an 'N1 Bloom' and the message identification numbers are highlighted by red boxes in Figure 8.

Detailed CDS fault pages for both faults logged

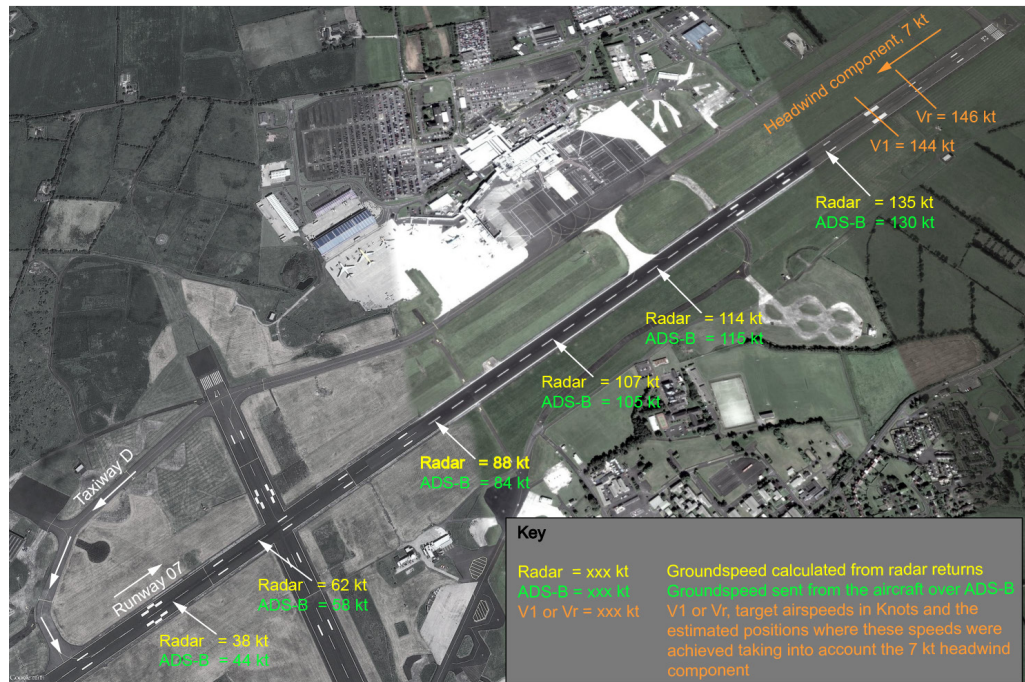
**Figure 10**

The radar installation at Belfast International Airport tracked C-FWGH along Runway 07 and during initial climb-out, when altitude data also became available from the aircraft's transponder. The radar returns allowed groundspeed for the aircraft to be calculated which was supplemented by both groundspeed and altitude data transmitted from the aircraft over its Automatic Dependent Surveillance – Broadcast (ADS-B) datalink. This data is shown in Figure 10 for the ground roll, where the text in yellow represents calculated groundspeed data from the radar track and, in green, the received ADS-B groundspeeds. Orange lines show the approximate position where the aircraft achieved airspeeds equivalent to the EFB-calculated  $V_1$  and  $V_R$ , considering the 7 kt headwind component.  $V_R$  would have been achieved approximately 300 m from the end of the runway.

Groundspeed data for the takeoff in relation to the EFB calculated  $V_1$  and  $V_R$   
 © 2017 Google, Image © 2017 DigitalGlobe

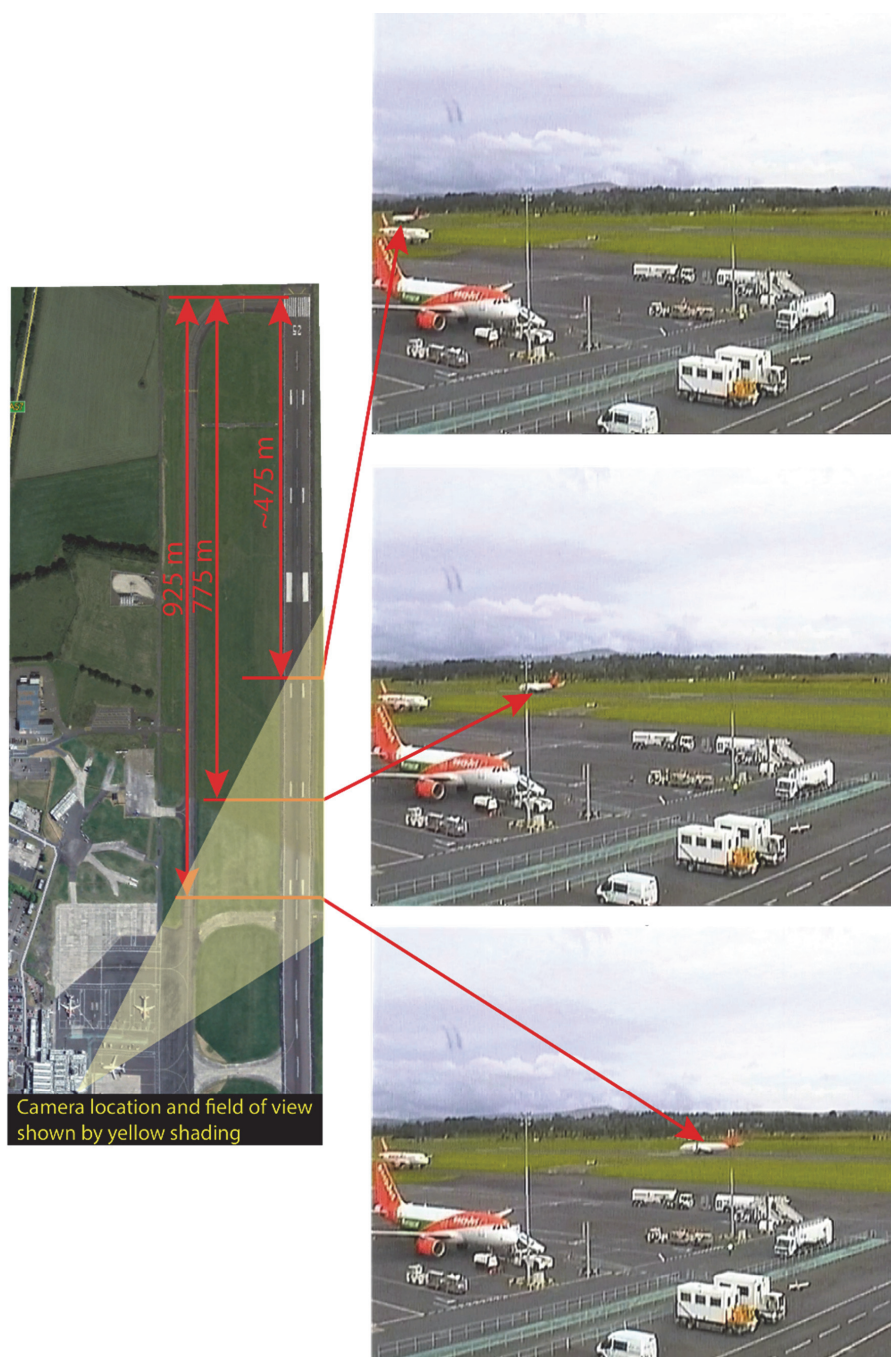
**Figure 12**

The airport operator provided the AAIB with closed-circuit television (CCTV) recordings of C-FWGH's takeoff from two cameras. The first camera's field of view recorded the segment between 1,000 m and 475 m from the departure end of Runway 07. At the end of this segment, C-FWGH had not rotated (Figure 12).

The first CCTV recording showing C-FWGH's takeoff

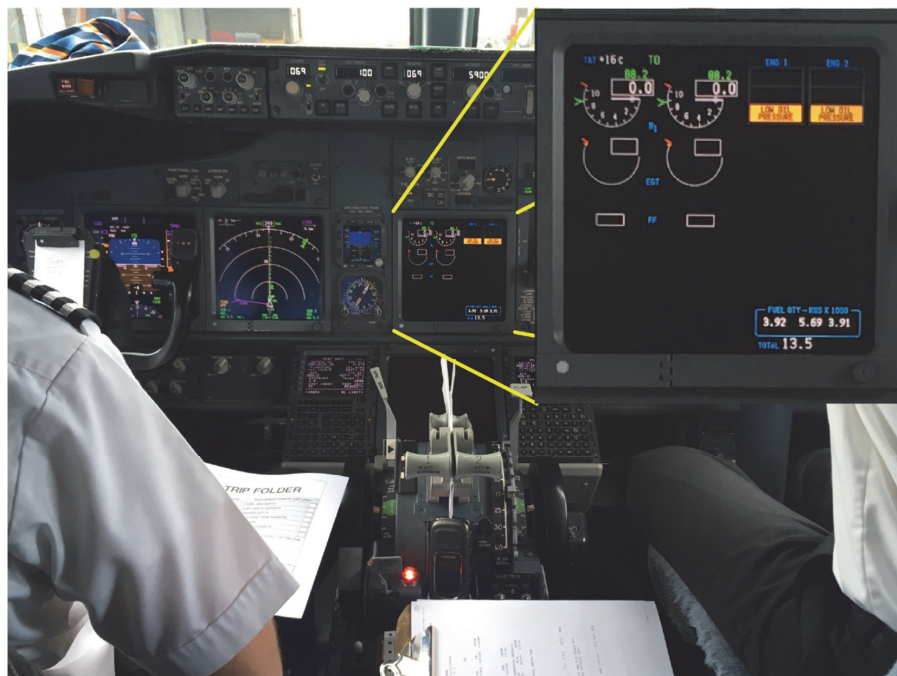
**Figure 14**

The engineer travelling in the cockpit took a photo before the aircraft first pushed back from the stand (Figure 14).

Cockpit photo and  $N_1$  display prior to first pushback

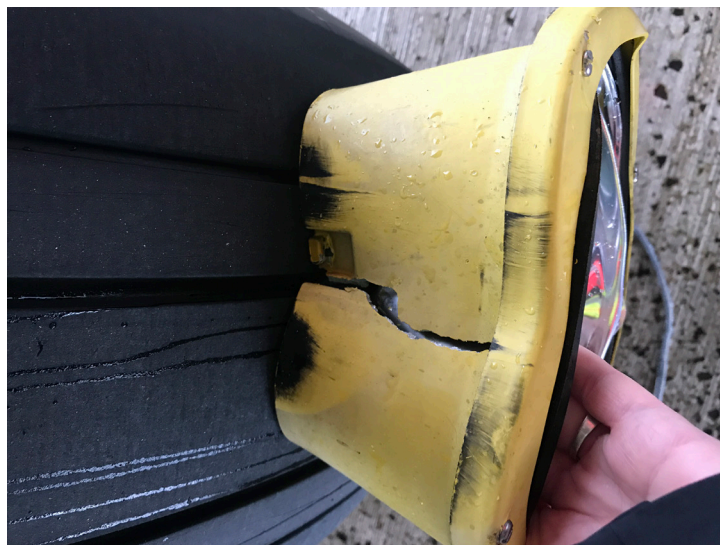
**Figure 16**

One of the supplementary approach lights within the Runway 07 stopway was found lying on the ground during the runway inspection. Closer examination revealed that the light had significant impact damage with evidence of black rubber deposits.

When compared with the tread on the tyres on C-FWGH, the pattern of rubber deposits indicated that the light had probably been struck by one of the main gear tyres. Chemical analysis of the rubber deposit was unable to confirm whether a main or nose landing gear tyre struck the light (Figure 16).

Aerodrome lights are designed to be frangible. If struck by an aircraft they are to break causing minimal or no damage to the aircraft. The crew were unaware that they had struck a runway light and there was no damage to the aircraft structure or tyre from striking the light.

Tread pattern comparison with main gear tyre

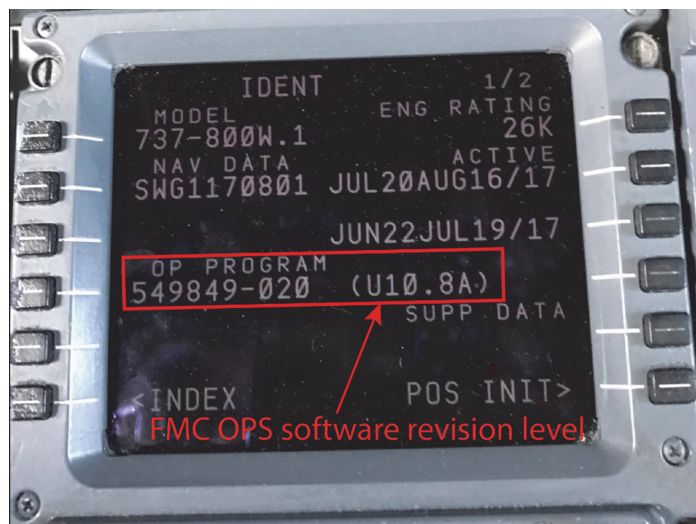
**Figure 18**

At the time of the serious incident, C-FWGH had an earlier revision of FMC OPS software installed, U10.8A (Figure 18), which did not include this crosscheck.

CDU IDENT page of C-FWGH
