Report on the investigation of a man overboard
from the creel fishing vessel
Annie T (CY 1)
with the loss of one life
in the Sound of Mingulay, Scotland
on 4 October 2015

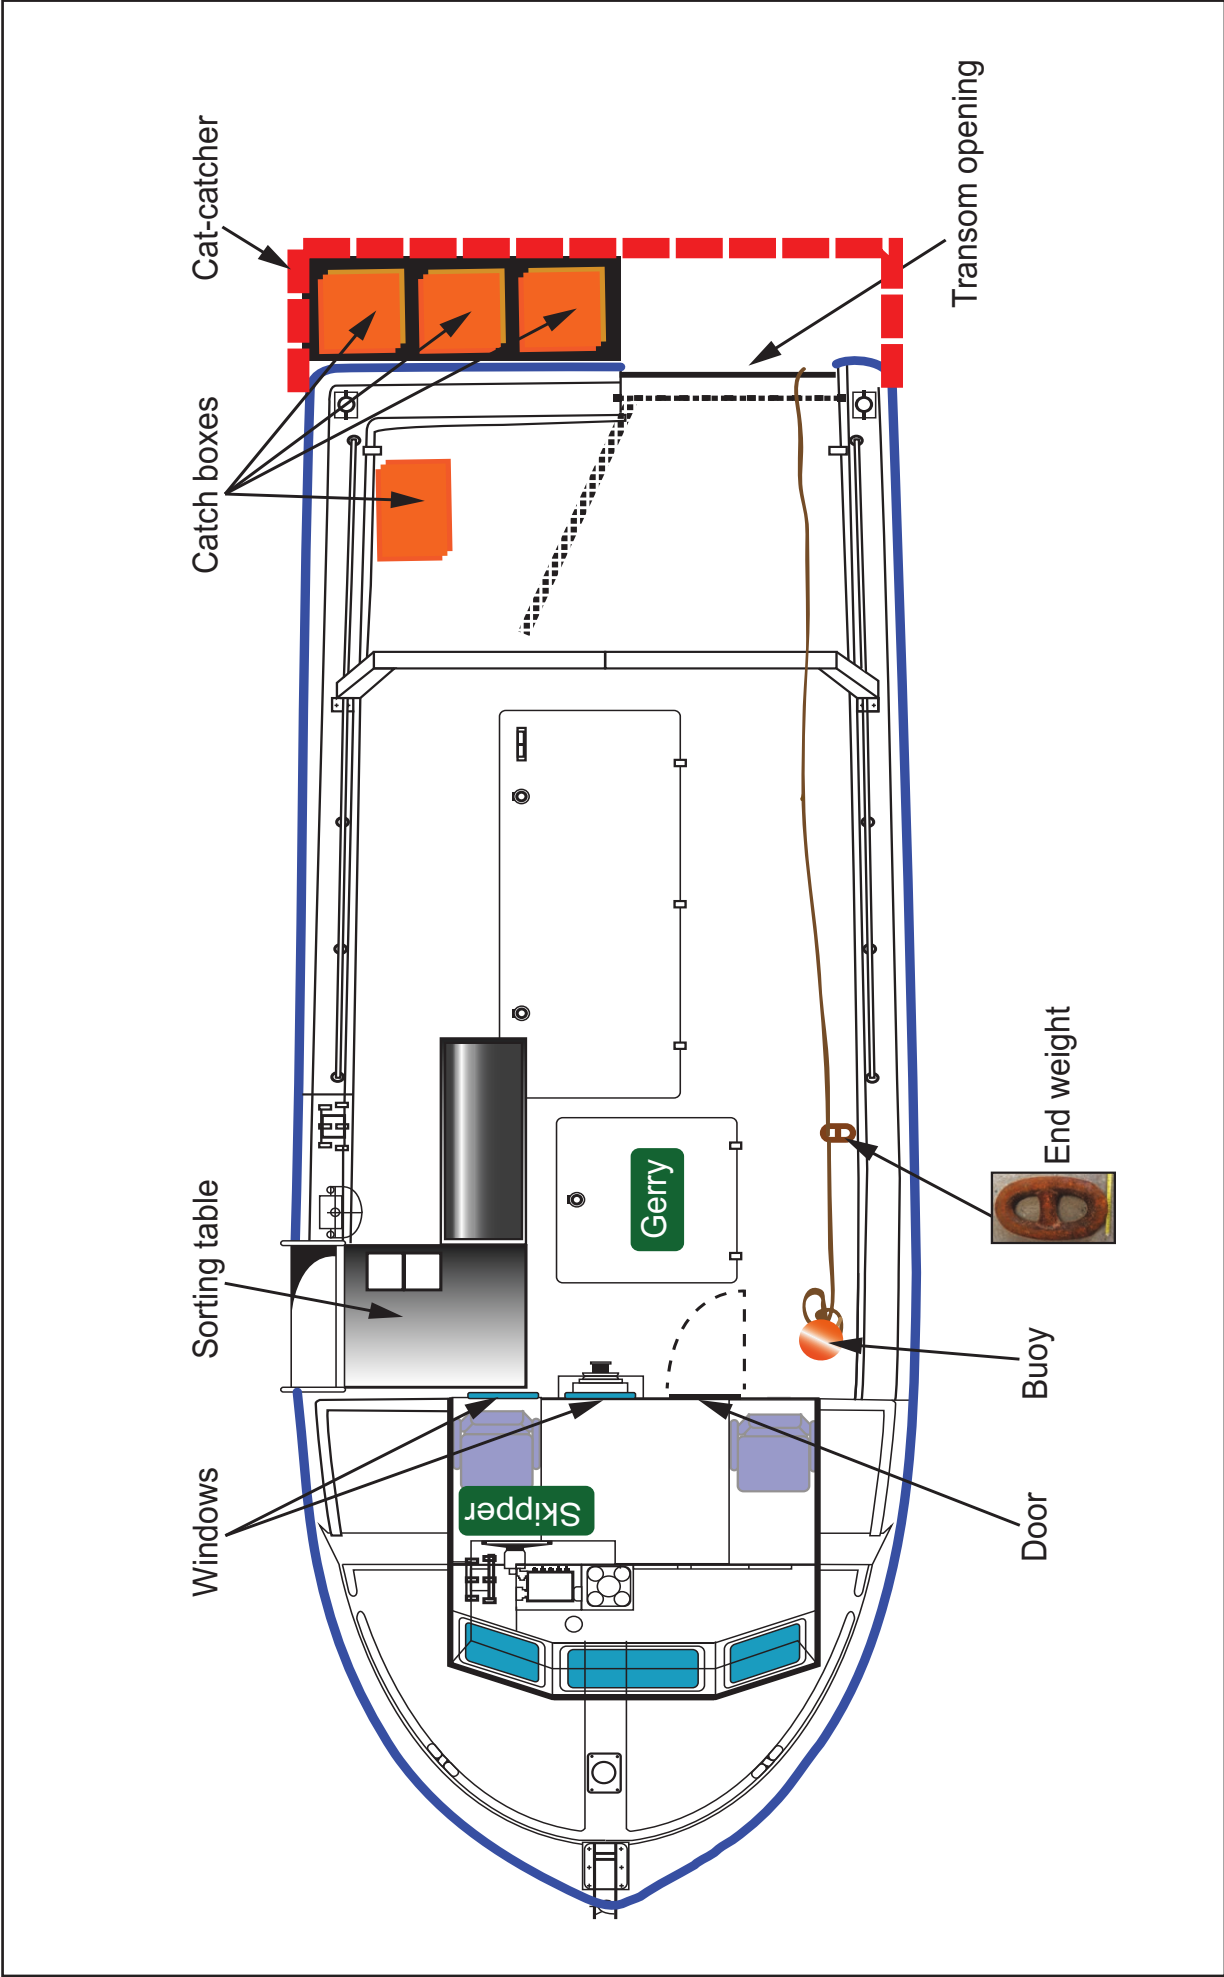
Figure 3: Position of the skipper and crewman just before the accident

The accident occurred because the crewman was in an unsafe position and became entangled in a rope while shooting creels. Neither the skipper nor the crewman wore lifejackets during fishing although three new, unused, constant wear lifejackets were found on board the vessel following the accident.

At around 1315, the skipper and Gerry were preparing to shoot a fleet of creels. Gerry was aft of the sorting table on the starboard side of the deck and the skipper was in the wheelhouse, looking aft through the window (**Figure 3**). Gerry threw the first buoy out through the transom opening at the stern, and the first weight and the creels followed. When the last creel had gone, Gerry followed his usual practice and moved towards the second weight, which had been placed on the deck near the wheelhouse door. He did this in order to carry it towards the stern of the vessel before letting it go. At around 1320 Gerry crossed the running line, and the skipper saw him fall to the deck. The skipper immediately put the throttle to full astern to try and prevent Gerry from being dragged overboard, but Gerry was pulled along the deck and into the sea through the transom opening (**Figure 4**). The skipper put the throttle to neutral and ran aft to the cat-catcher¹. He could see Gerry in the water approximately 3-3.5m astern and to starboard. Being a non-swimmer, he was panicking as he tried to tread water. One of Gerry's boots was seen floating near him. The skipper shouted to him to ask if he was free of the rope and Gerry replied that he was.

Annie T's skipper has introduced a mechanism in the creel shooting process that eliminates the need for crewmen to come into contact with fishing gear during shooting operations.

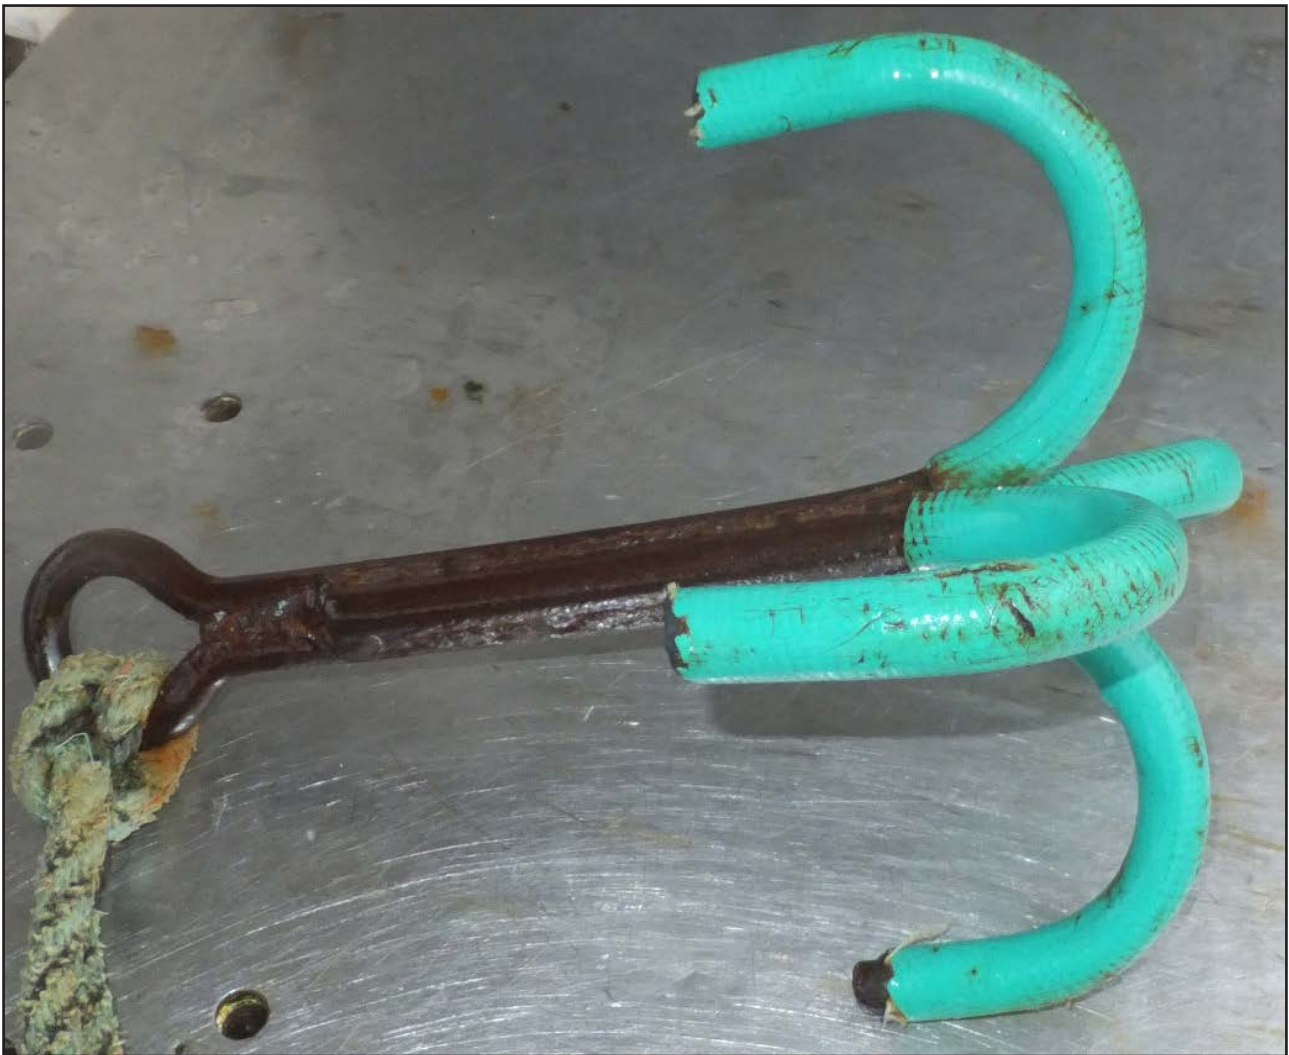
Figure 6: Grappling hook used to lift the casualty

The skipper returned to the deck controls and manoeuvred *Annie T* to bring Gerry amidships on the starboard side before attempting to secure a rope to him using the vessel's grappling hook (**Figure 6**). After failing to lift Gerry with his hands, he

managed to hook the grapple onto several layers of Gerry's clothing and was able to lift him back on board using the hauler. Having laid Gerry on the deck the skipper thought he detected a faint pulse.

- 2016/146** Prioritise the introduction of legislation that will require the compulsory wearing of personal flotation devices on the working decks of all fishing vessels while at sea.
- 2016/147** Issue guidelines regarding manoverboard recovery equipment for fishing vessels under 15m in length.

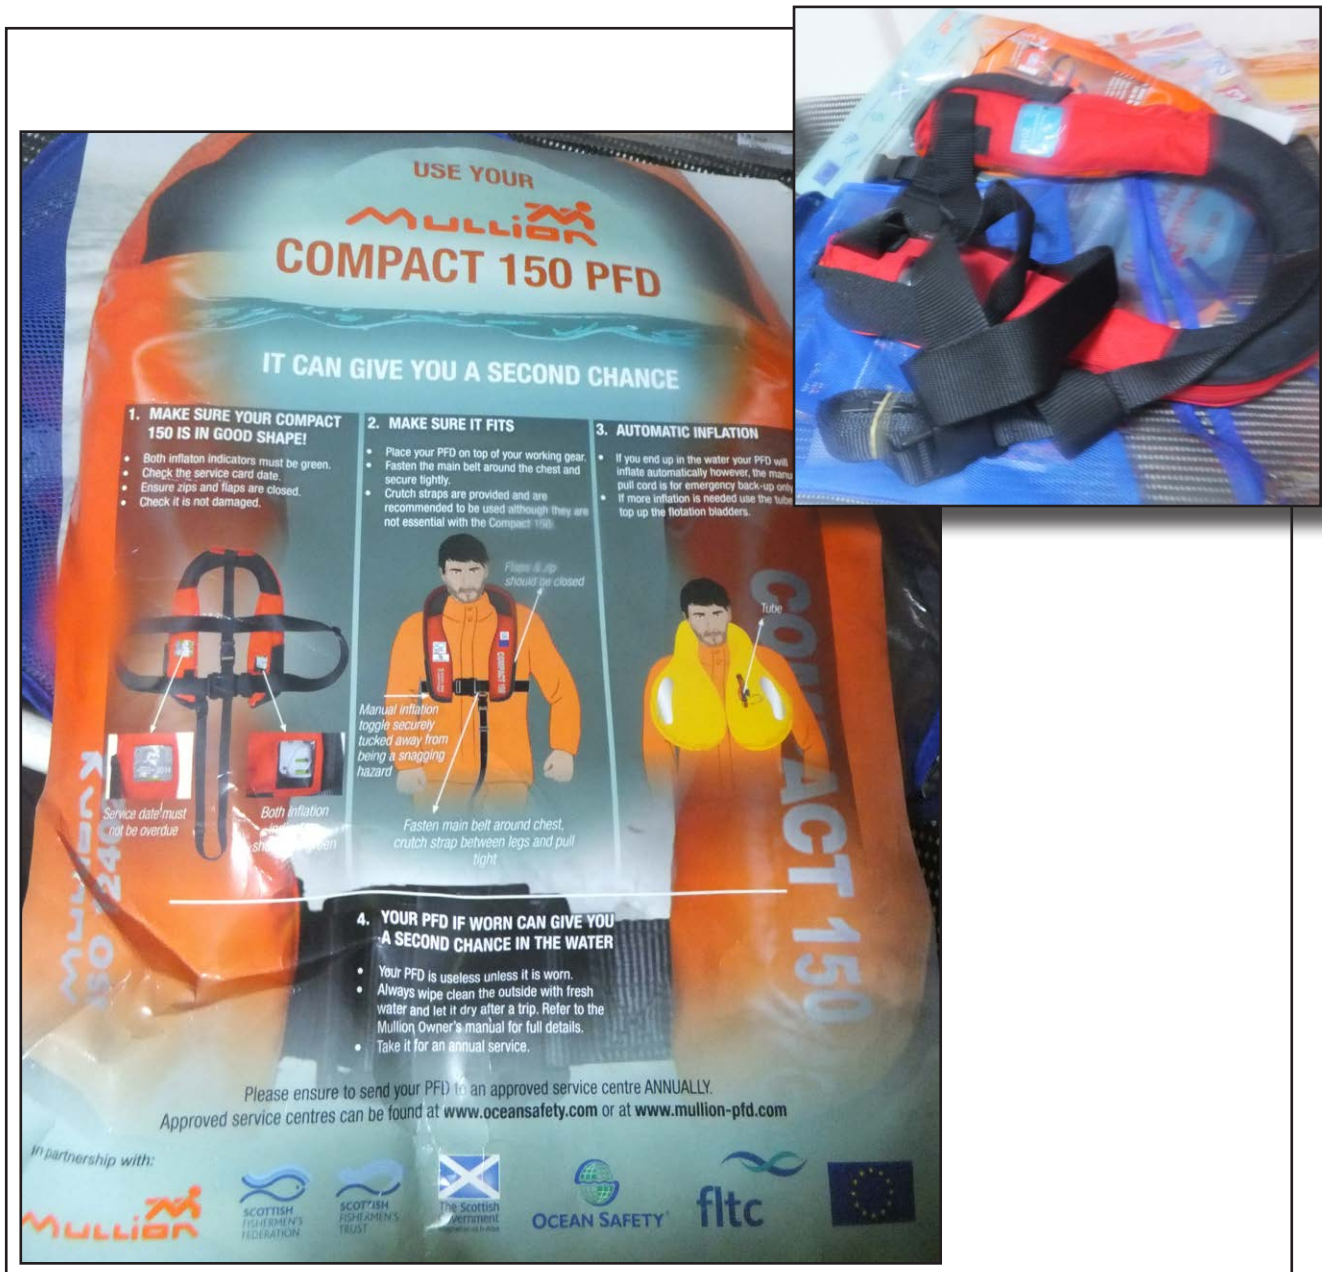
Figure 8: Lifejacket in its original package (inset: lifejacket strap)

During the investigation, three Mullion Compact 150 Newton (N) buoyancy, constant wear lifejackets were found on board *Annie T* in the storage space forward of the wheelhouse. They were unused and in their original packaging (**Figure 8**).

Had Gerry been wearing one of the constant wear lifejackets available on board *Annie T* while he was working on deck it is likely that he would have survived this accident.
