AIRCRAFT ACCIDENT REPORT 2/2018

Report on the serious incident to
Boeing 737-86J, C-FWGH
Belfast International Airport
on 21 July 2017

Air Accidents Investigation Branch

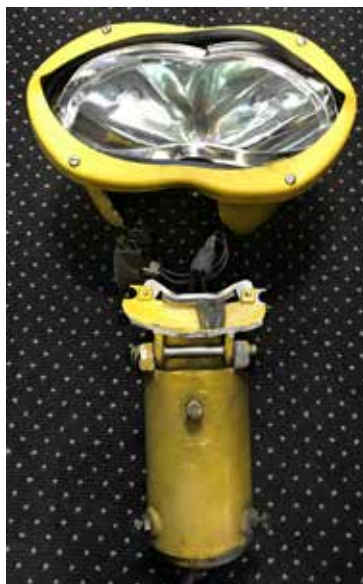
Figure 2

One supplementary approach light for Runway 25 at BFS was found damaged (Figure 2). The light was found crushed and lying on the ground having been knocked from its mounting¹⁰.

Supplementary approach light damage

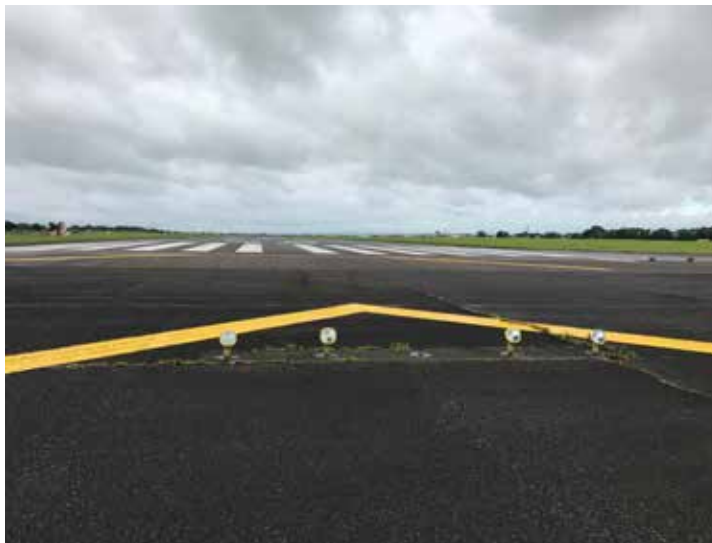
Within the stopway were two sets of supplementary approach lights for Runway 25. Each of these sets had thirteen lights set out in three groups across the tarmac. These lights were positioned 36 cm above the stopway surface. The first set of lights was 29 m beyond the end of Runway 07, with the stopway ending 60 m beyond the end of Runway 07. The aircraft struck the centre light within the first set of supplementary approach lights. Figure 5 shows the layout of the lights, together with the dimensions of the stopway and indicates the direction of travel of the aircraft and the light the aircraft struck. Figure 6 shows the view from the stopway with the centre light missing.

The view from the stopway showing the centre light missing

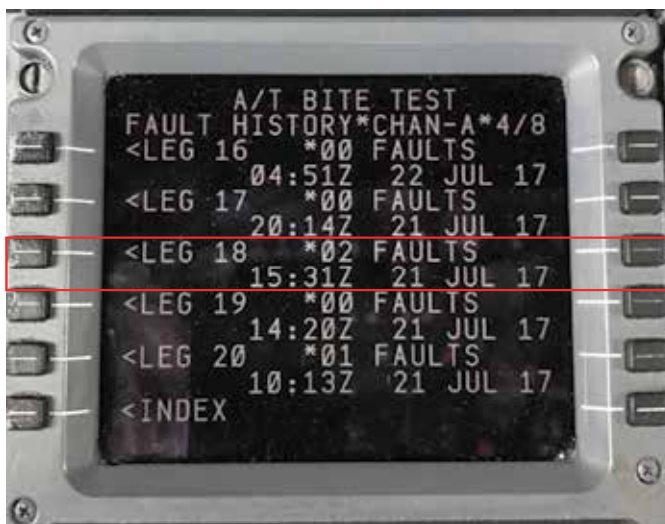
Figure 7

The CDUs support an interface to Built-in Test Equipment (BITE) for various aircraft systems, including the autothrottle system. The AAIB examined the autothrottle BITE data on the CDUs and this showed that two faults¹⁴ had been logged for the incident sector (see the red box in Figure 7).

CDU autothrottle BITE history

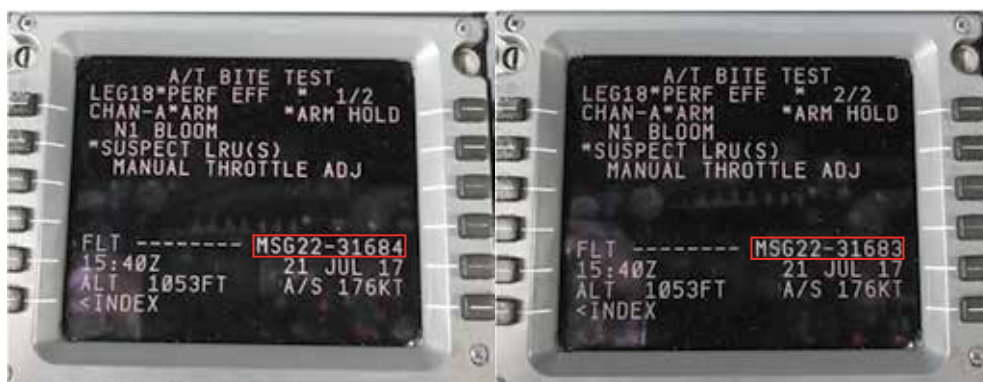
Figure 8

These faults related to the initial climb-out from BFS, and the CDS pages for them are shown in Figure 8. Both messages relate to an 'N1 Bloom' and the message identification numbers are highlighted by red boxes in Figure 8.

Detailed CDS fault pages for both faults logged

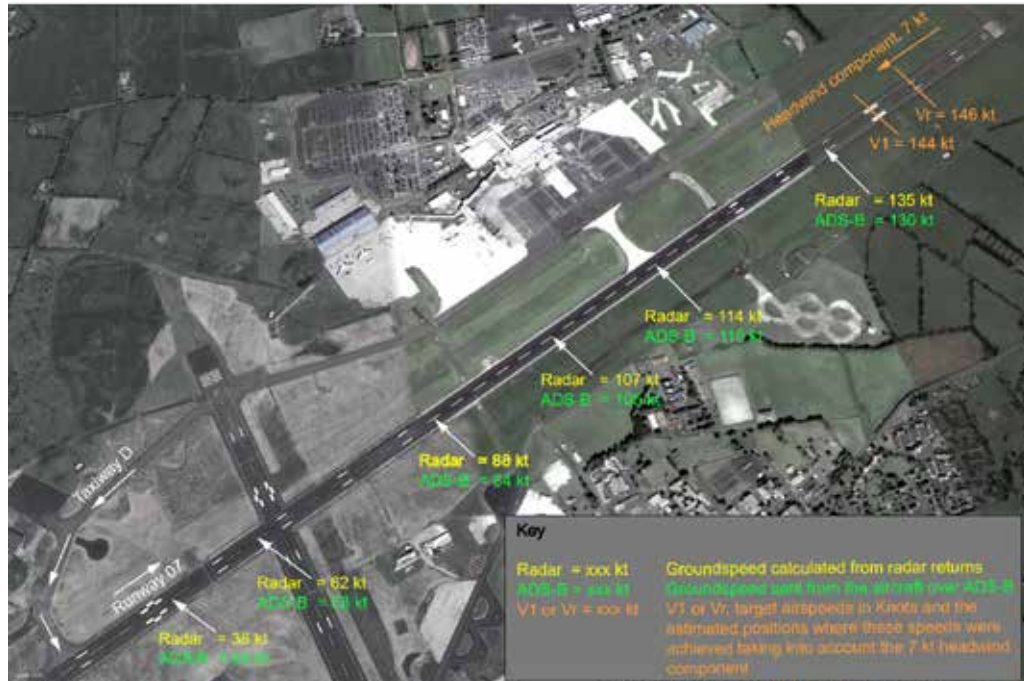
The radar installation at Belfast International Airport tracked C-FWGH along Runway 07 and during initial climb-out, when altitude data also became available from the aircraft's transponder. The radar returns allowed groundspeed for the aircraft to be calculated which was supplemented by both groundspeed and altitude data transmitted from the aircraft over its Automatic Dependent Surveillance – Broadcast (ADS-B) datalink. This data is shown in Figure 10 for the ground roll, where the text in yellow represents calculated groundspeed data from the radar track and, in green, the received ADS-B groundspeeds. Orange lines show the approximate position where the aircraft achieved airspeeds equivalent to the EFB-calculated V_1 and V_R , considering the 7 kt headwind component. V_R would have been achieved approximately 300 m from the end of the runway.

Groundspeed data for the takeoff in relation to the EFB calculated V_1 and V_R
 © 2017 Google, Image © 2017 DigitalGlobe

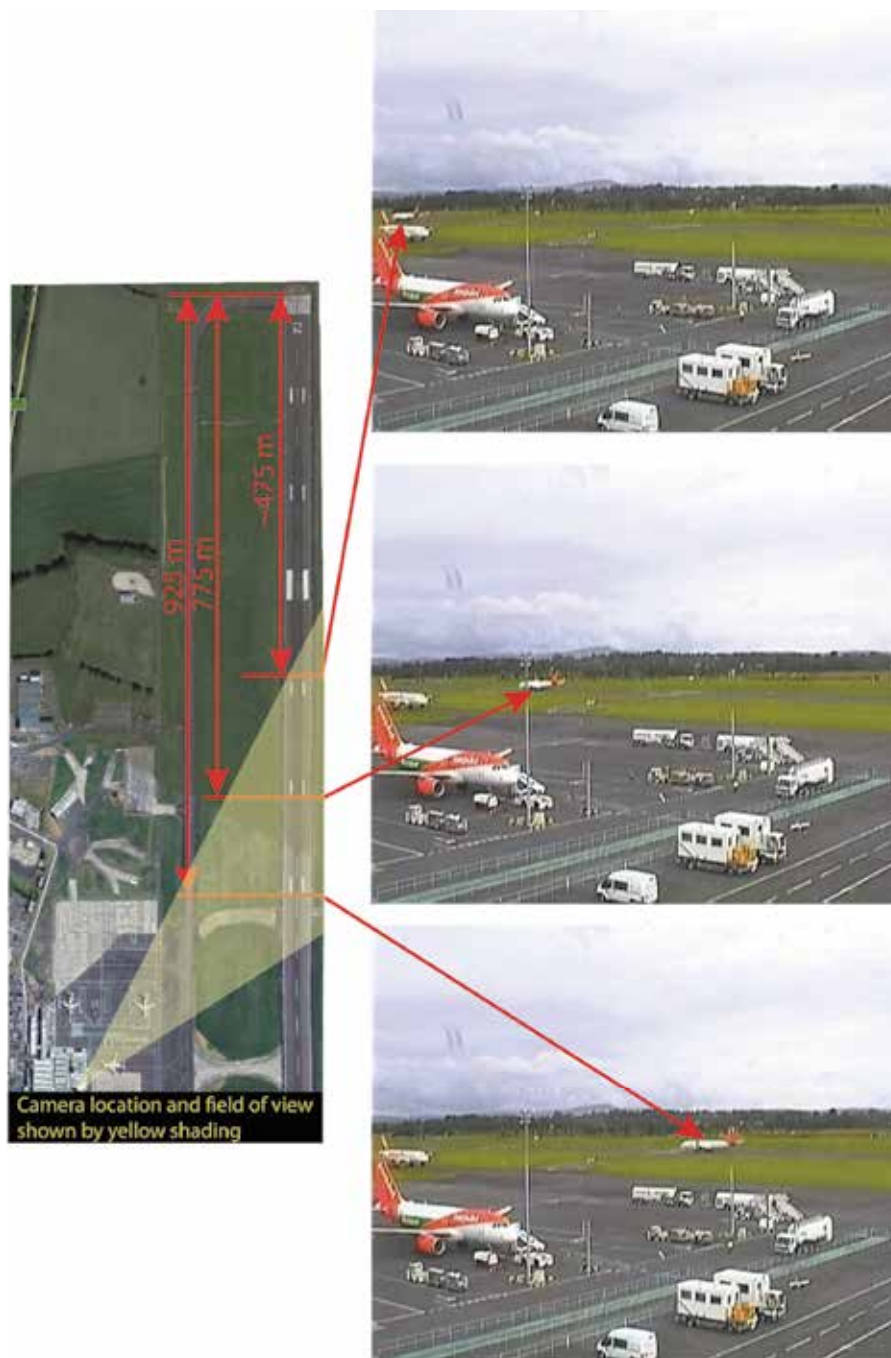
Figure 12

The airport operator provided the AAIB with closed-circuit television (CCTV) recordings of C-FWGH's takeoff from two cameras. The first camera's field of view recorded the segment between 1,000 m and 475 m from the departure end of Runway 07. At the end of this segment, C-FWGH had not rotated (Figure 12).

The first CCTV recording showing C-FWGH's takeoff

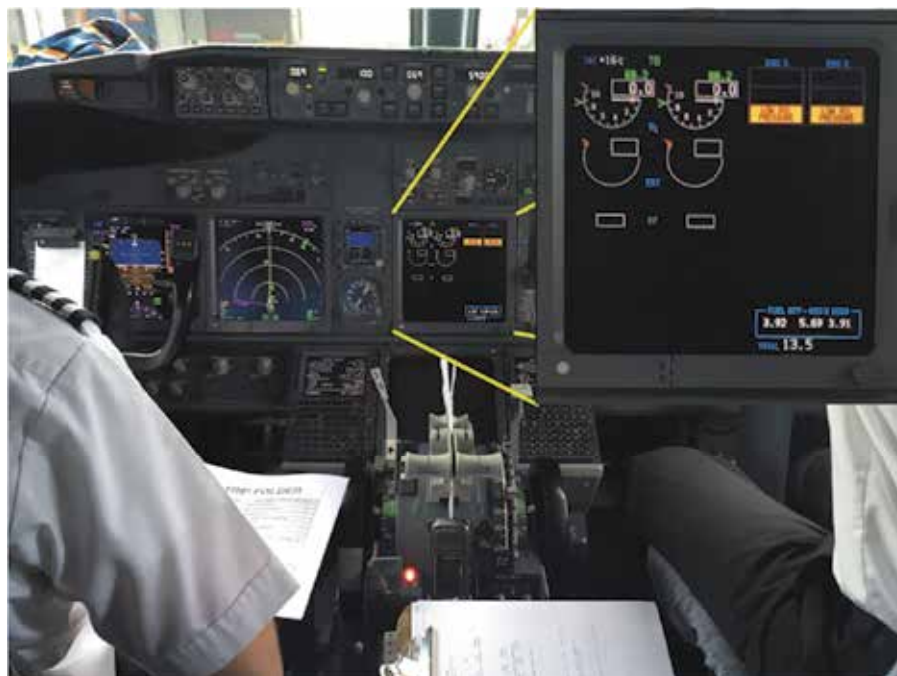
Figure 14

Cockpit photo and N_1 display prior to first pushback

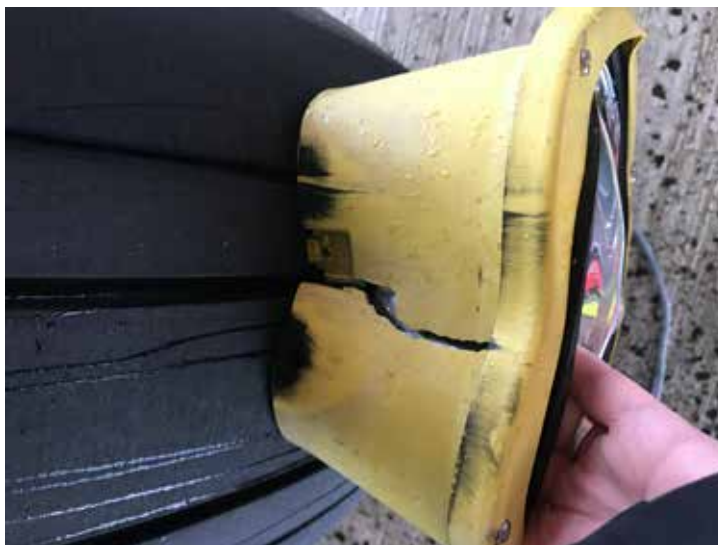
Figure 16

One of the supplementary approach lights within the Runway 07 stopway was found lying on the ground during the runway inspection. Closer examination revealed that the light had significant impact damage with evidence of black rubber deposits.

When compared with the tread on the tyres on C-FWGH, the pattern of rubber deposits indicated that the light had probably been struck by one of the main gear tyres. Chemical analysis of the rubber deposit was unable to confirm whether a main or nose landing gear tyre struck the light (Figure 16).

Aerodrome lights are designed to be frangible. If struck by an aircraft they are to break causing minimal or no damage to the aircraft. The crew were unaware that they had struck a runway light and there was no damage to the aircraft structure or tyre from striking the light.

Tread pattern comparison with main gear tyre

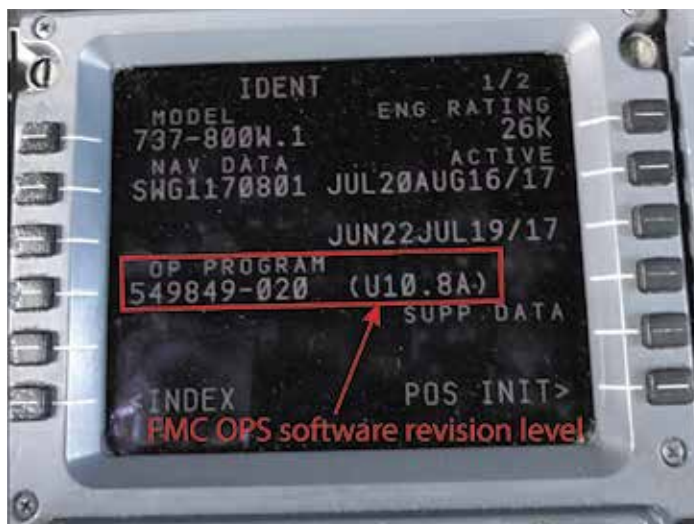
Figure 18

At the time of the serious incident, C-FWGH had an earlier revision of FMC OPS software installed, U10.8A (Figure 18), which did not include this crosscheck.

CDU IDENT page of C-FWGH
