Report on the investigation into
the capsize and foundering of the fishing vessel
Solstice (PH199)
resulting in one fatality
approximately 7 miles south of Plymouth, England
26 September 2017

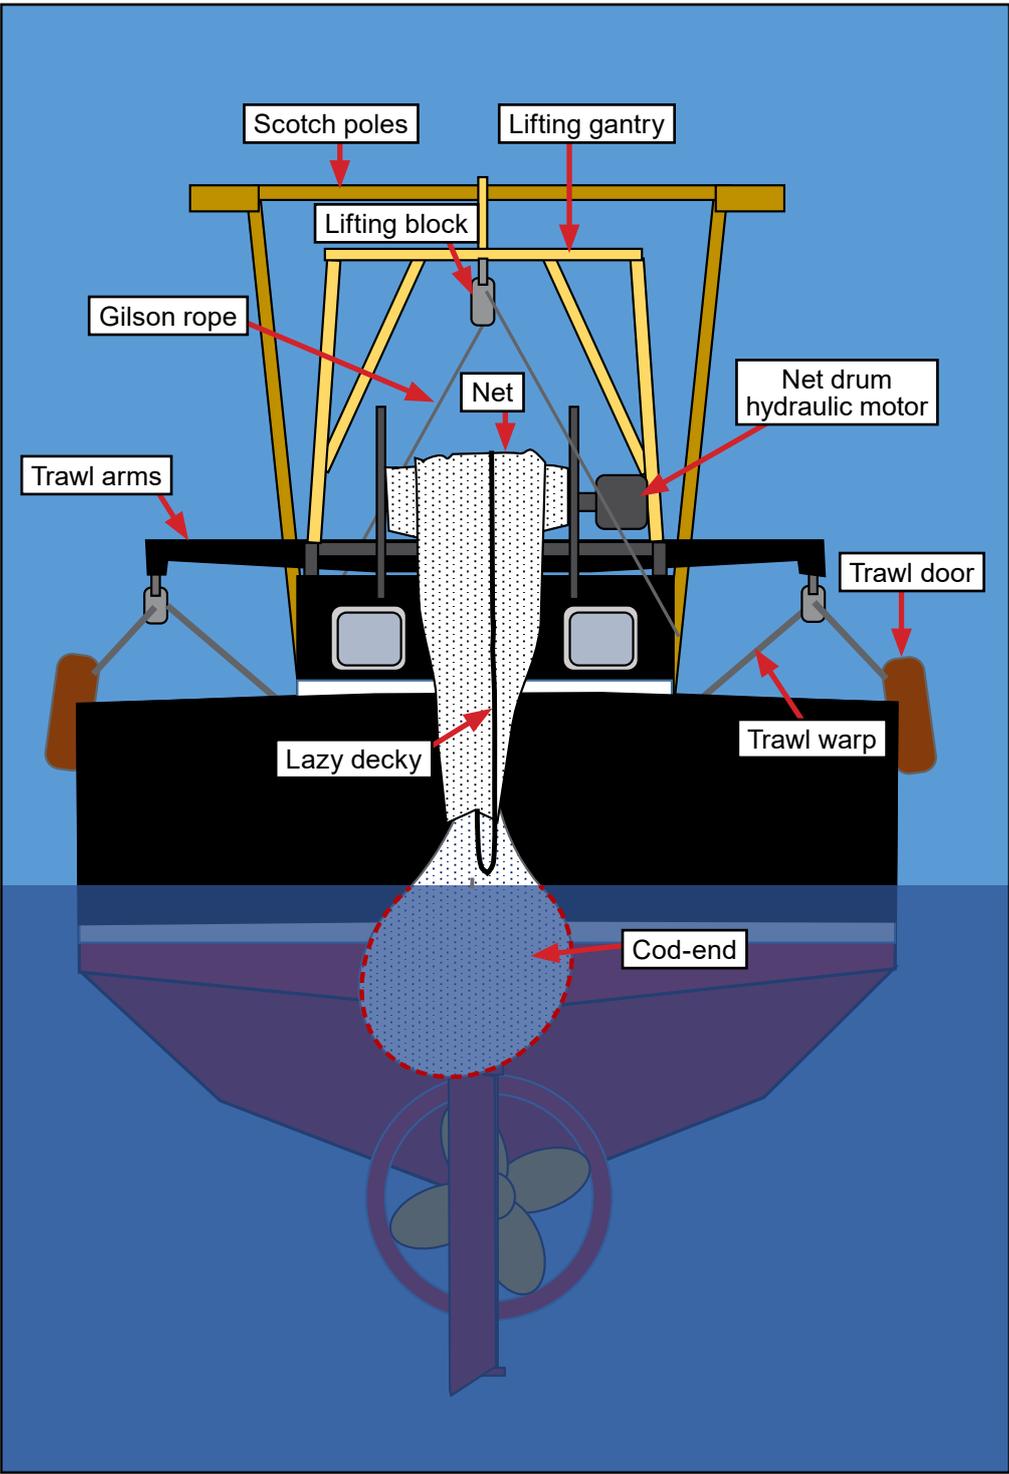
Figure 4: Recovery of cod-end – view from astern

Tony and the skipper visually inspected the net drum and concluded that its hydraulic motor or gearbox had probably failed. Realising that they could not repair the net drum, Tony decided to attach a hook to the gilson rope and use the main deck winch to haul in the net and land the catch.

The skipper went forward to operate the winch while Tony and the crewman stayed aft to recover the net. The crewman attached the lifting hook to the net and the skipper hauled in on the gilson rope. Each time the lifting hook reached the pulley block at the top of the aft gantry (**Figure 5**), the net was secured by a rope to the handrail at the stern of the wheelhouse and the hook lowered. The loose section of net was then laid on the deck behind the wheelhouse. This process was repeated many times. As the cod-end started to rise out of the water the rope used to tie off the net parted and the weight of the catch pulled the net overboard for a second time. The process of recovering the catch was started again.

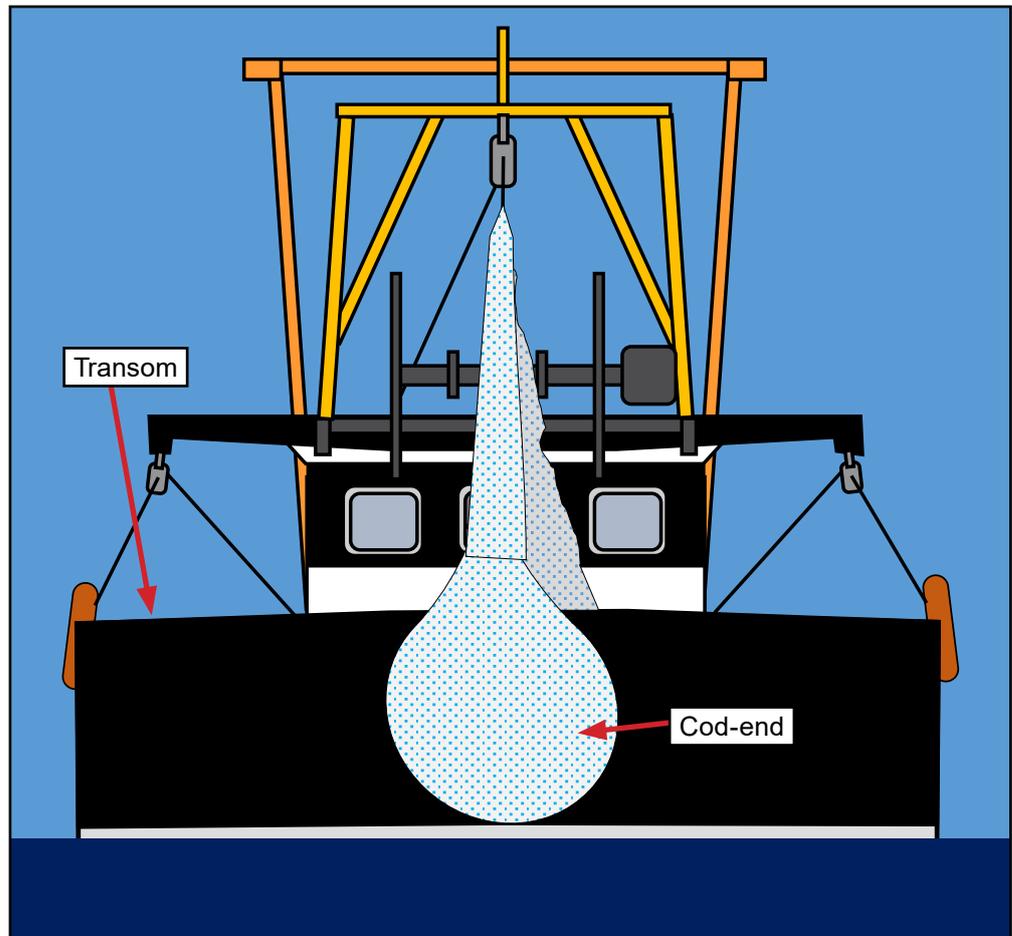
Figure 6: Cod-end out of the water, resting on the transom – view from astern

At about 1930, the cod-end was lifted clear of the water (**Figure 6**); it was full of fish, sand and moss. With the weight of the catch suspended from the gantry block, *Solstice* started to roll more heavily and the cod-end began to roll along the top of the transom. As the vessel rolled to port, the gilson rope and net slipped over the net drum cheek⁸ plate. As the cod-end swung further from the centreline it caused *Solstice* to list heavily to port (**Figure 7**).

If not already apparent, the crew should have realised the weight they were trying to lift was excessive when the net drum failed. A further indicator was the parting of the rope used to hold the weight of the net during the subsequent attempts to recover the catch.

The weight in the net alone would have significantly reduced the vessel's freeboard aft and therefore affected its stability. Using the lifting block rigged at the top of the gantry magnified the problem because the weight of any object acts through the point of suspension. As soon as the cod-end was lifted clear of the water, its VCG and the effect of its full weight would have shifted to the top of the gantry block (**Figure 32**). This would have caused *Solstice's* VCG to move even further upwards, making the vessel dangerously unstable.

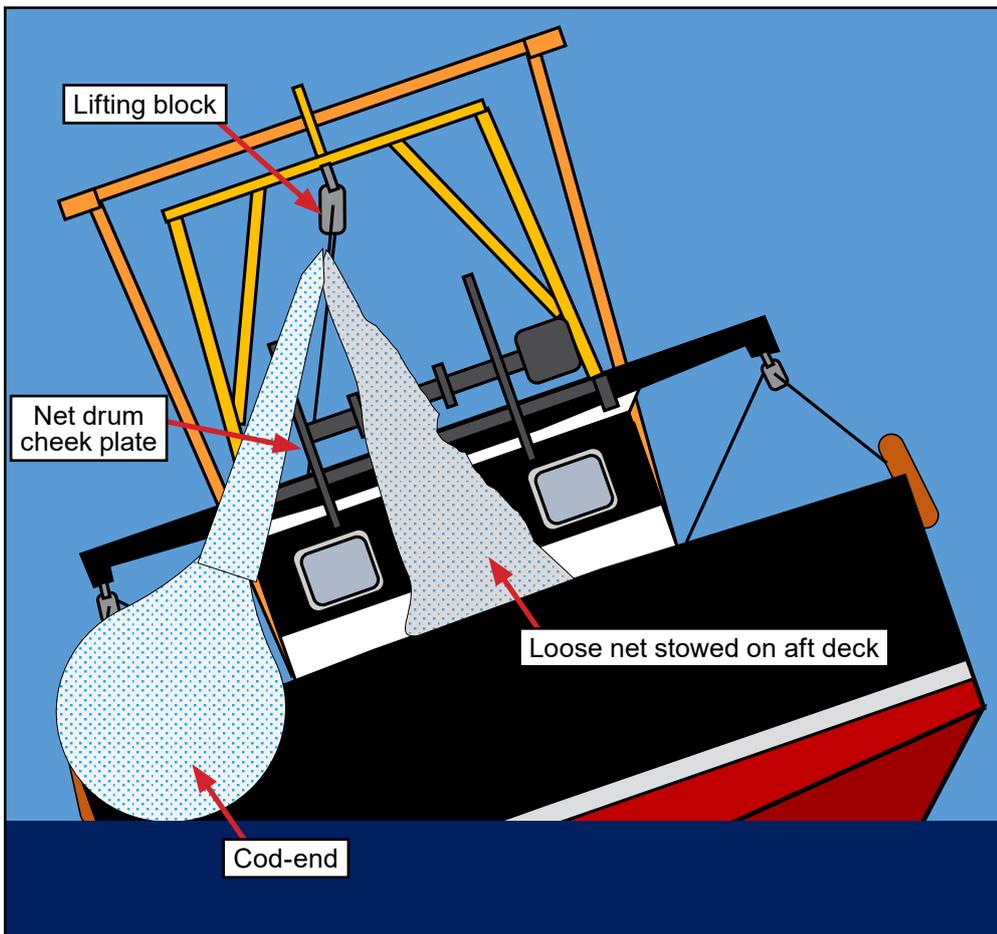
Figure 7: Cod-end on port quarter, heavy list to port as cod-end rolled across the transom – view from astern

When a suspended load swings outward in the direction of any heel, it pulls the vessel further over to that side, increasing the heel and the risk of capsize. If the righting moment is insufficient, the vessel cannot correct the heel and it will capsize. This is what happened when the cod-end started to roll across *Solstice's* transom.

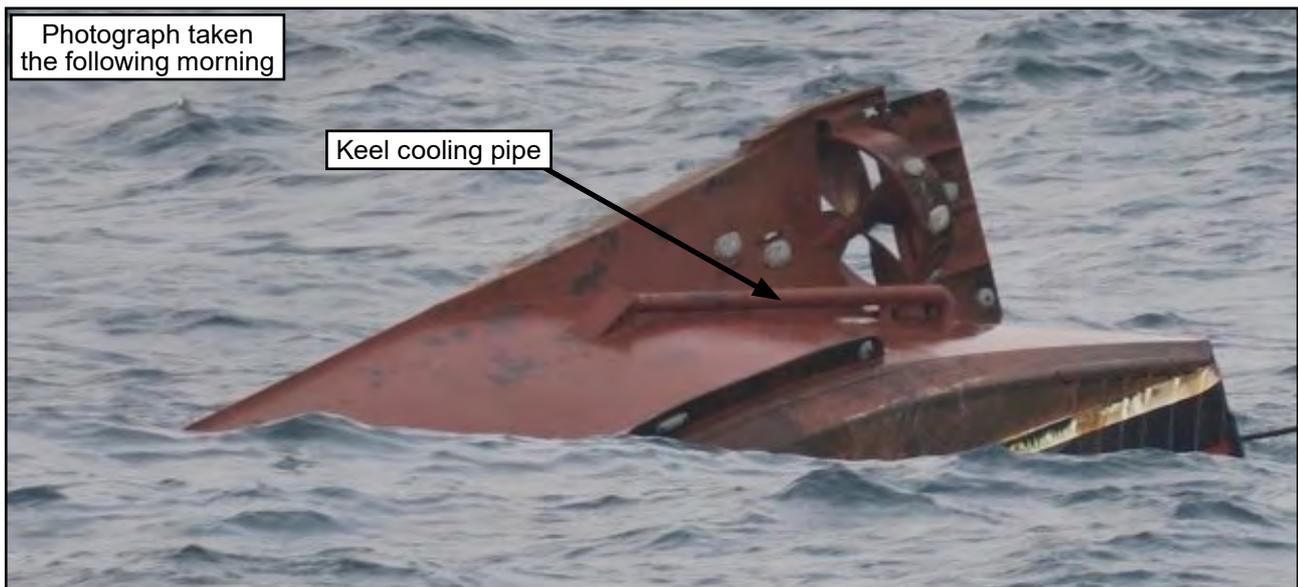
Figure 8: Upturned hull floating on surface

Solstice remained afloat with its upturned hull protruding out of the water (**Figure 8**). The crewman helped the skipper swim to *Solstice*'s hull and using the exposed scupper drains and engine cooling pipes, he climbed out of the water onto the upturned hull. He then took off his waterproof leggings and used them to help pull the skipper out of the water. Without any means of raising an alarm, the two men lay against the engine's keel cooling pipe for warmth.

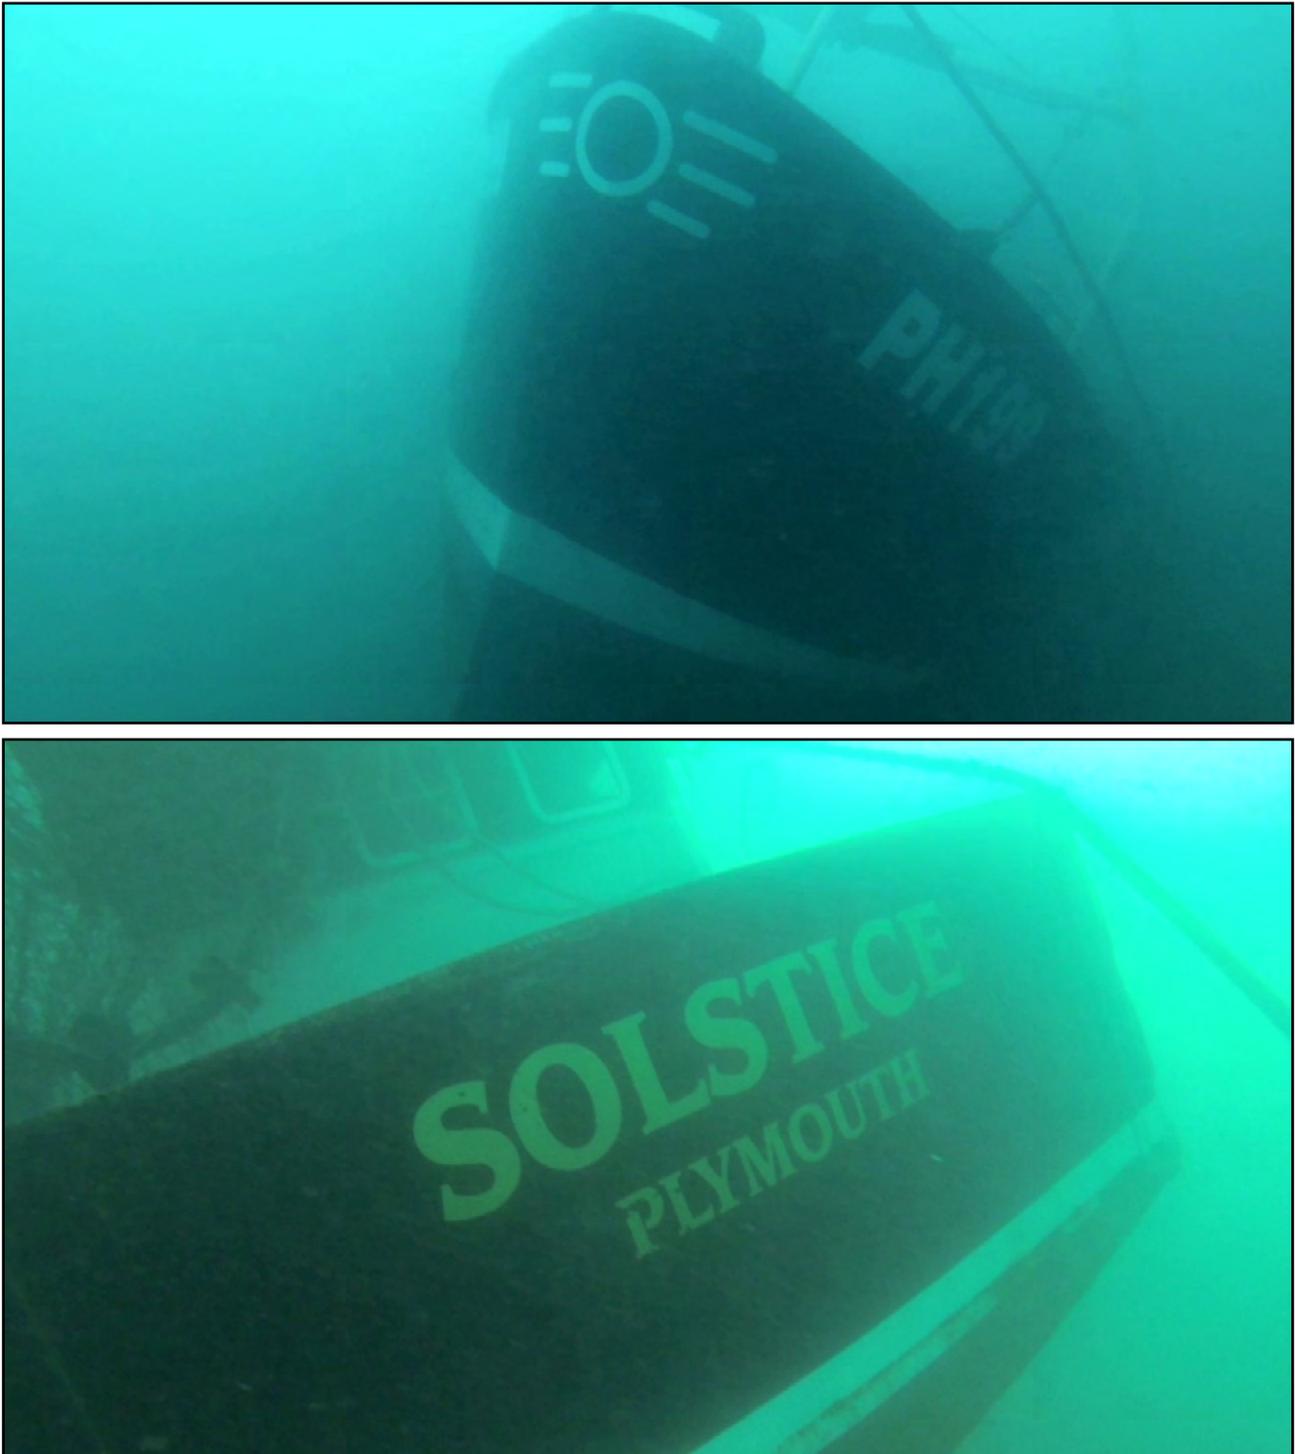
Figure 20: *Solstice* wreck lying upright in 26m of water

- *Solstice* was lying upright on the seabed at a depth of 26m (**Figure 20**).
- Its hull was intact.

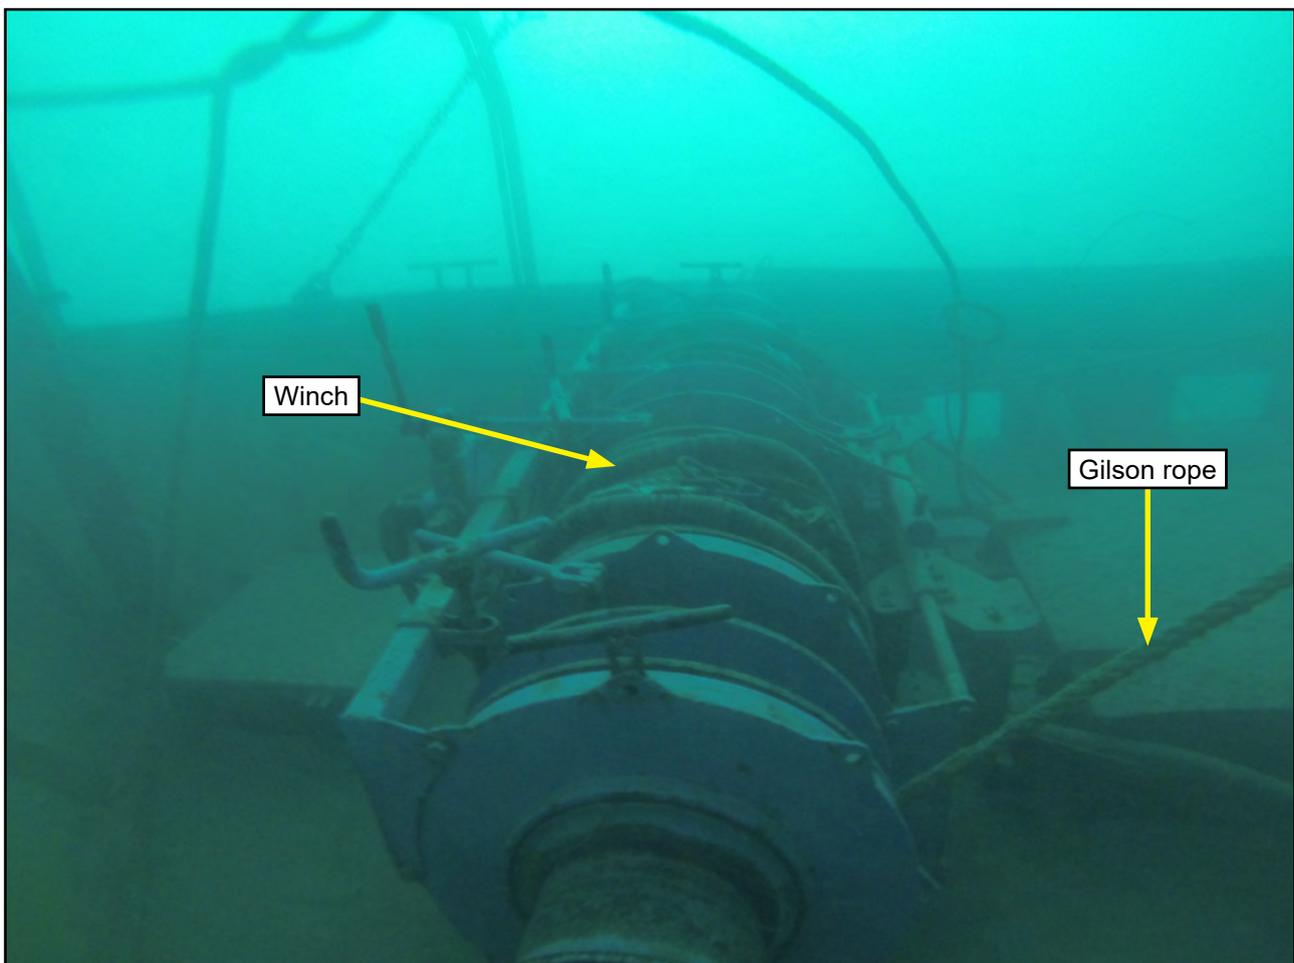
Figure 21: Wreck showing winch and gilson rope

- The gilson rope used to haul the net out of the water was 24mm diameter and was connected to the outer drum on the port side of the forward winch (**Figure 21**). The rope was rove through a block on the port side of the scotch poles to the lifting block at the top of the aft gantry.
- The forward store deck hatch was closed and secured in position by one of its two locking dogs.
- The fish hold hatch cover was in the closed position but was not locked shut.
- The wheelhouse controls (**Figure 22**) indicated that:
 - the forward winch was clutched in;
 - the propeller was de-clutched; and
 - the engine was operating at above idle speed.
- The starboard lifebuoy was still in its cradle (**Figure 23**).
- The aft deck freeing ports were closed and wedged shut (**Figure 24**).
- The mid and forward deck freeing ports were open.

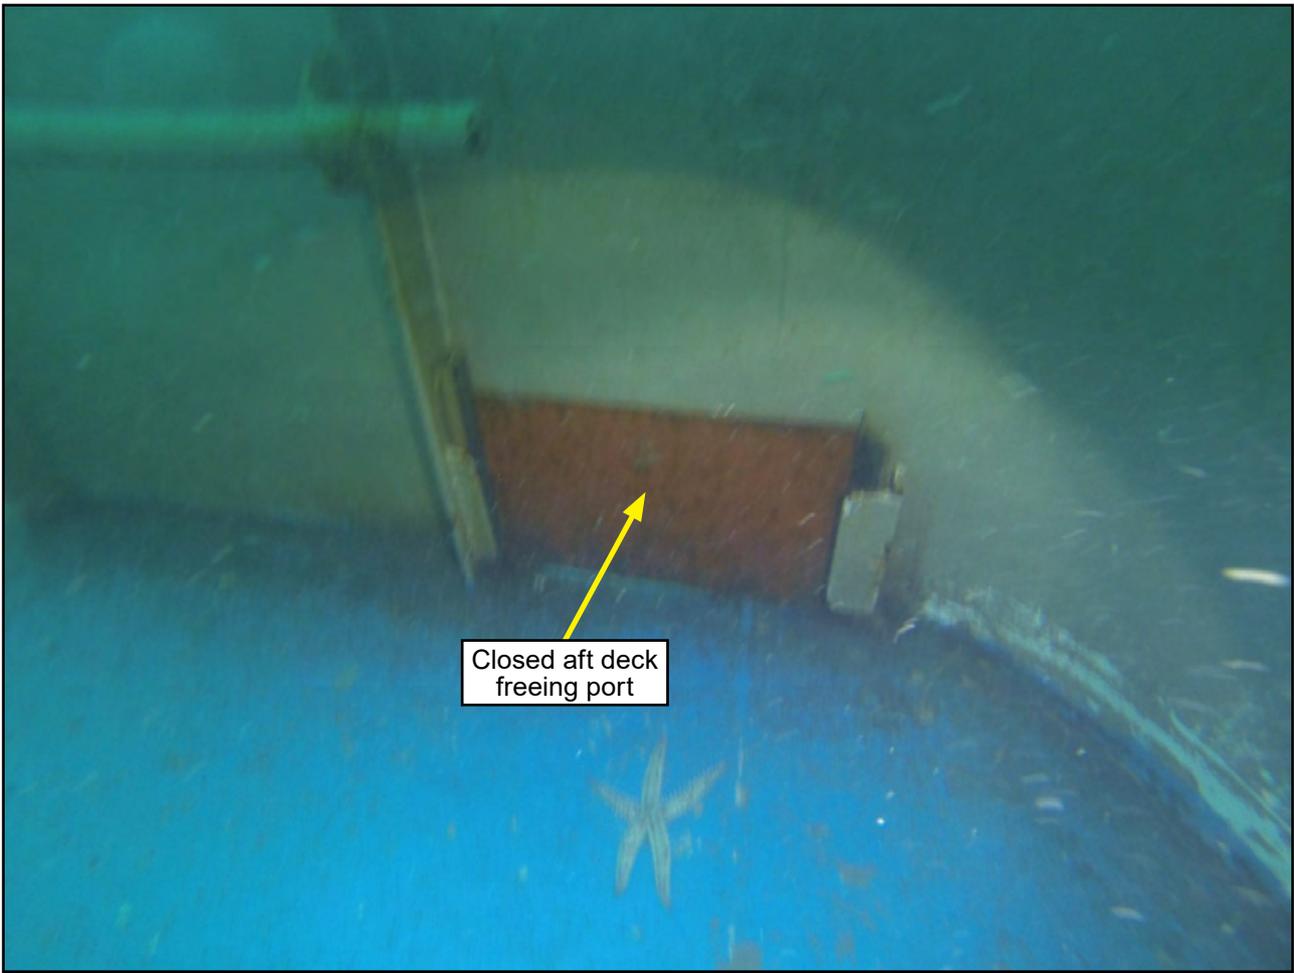
Figure 24: Aft freeing ports, closed and wedged shut

The wreck dive survey identified that the freeing ports on *Solstice's* aft deck had been wedged shut (**Figure 24**). The crew's reasoning for this was understandable as water on the aft deck would have been more problematic to the crew because that was their working area. Furthermore, the likelihood of the aft deck freeing ports being immersed would have been higher when stern trawling. This was because the trawl arms were positioned higher than the hinged dredge warp outriggers, which would have caused the vessel to trim further by the stern and therefore reduce the freeboard aft (**Figure 35**).

It is unlikely that the blockage of the aft freeing ports was a significant factor in this case, given the proximity of *Solstice's* other freeing ports. Nevertheless, any trapped water would have contributed to the capsize.

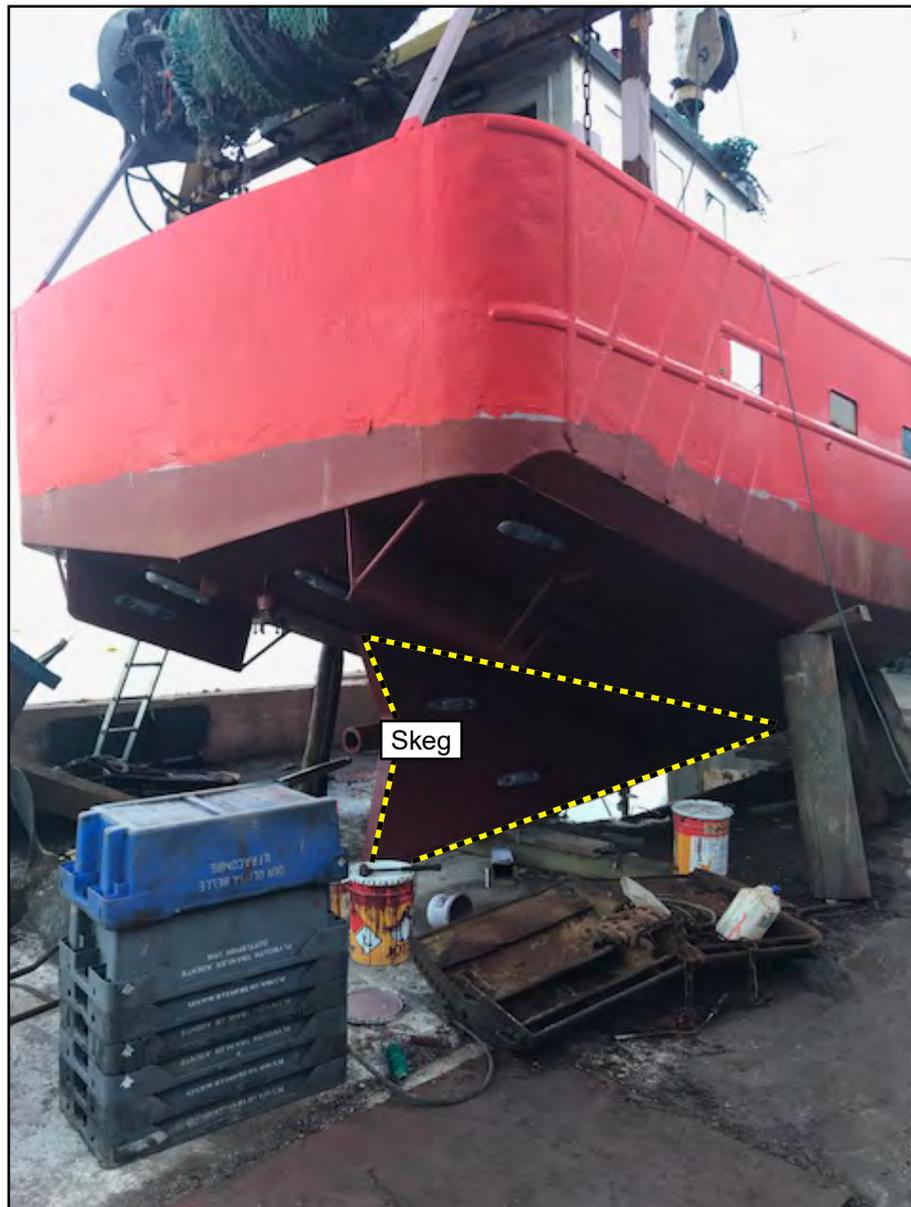
Figure 25: Similar vessel with identical hull design

On 29 September 2017, a fishing vessel with an identical hull design (**Figure 25**) and similar rigging to *Solstice* was roll and heel tested by the MCA at the port of Brixham. The vessel was predominantly engaged as a stern trawler and recovered its catch over the stern.

The roll test identified that the vessel met the requirements for the 'depart port' condition and met the freeboard standards¹⁷, but was deficient when measured against the Heel Test standard.

The report noted that the results did not take account of the type of fishing being undertaken or the loads "seen" by the axis of the net drum or gantry when hauling. The measurements also did not consider the ability of the hull form to provide sufficient reserve buoyancy or stability.

Following the roll test, the vessel owner made several alterations to reduce weight high up. The MCA surveyor recommended the vessel owner to seek additional advice to verify the loadings and limits to the working of fishing gear aft.

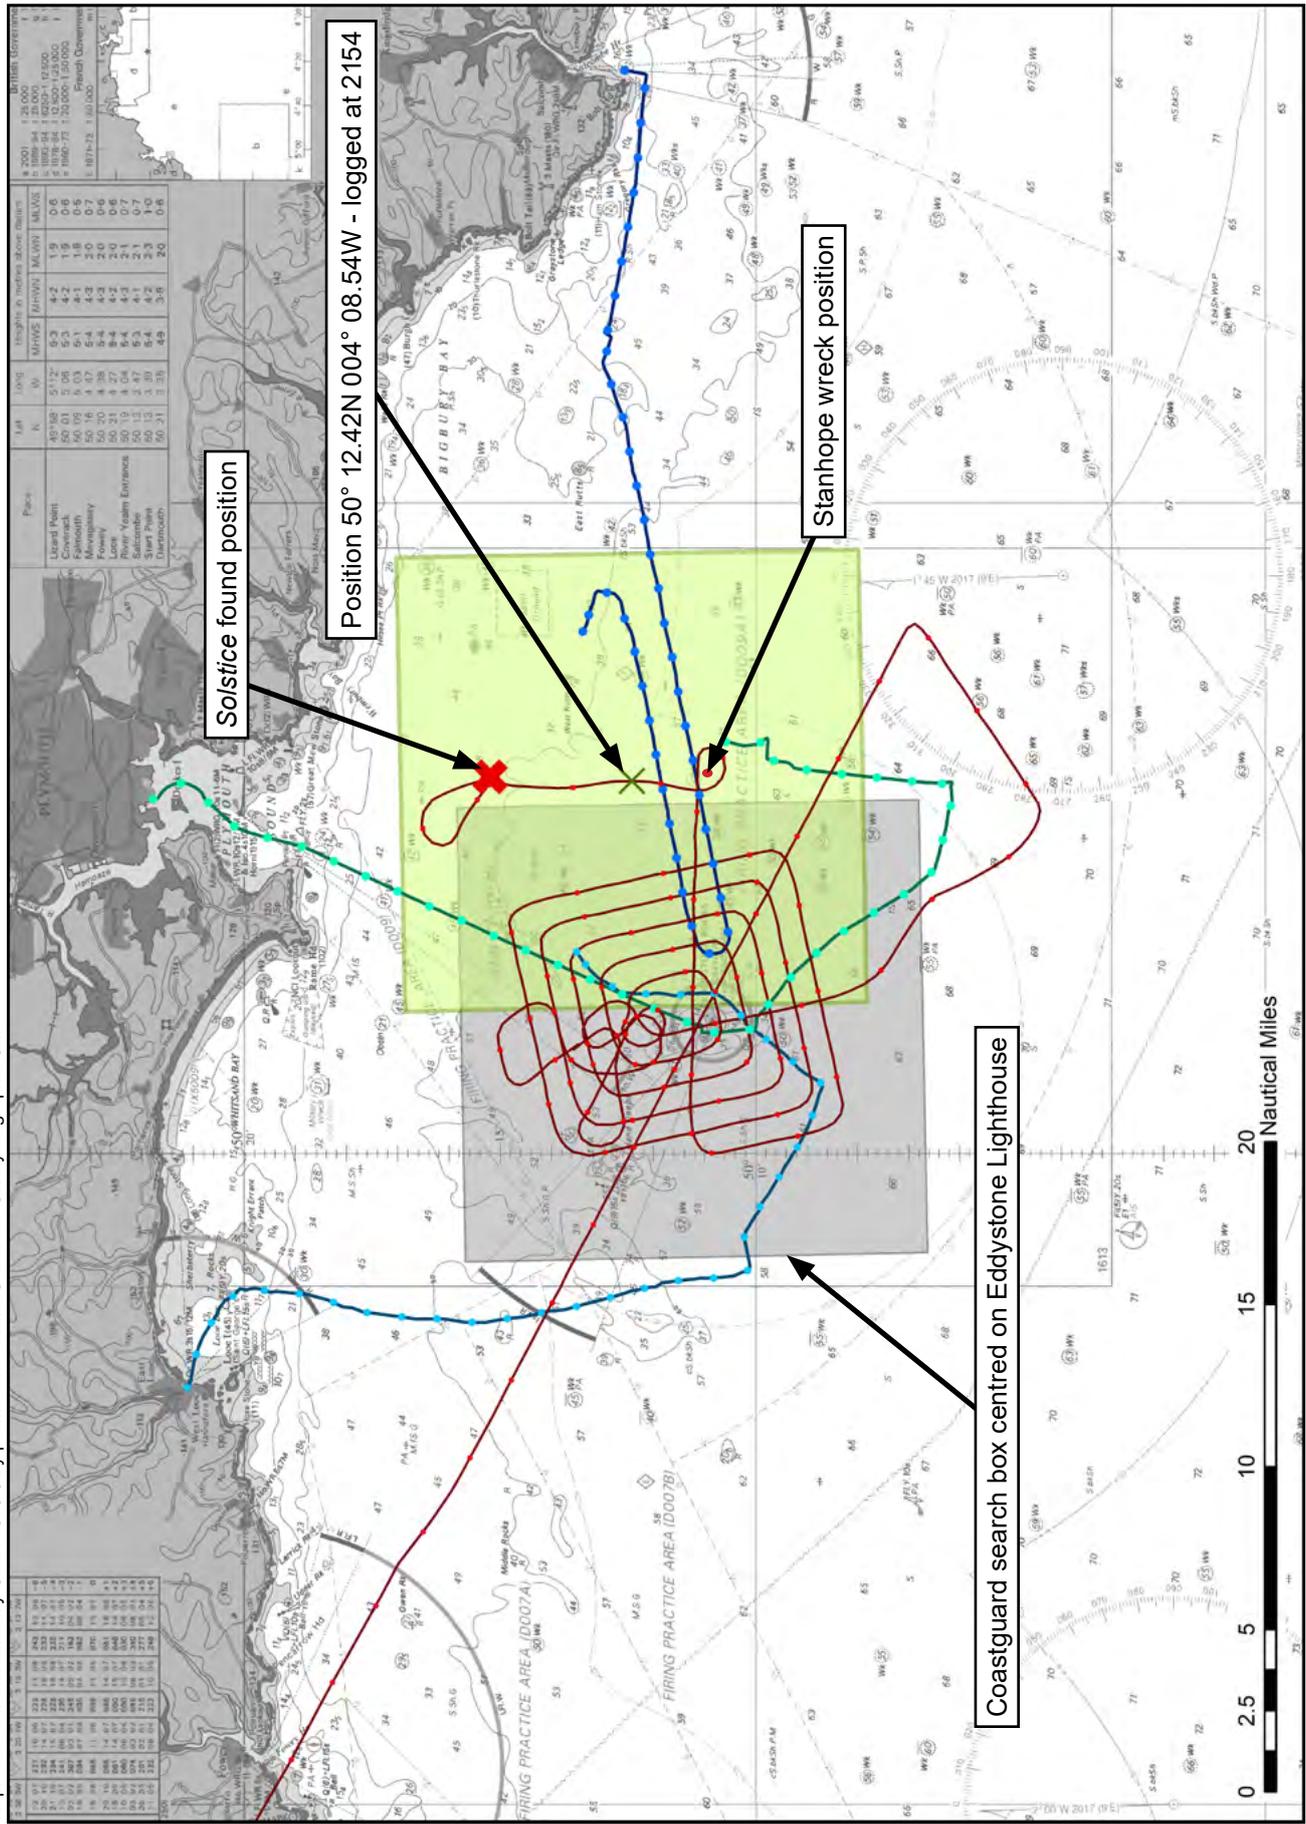
Figure 36: Coastguard search box centred on approximate position logged at 2154

When the lifeboats were launched, and the SAR helicopter tasked, the SMC did not have a detailed plan, so the Eddystone Lighthouse was used as the centre point of the search. This was because the numerous sightings reported by local fishermen (**Figure 28**) were not chronologically logged or charted, and therefore no one had a clear overview of the situation.

The success of a SAR mission often depends on the speed with which the operation is planned and carried out. The prompt collection and evaluation of information, and timely tasking of SAR assets, is therefore critical. In this case the evaluation of the information gathered was slow and the SAR mission planning process was hampered by the SMC's involvement in the initial information gathering and communications search. Had the SMC or the Duty Controller been able to stand back and take an overview, it is likely that the mission would have been escalated to the distress phase much sooner and the search plan centred on *Solstice*'s last reported position (**Figure 36**). In turn, this would probably have resulted in the upturned hull being found and survivors rescued much earlier.
