SAFETY FLYER TO THE FISHING INDUSTRY

Fishing vessel *Solstice*, capsized and sinking resulting in the loss of one life, 26 September 2017

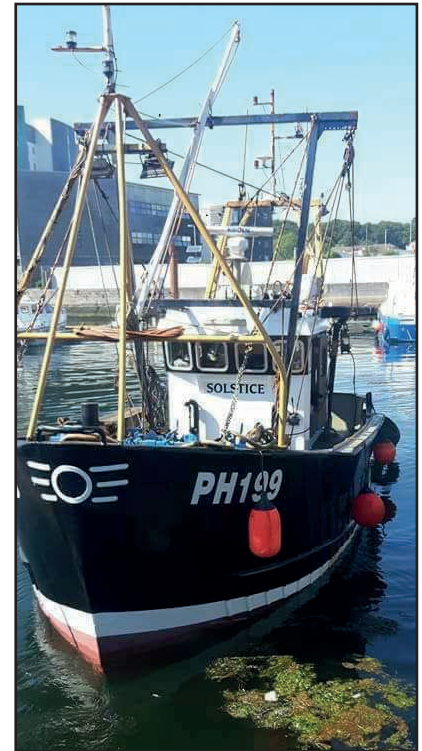
Figure 1: *Solstice*

At 1938 on 26 September 2017, the 9.9m fishing vessel *Solstice* (**Figure 1**) capsized in calm weather conditions about 7 miles south of Plymouth. The skipper and crewman were rescued from the vessel's upturned hull (**Figure 2**) about 5½ hours later, but the vessel's owner was trapped and drowned in the wheelhouse. *Solstice* later sank.

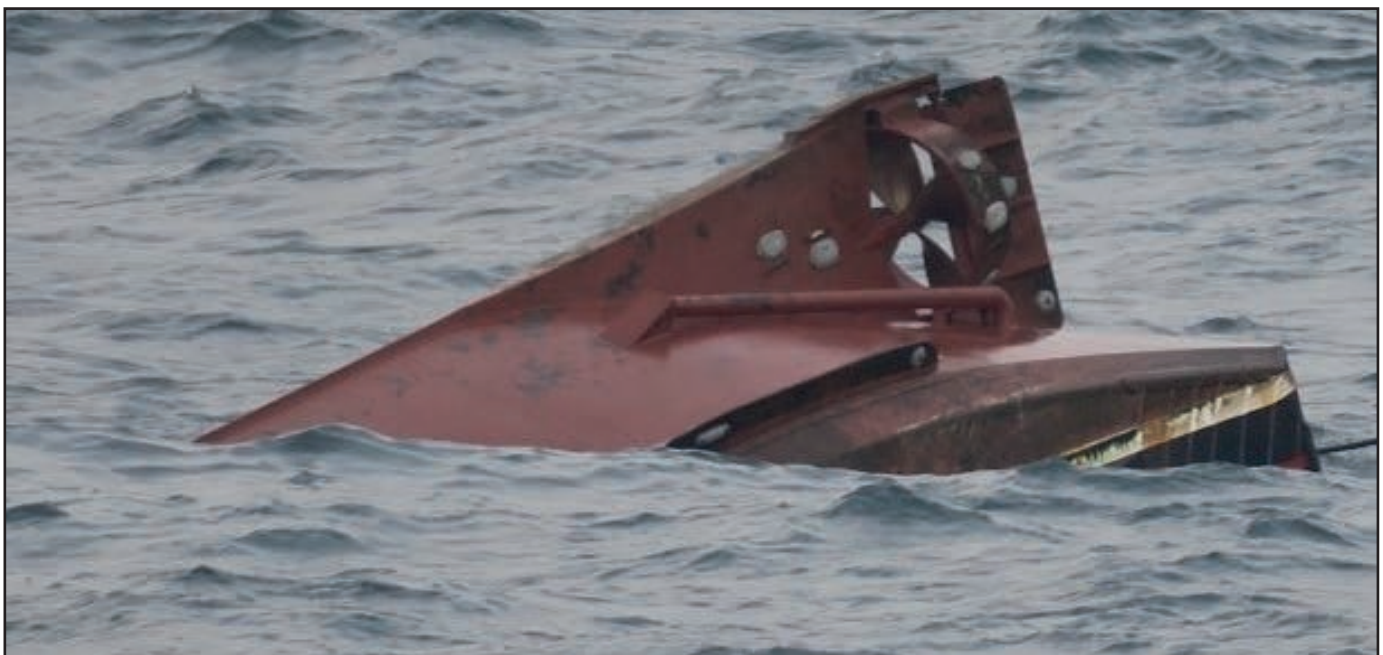
Figure 2: Upturned hull floating on surface (photograph taken the following morning)

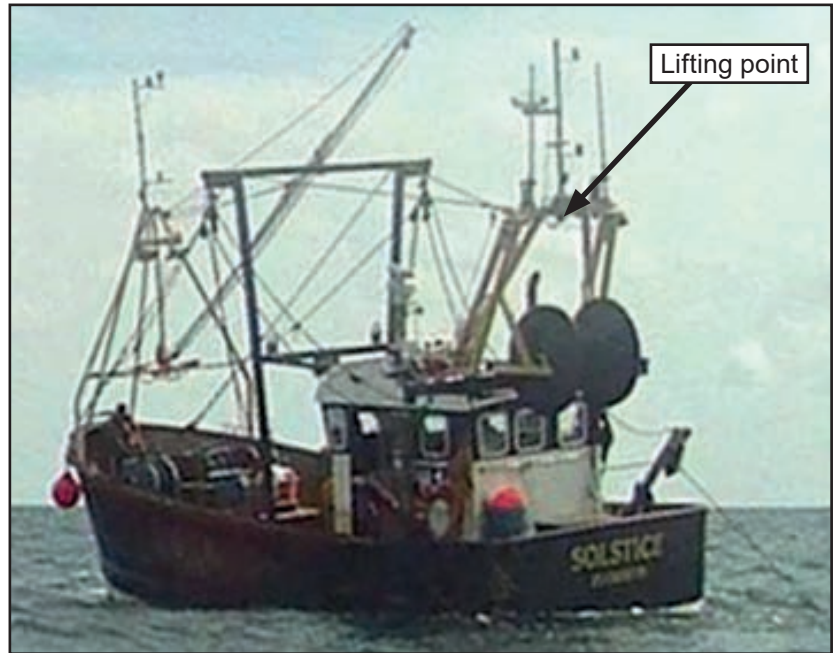
- *Solstice* capsized because it did not have sufficient transverse stability to safely lift the contents of its net on board over the stern. This was primarily because the weight in the net was excessive and the height of the lifting point at the stern was high (**Figure 3**).

Figure 3: *Solstice* scallop dredging four weeks before the accident

- It is important to have a clear understanding of your vessel's stability, but the impact that fishing methods have on stability cannot be emphasized enough. Talk to your local fishing vessel surveyors and seek expert advice if necessary before commencing any structural modifications, but especially modifications to change or alter the method of fishing.
