# AAIB Bulletin S2/2018

## *SPECIAL*

### ACCIDENT

<b>Aircraft Type and Registration:</b>	Agusta AW169, G-VSKP
<b>No &amp; Type of Engines:</b>	2 Pratt & Whitney Canada PW210A turboshaft engines
<b>Year of Manufacture:</b>	2016 (Serial no: 69018)
<b>Location</b>	King Power Stadium, Leicester
<b>Date &amp; Time (UTC):</b>	27 October 2018 at 1937 hrs
<b>Type of Flight:</b>	Private
<b>Persons on Board:</b>	Crew - 1                      Passengers - 4
<b>Injuries:</b>	Crew - 1 (Fatal)              Passengers - 4 (Fatal)
<b>Nature of Damage:</b>	Aircraft destroyed
<b>Commander's Licence:</b>	Airline Transport Pilot's Licence (A and H)
<b>Commander's Age:</b>	53 years
<b>Commander's Flying Experience:</b>	To be confirmed Last 90 days - 40 hours Last 28 days - 7 hours
<b>Information Source:</b>	AAIB Field Investigation

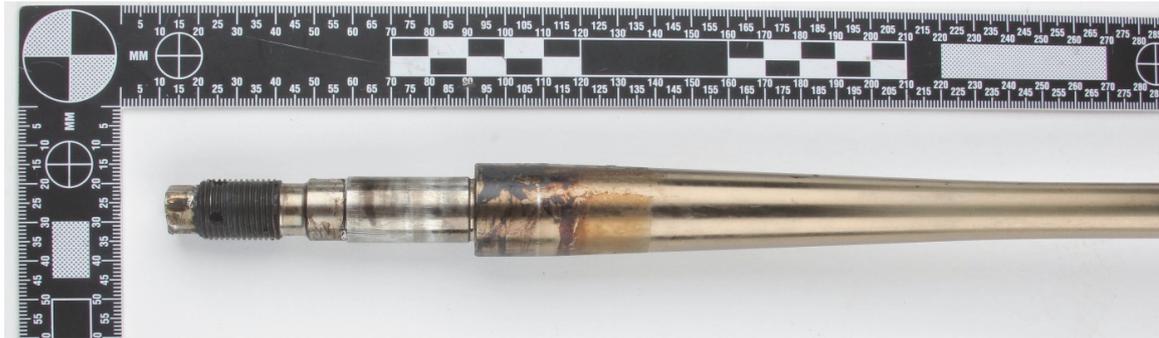
**Figure 5**

The control shaft, the locking nut and pin carrier, and the duplex bearing/sliding unit assembly were removed from the wreckage and inspected in detail. The locking nut on the bearing end of the control shaft was found to have a torque load significantly higher than the required assembly value. The inner races of the bearing could only be rotated a few degrees in either direction by hand. There was a build-up of black grease inside the slider unit around the inboard face of the duplex bearing. The section of the control shaft adjacent to this bearing face showed evidence of burnt-on grease and was discoloured along its length (Figure 5).

Duplex bearing location on tail rotor actuator control shaft after removal

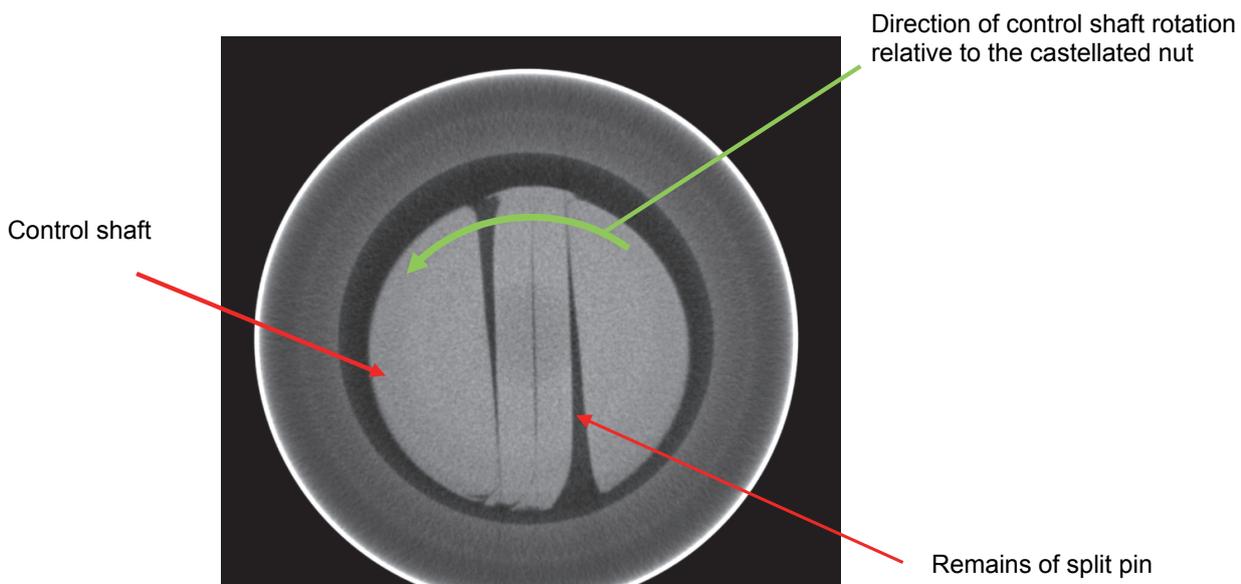
**Figure 6**

The components were then inspected using a Computed Tomography (CT) Scanner. This uses x-rays to image the inside of the components, then recreates them as a 3-D model. The results showed that the nut and pin carrier were friction welded together. The threaded portion of the control shaft, at the actuator end, was inside the outer shaft and contained the remains of the split pin. The top and bottom of the split pin had been sheared off in rotation (Figure 6).

CT Scan through tail rotor actuator control shaft (viewed from actuator end)

Sufficient force and torque had been applied to the castellated nut on the actuator end of the control shaft to friction weld it to the pin carrier and to shear the installed split pin. The observed condition of the duplex bearing and the increased torque load on the castellated nut that remained on the spider end of the shaft is consistent with rotation of the tail rotor actuator control shaft. Whilst the shaft was rotating and a yaw control input was applied, the shaft “unscrewed” from the nut, disconnecting the shaft from the actuator lever mechanism, and causing the nut to become welded to the pin carrier.

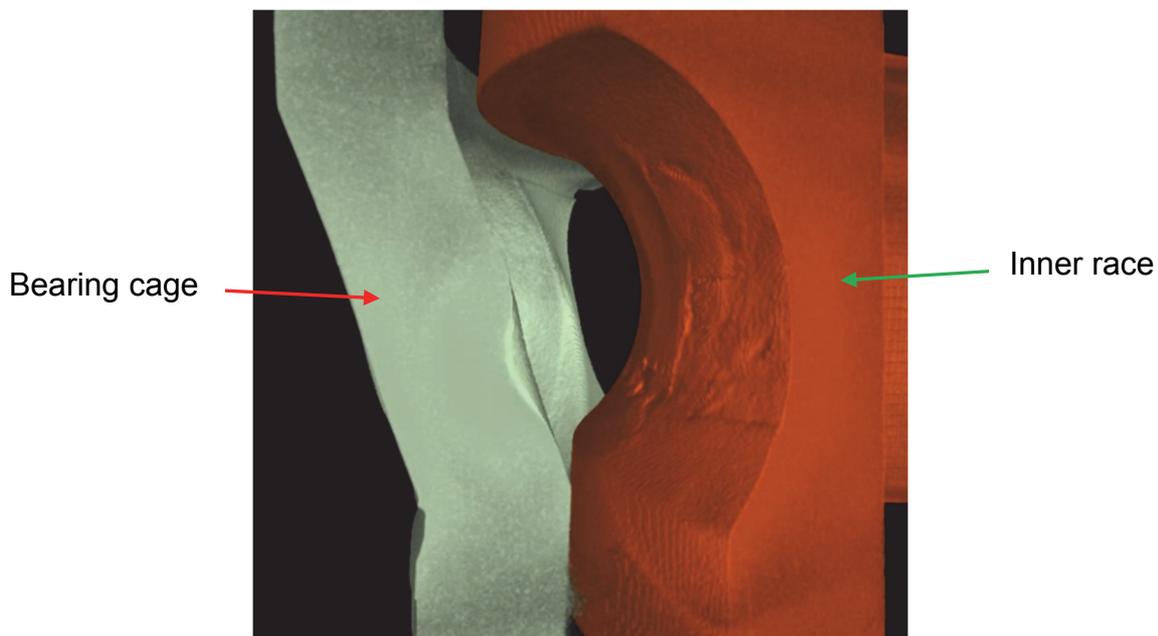
**Figure 7**

The scan of the bearing showed fractures to the bearing cages and significant damage to the surface of the inner bearing races, the damage being worse on the inboard bearing race (Figure 7) where there was also evidence of sub-surface damage.

CT imagery of duplex bearing inboard inner ring surface damage

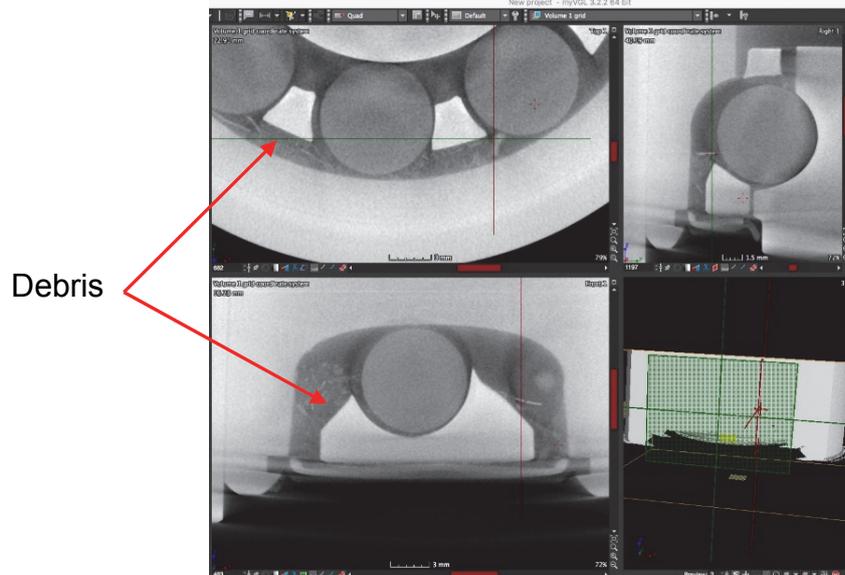
**Figure 8**

The scan also showed evidence of debris accumulating in the bearing raceways (Figure 8).

The bearing was then removed from the sliding unit and disassembled, revealing evidence of relative rotation between the sliding unit and the bearing outer ring. The debris present on the CT scan was identified as a combination of black dust and metallic particles. No grease, in its original form, remained in the bearing. Visual inspection of the surface of the bearing races confirmed the extent of the damage seen in the CT scans.

Scan images of duplex bearing showing raceway debris accumulation
