## Uncontrolled closure of a hatch cover resulting in one crew fatality on the cargo vessel *SMN Explorer* Alexandra Dock, King's Lynn on 1 February 2018

### SUMMARY

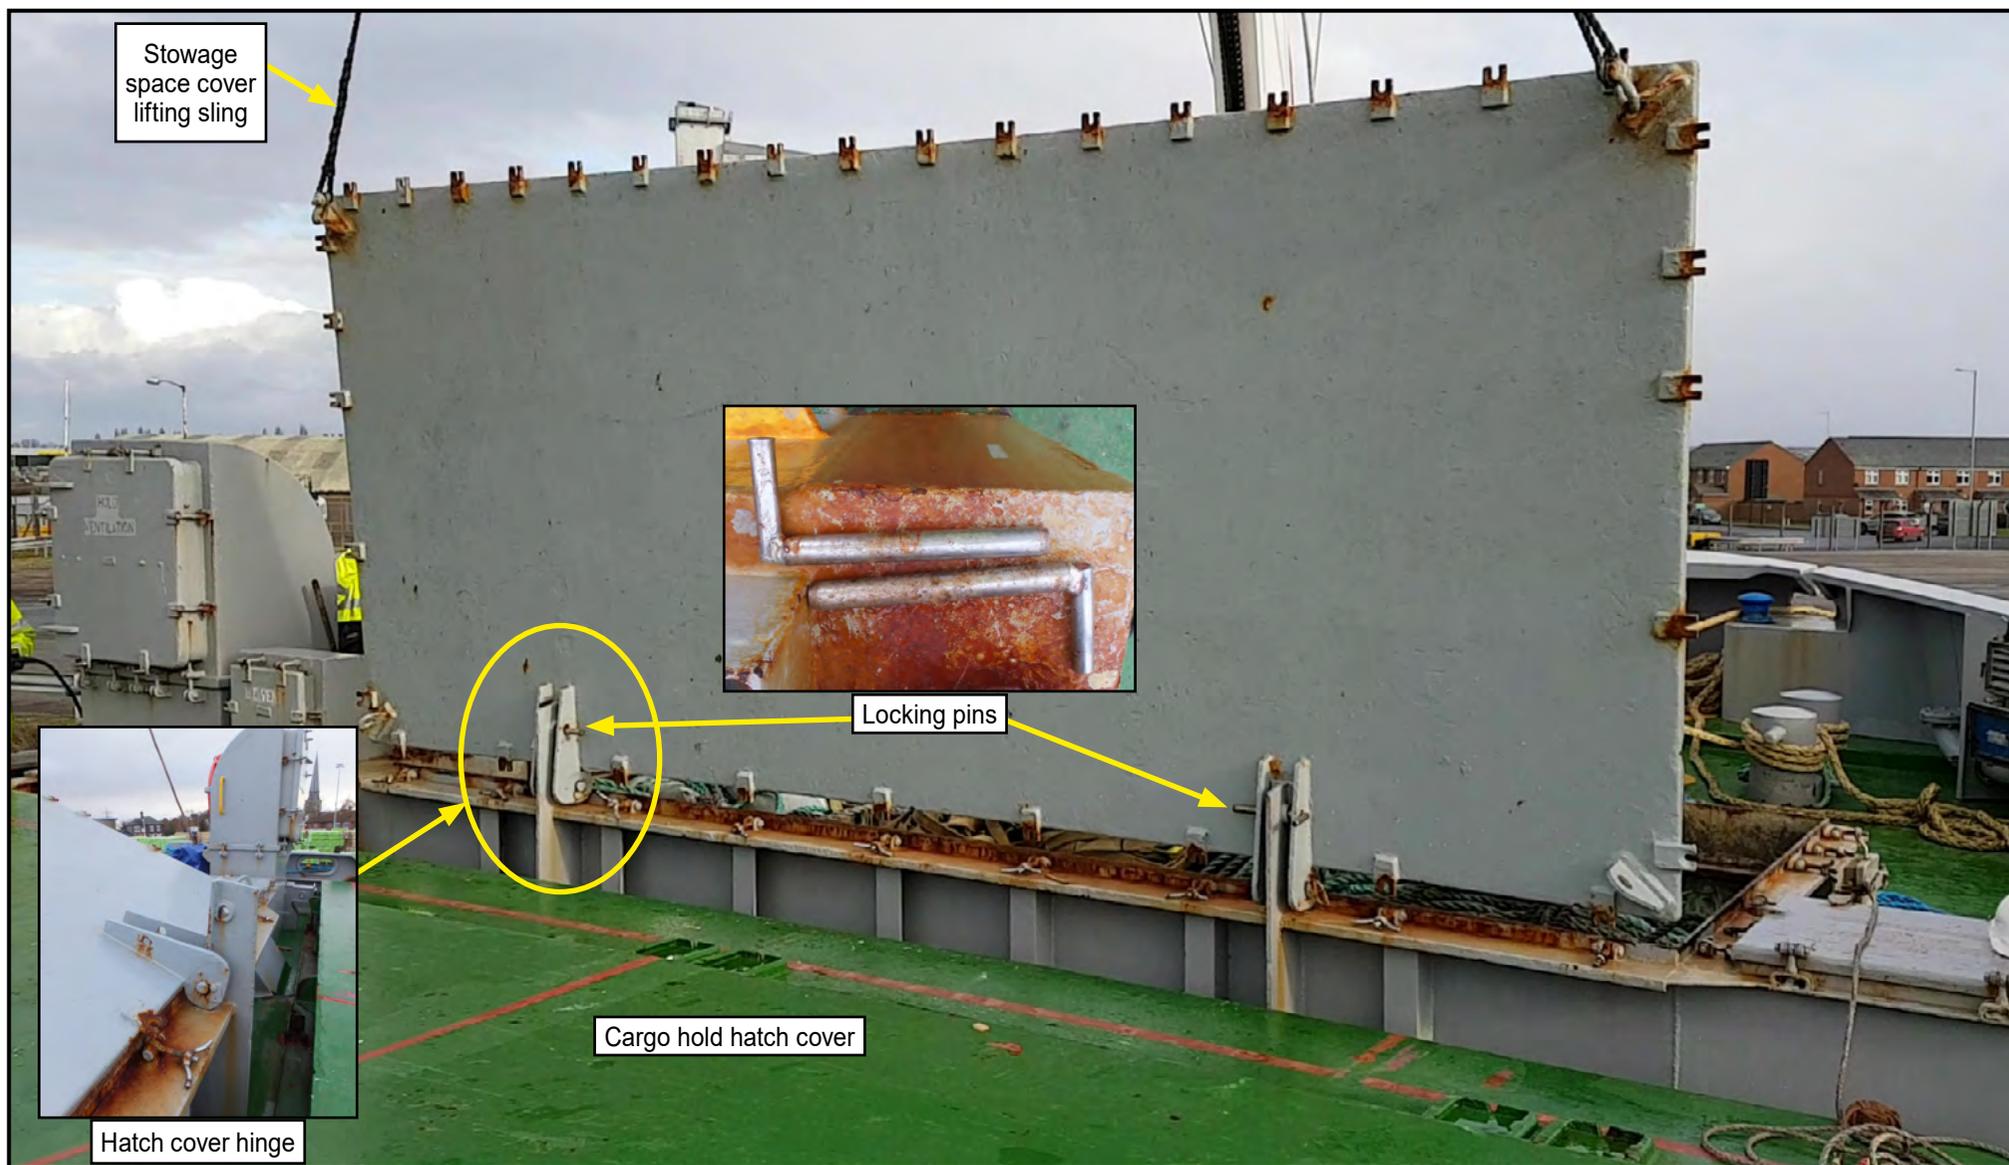
**Figure 1:** Stowage space hatch cover in opened position

In the open position, the hinged cover rested in a vertical position on its backstops and was locked in place by two locking pins. The stowage space hatch cover's original locking pins had been discarded due to corrosion, and new pins were on order. As an interim measure, the crew used the anchor guillotine locking pins to secure the cover in its open position.

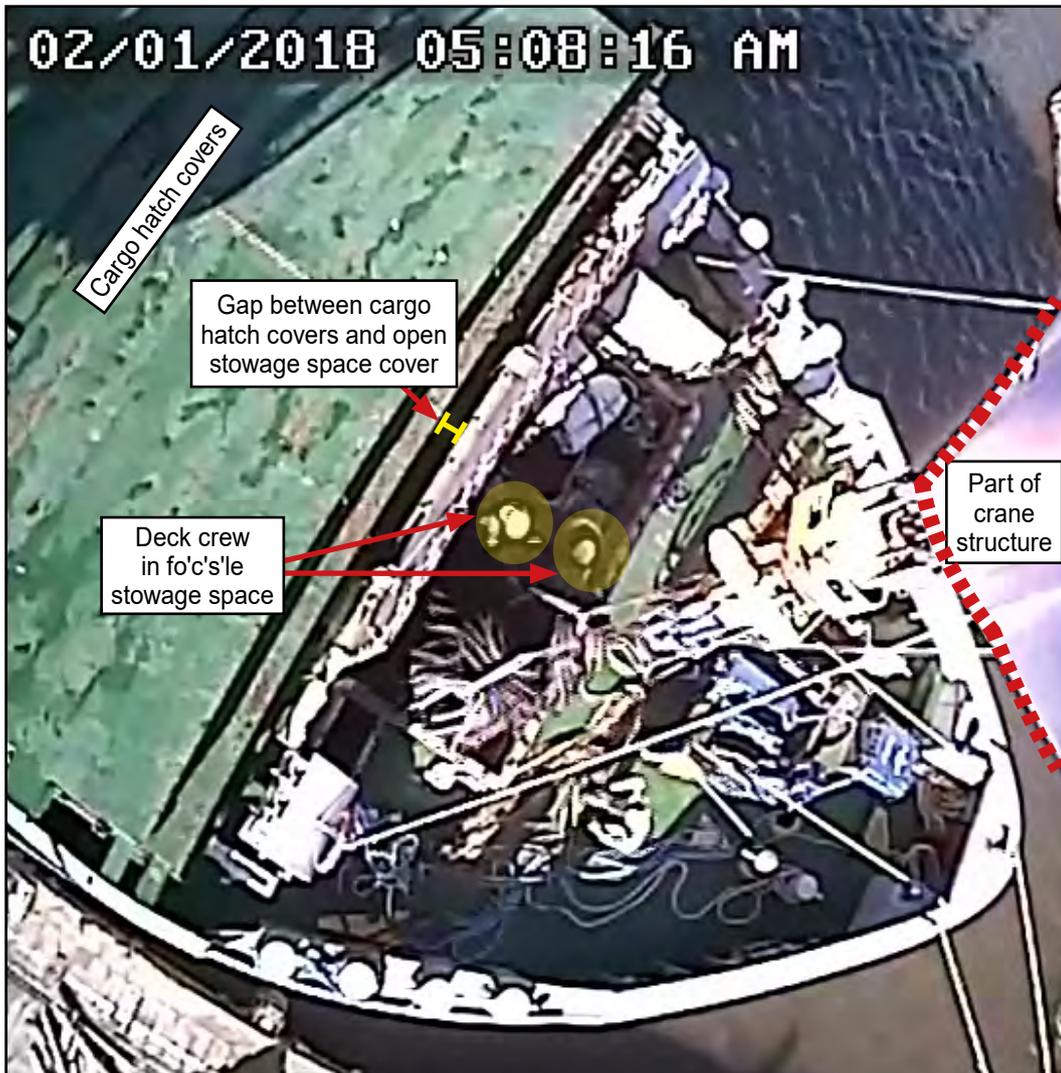
Figure 2: Snapshot taken from dockside crane camera

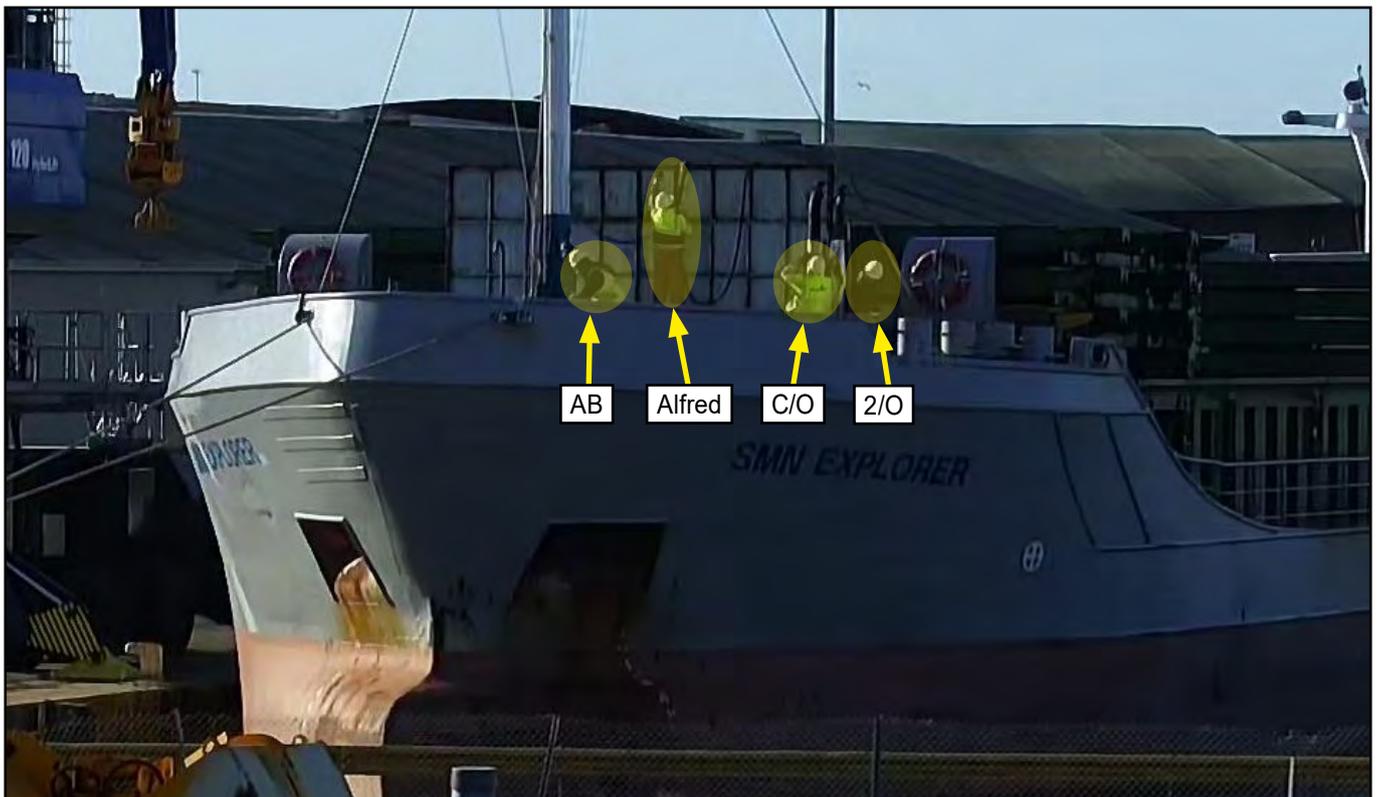
As the C/O lowered the crane hook, Alfred climbed over the fo'c's'le stowage space hatch combing and walked over the cargo slings to the hatch cover. Alfred then climbed up the inside of the hatch cover, using the framing as hand and foot holds, and reached up to grab the lifting slings (**Figure 3**). As he did so the hatch cover fell forward, trapping him between the hatch cover and the hatch coaming.

Figure 3: Position of the deck crew as Alfred climbed up the underside of the stowage space cover

The hatch cover fell on top of Alfred because he put his weight on the inside of the open cover after its locking pins had been removed and before the crane hook had been attached to the lifting slings and tensioned. This procedural lapse occurred because a safe system of work had not been developed for opening and closing the hatch cover and because the operation was not properly supervised. Factors that contributed to this include:

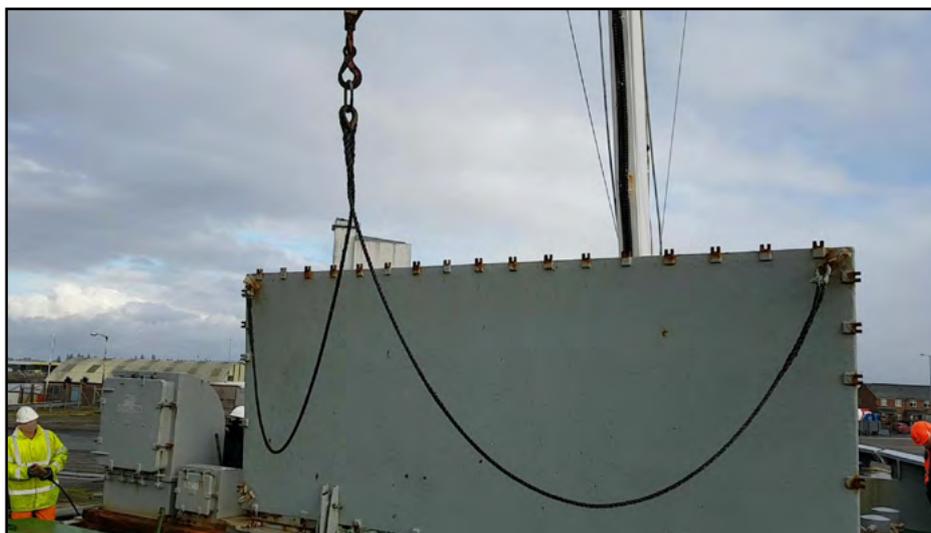
**Figure 4:** Hatch cover slings attached to crane hook

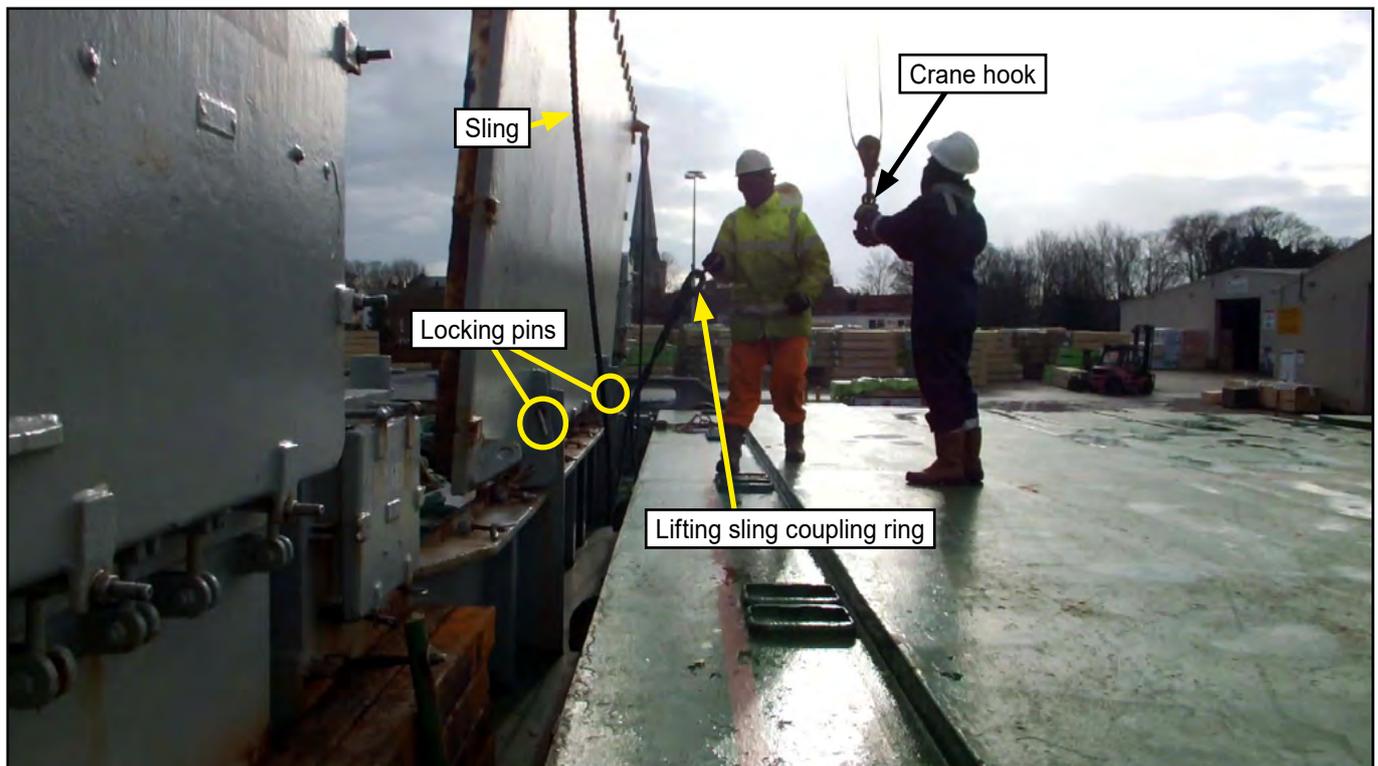
**Figure 5:** Crew demonstrating revised procedures after accident

After the accident, the C/O wrote and demonstrated a procedure that removed the need to enter the stowage space while opening and closing its hatch cover. The revised procedure required the crew to climb on top of the cargo hold hatch covers instead. This procedural approach might seem obvious; it certainly removed the need to enter a potential danger zone, walk on uneven surfaces and climb up the underside of the cover. Nevertheless, it is understandable why this procedure was not adopted previously by *SMN Explorer's* crew. On the day of the accident four of the vessel's cargo hold hatch covers had been stacked on top of each other behind the fo'c's'le stowage space. This made access behind the open cover difficult (**Figure 7**). On other occasions the forward cargo hold hatch covers could be stowed aft, creating a serious fall hazard.

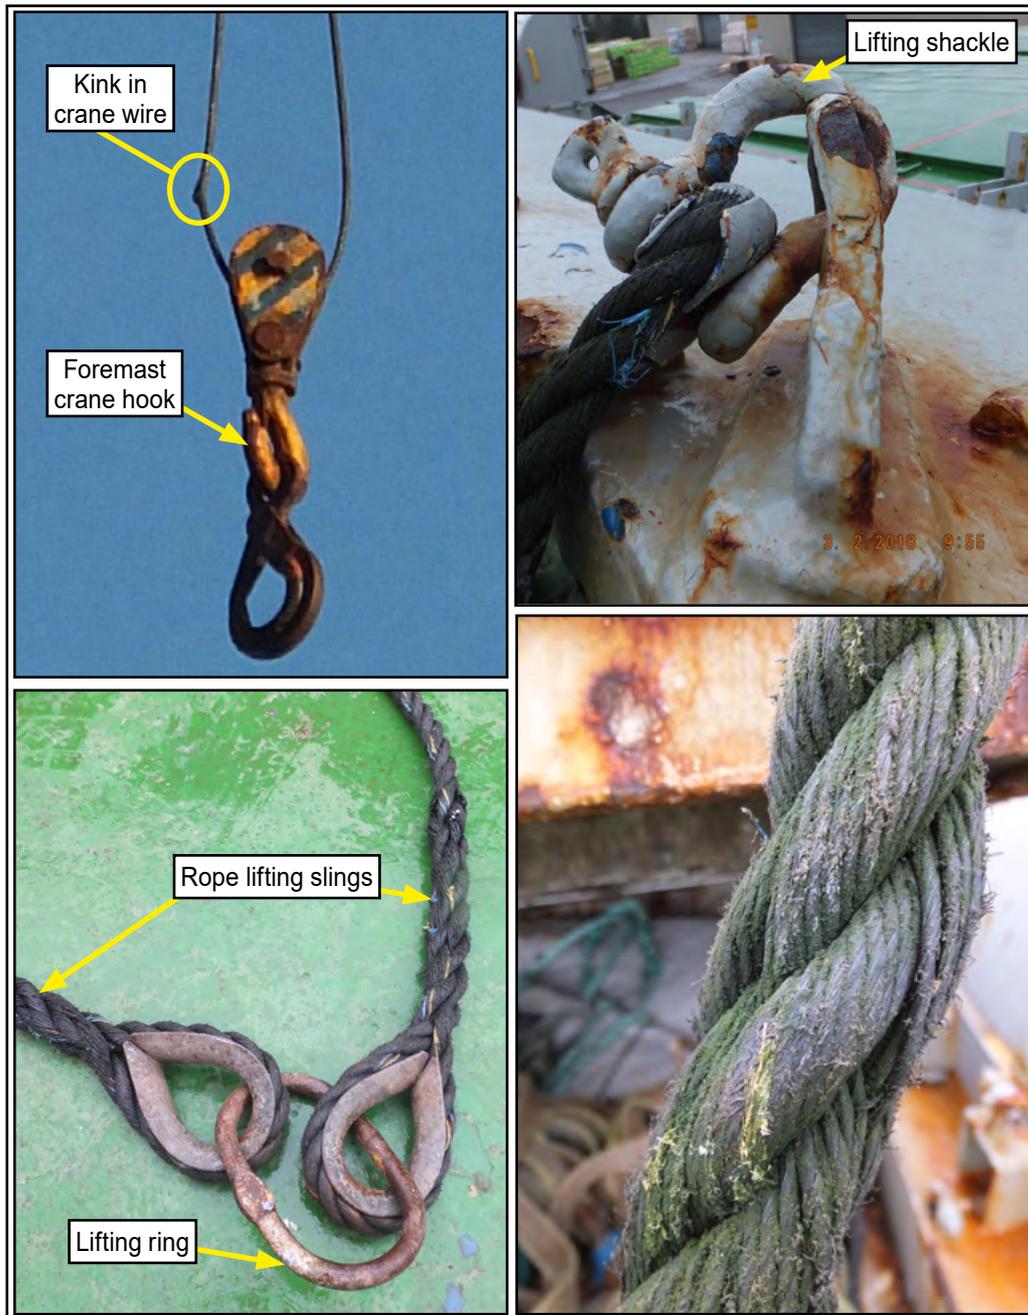
- Numerous hand and foot marks were present on the stowage space hatch cover's internal frames.
- The anchor guillotine locking pins were a loose fit in the hatch cover and backstop locating holes, and had no means of being locked in place.
- The rope lifting slings appeared to be in poor condition.

- Much of the lifting gear examined on the fo’c’s’le deck was found to be in a similarly poor state (**Figure 6**).
- There was no lifting appliance register on board.

**Figure 6:** Stowage space cover lifting gear

The opening and closing of the fo'c's'le stowage space hatch cover was a lifting operation and, as such, it should have been properly planned and executed. Furthermore, the equipment used to lift the cover should have been subject to strict maintenance and testing routines that should have been recorded in a lifting appliance register. This was not the case; the SMS contained no guidance for planning lifting operations or the maintenance of lifting equipment. The vessel held no certification for the foremast crane and the condition of much of the lifting gear inspected by the MAIB was poor.

| <b>2018/135</b> | Ensure that <i>SMN Explorer</i> and all its managed vessels have systems in place to manage and record the maintenance of lifting appliances. |

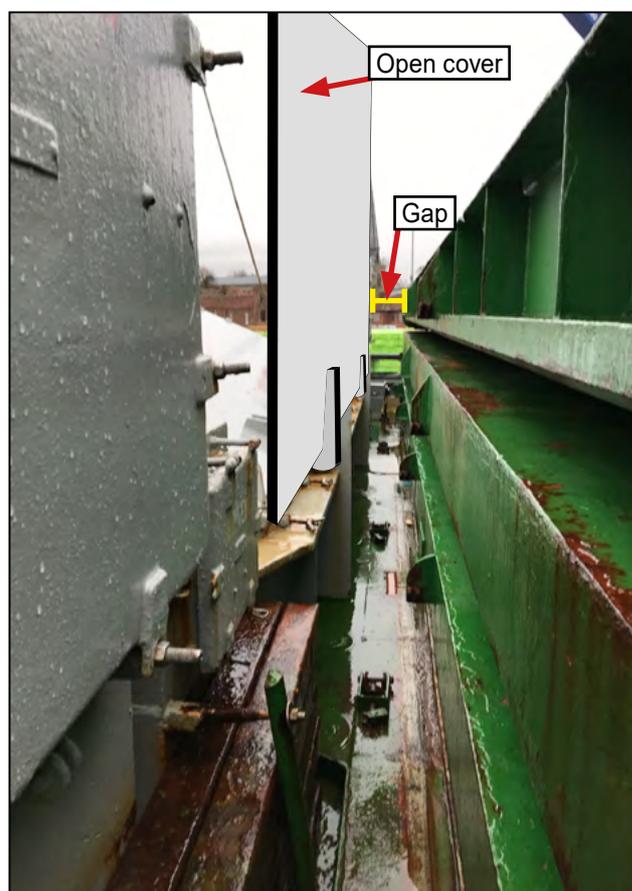
**Figure 7:** Gap between the open stowage space cover and the stacked cargo hatch covers
